Prestons Subdivision
GEOTECHNICAL REPORT FOR LOT 913
CDL Land NZ Limited

30 April 2021
Revision: 1
Reference: 235361

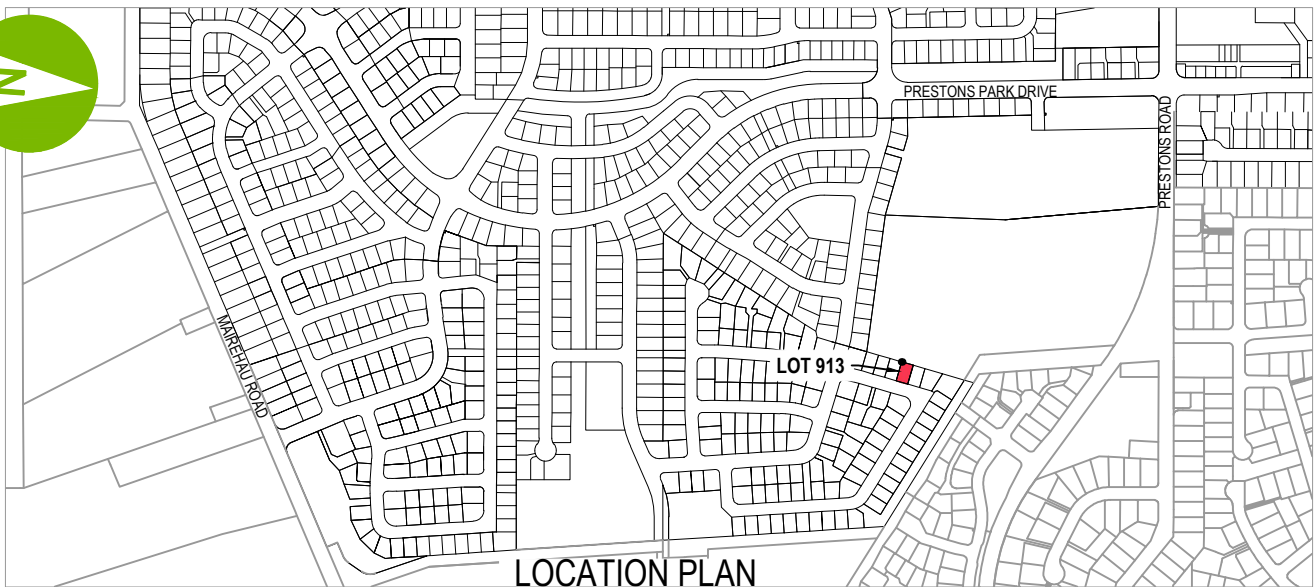
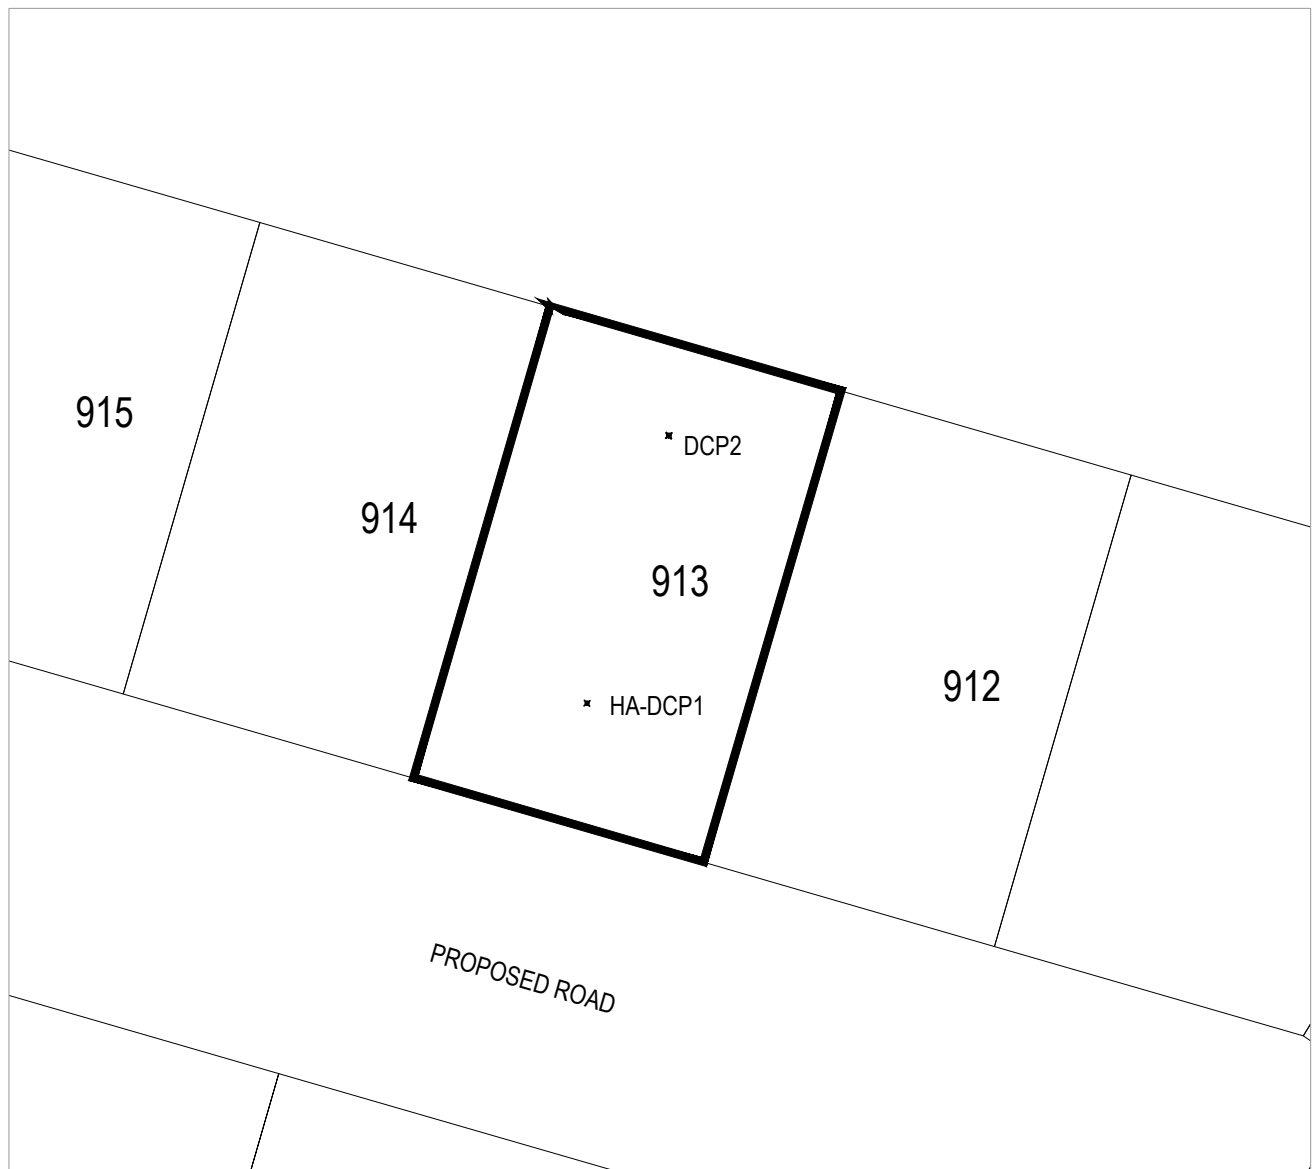
PROJECT
PRESTONS PARK
TITLE
LOT 913 SITE LOCATION PLAN FIGURE 1

This building consent report is for Lot 913 which is located in Stage 4 of the Prestons South Subdivision development (refer Figure 1 in Appendix A). The lot is bordered by residential lots to the north and south, an access road to the east and the Alpine View Retirement Village to the west.

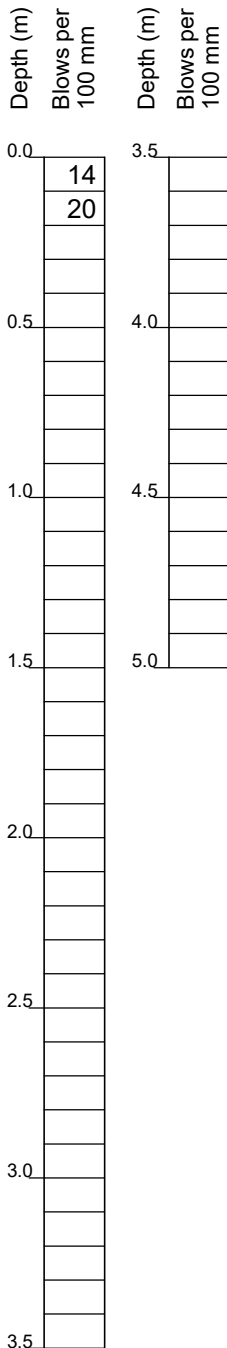
DCP logs indicate 5 blows per 100mm penetration, which is equivalent to an ultimate bearing capacity of 300kPa, was consistently encountered from a shallow depth.

20 blows for 100mm in the last increment.
Co-ordinates and elevation data from site survey.
Elevation based on Christchurch Drainage Datum.
Effective refusal, 20+ blows per 100mm

NZS 3604:2011 'Good Ground' Acceptance Criteria
MBIE '200kPa geotechnical ultimate bearing capacity' Acceptance Criteria

Based on our understanding of the site works and the investigation results, we recommend that NZS3604:2011 compliant foundations are embedded a minimum depth of 0.4m below current ground level.
