Prestons Subdivision
GEOTECHNICAL REPORT FOR LOT 915
CDL Land NZ Limited

30 April 2021
Revision: 1
Reference: 235361

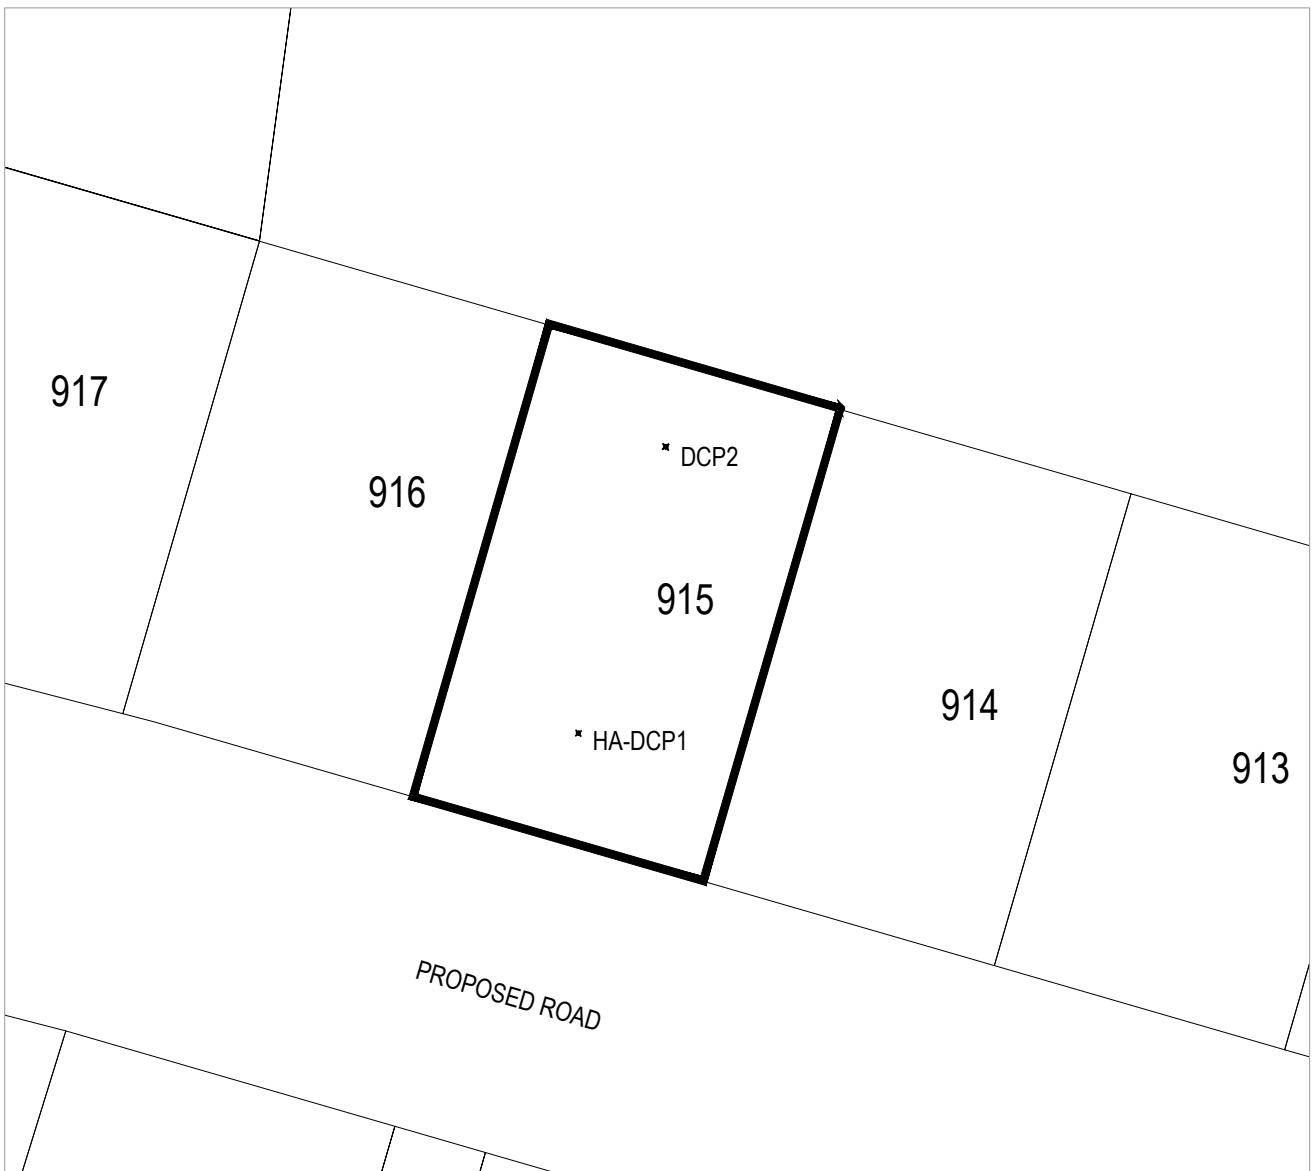
PROJECT	
PRESTONS PARK	
TITLE	
LOT 915 SITE LOCATION PLAN FIGURE 1

This building consent report is for Lot 915 which is located in Stage 4 of the Prestons South Subdivision development (refer Figure 1 in Appendix A). The lot is bordered by residential lots to the north and south, an access road to the east and the Alpine View Retirement Village to the west.

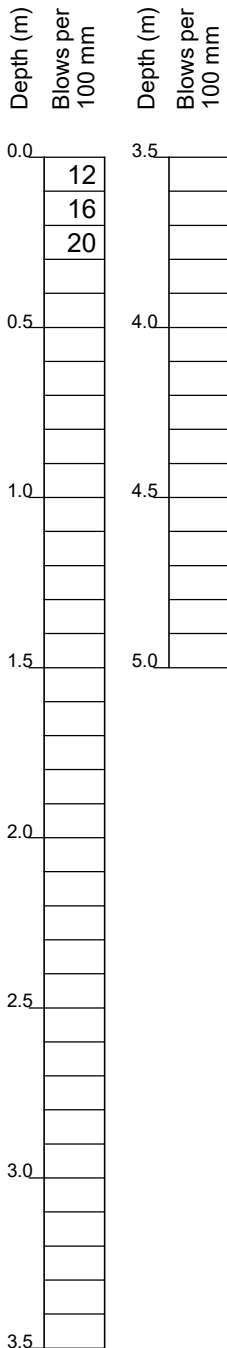
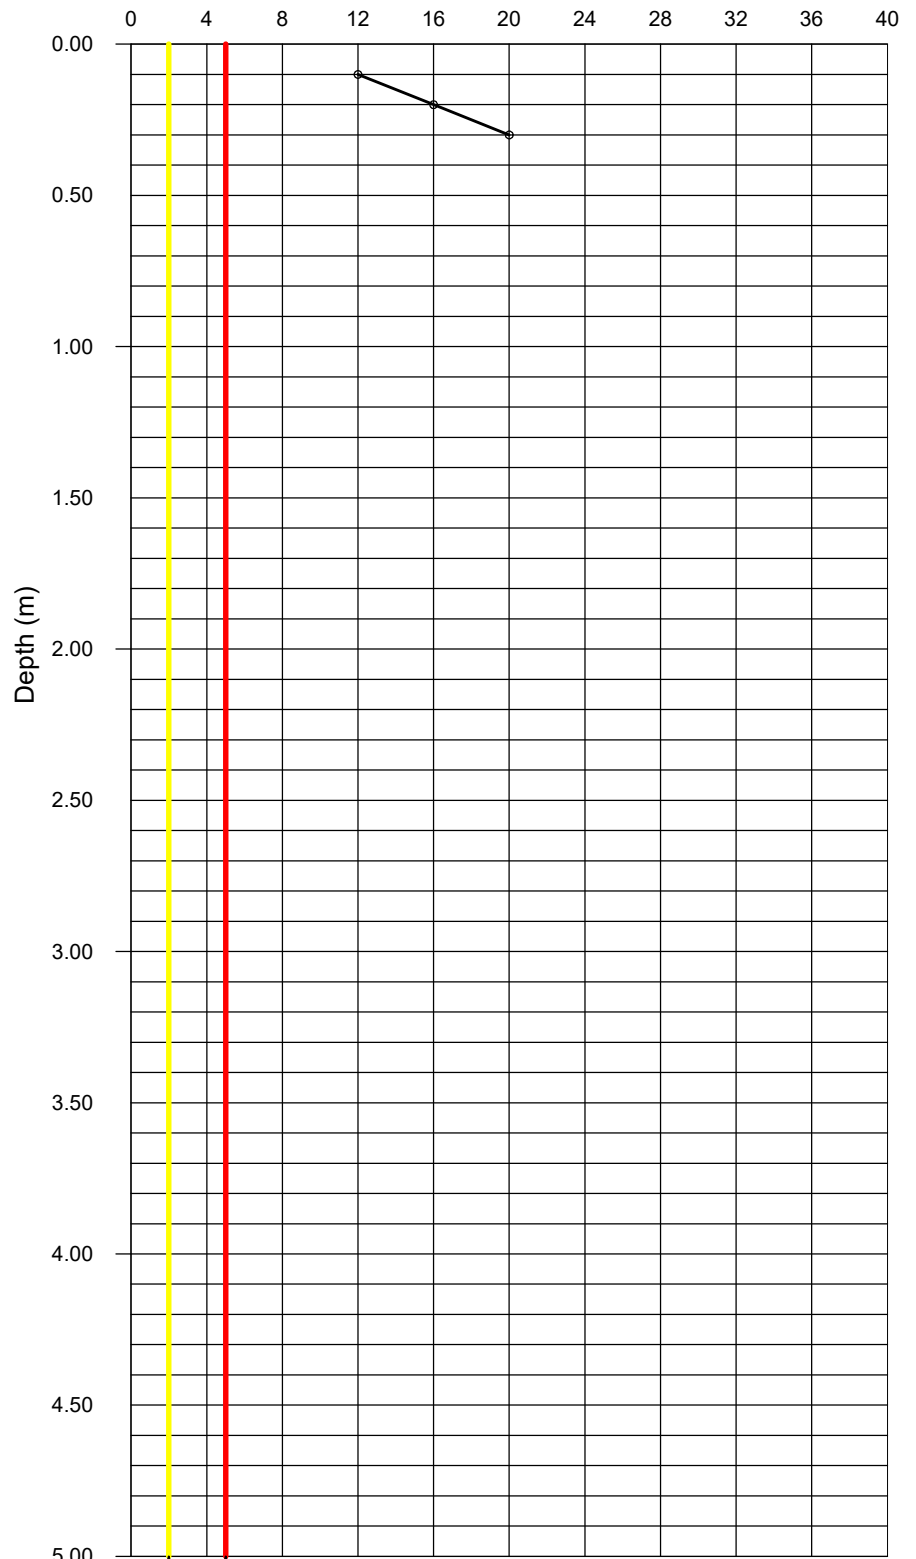
DCP logs indicate 5 blows per 100mm penetration, which is equivalent to an ultimate bearing capacity of 300kPa, was consistently encountered from a shallow depth.

20 blows for 100mm in the last increment.
Co-ordinates and elevation data from site survey.
Elevation based on Christchurch Drainage Datum.
Effective refusal, 20+ blows per 100mm

NZS 3604:2011 'Good Ground' Acceptance Criteria
MBIE '200kPa geotechnical ultimate bearing capacity' Acceptance Criteria

Based on our understanding of the site works and the investigation results, we recommend that NZS3604:2011 compliant foundations are embedded a minimum depth of 0.4m below current ground level.
