Prestons Subdivision  
GEOTECHNICAL REPORT FOR LOT 916  
CDL Land NZ Limited

30 April 2021  
Revision: 1  
Reference: 235361

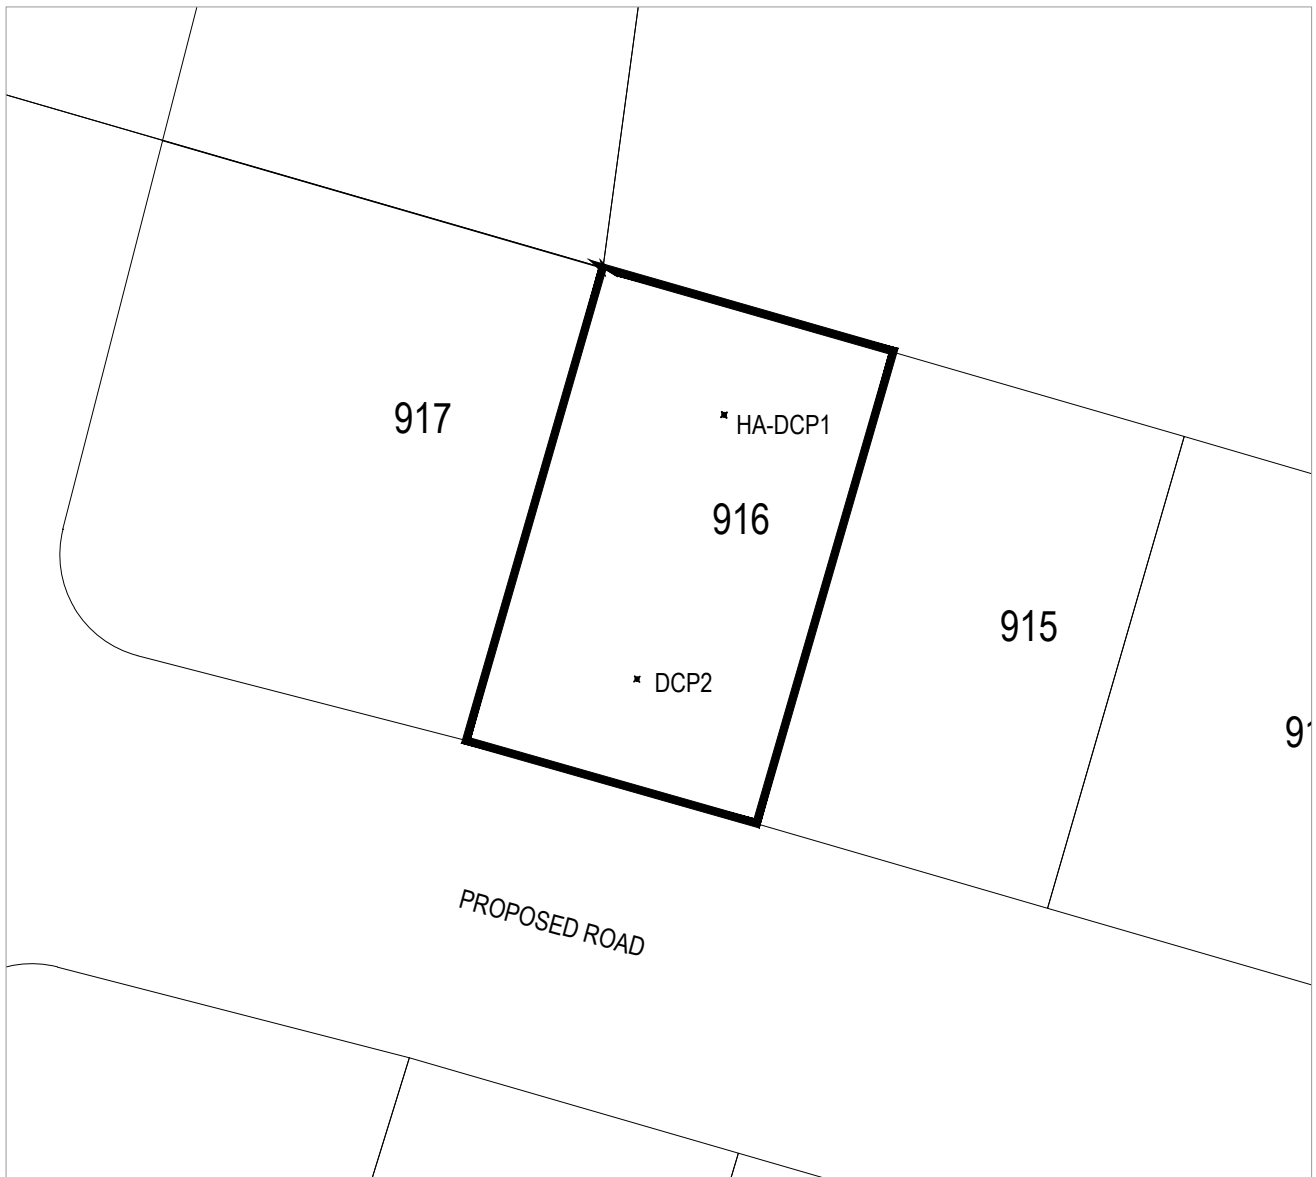
PROJECT
PRESTONS PARK
TITLE
LOT 916 SITE LOCATION PLAN FIGURE 1

This building consent report is for Lot 916 which is located in Stage 4 of the Prestons South Subdivision development (refer Figure 1 in Appendix A). The lot is bordered by residential lots to the north and south, an access road to the east and the Alpine View Retirement Village to the west.
