Prestons Park Subdivision
GEOTECHNICAL REPORT FOR LOT 898
CDL Land NZ Limited

12 February 2021
Revision: 1
Reference: 235361

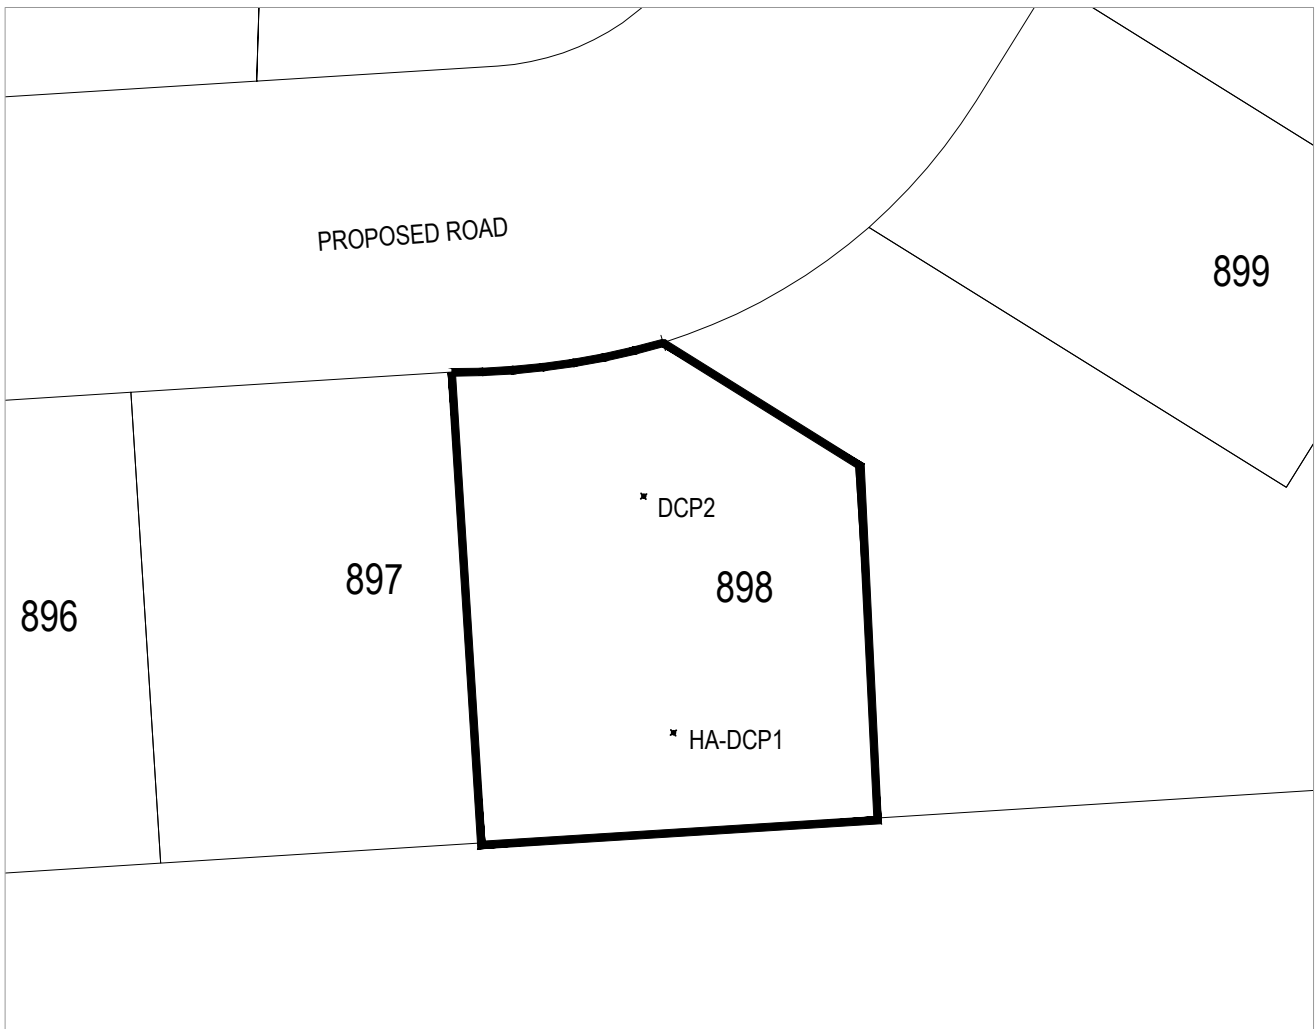
This building consent report is for Lot 898 which is located in Stage 4 of the Prestons South Subdivision development (refer Figure 1 in Appendix A). The lot is bordered by a residential lot to the south, an access road to the west, a storm water channel to the east and a local purpose reserve (utility) to the north.

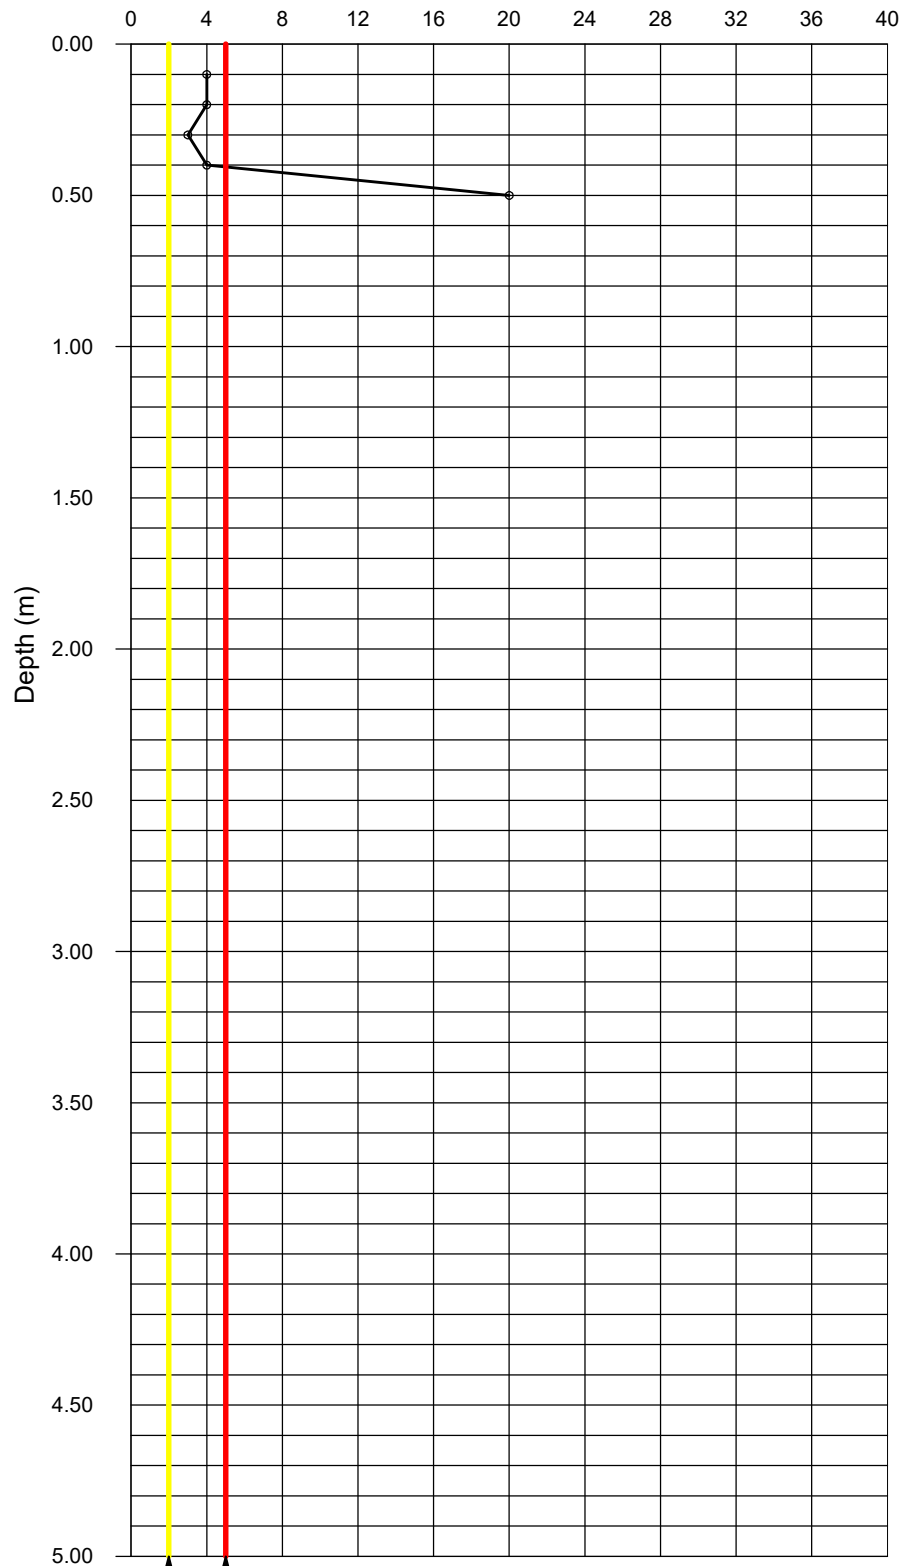
Depth (m)	Blows per 100 mm	Depth (m)	Blows per 100 mm
0.0	4	3.5	
0.1	4		
0.2	3		
0.3	4		
0.4	20		
0.5		4.0	
1.0		4.5	
1.5		5.0	
2.0			
2.5			
3.0			
3.5

20 blows for 100mm in the last increment.
Co-ordinates and elevation data from site survey.
Elevation based on Christchurch Drainage Datum.
Effective refusal on gravel, 20+ blows per 100mm

NZS 3604:2011 'Good Ground' Acceptance Criteria
MBIE '200kPa geotechnical ultimate bearing capacity' Acceptance Criteria

Two DCPs were carried out with the locations and results uploaded to the NZGD. The DCP test results are attached in Appendix B. One of the DCPs was located adjacent to the hand auger borehole, with the second DCP located on the opposite half of the lot.

DCP logs indicate two blows per 100mm penetration, which is equivalent to an ultimate bearing capacity of 200kPa, was consistently encountered from a shallow depth.

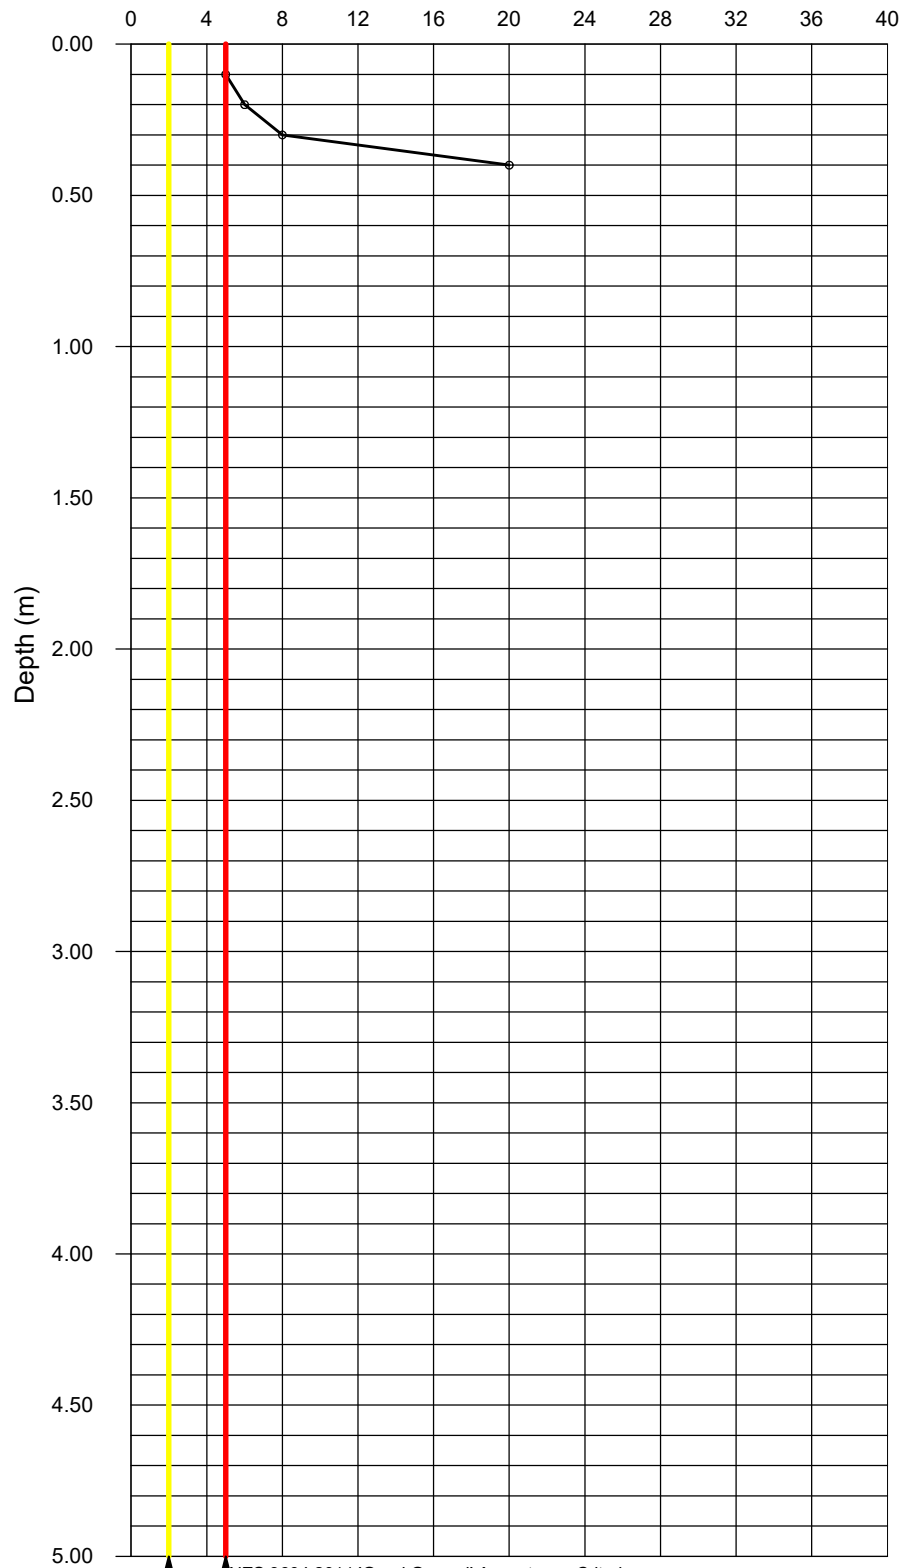
20 blows for 100mm in the last increment.
Co-ordinates and elevation data from site survey.
Elevation based on Christchurch Drainage Datum.
Effective refusal on gravel, 20+ blows per 100mm

NZS 3604:2011 'Good Ground' Acceptance Criteria
MBIE '200kPa geotechnical ultimate bearing capacity' Acceptance Criteria
