Prestons Park Subdivision
GEOTECHNICAL REPORT FOR LOT 899
CDL Land NZ Limited

23 April 2021
Revision: 1
Reference: 235361

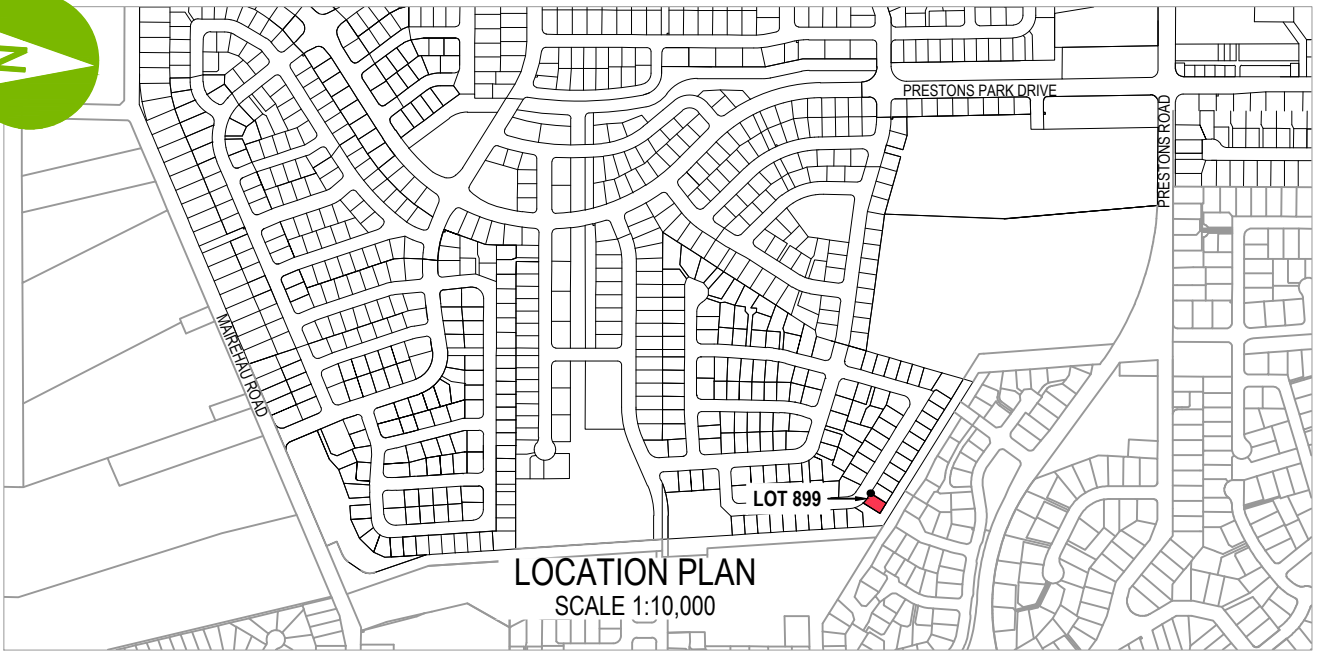
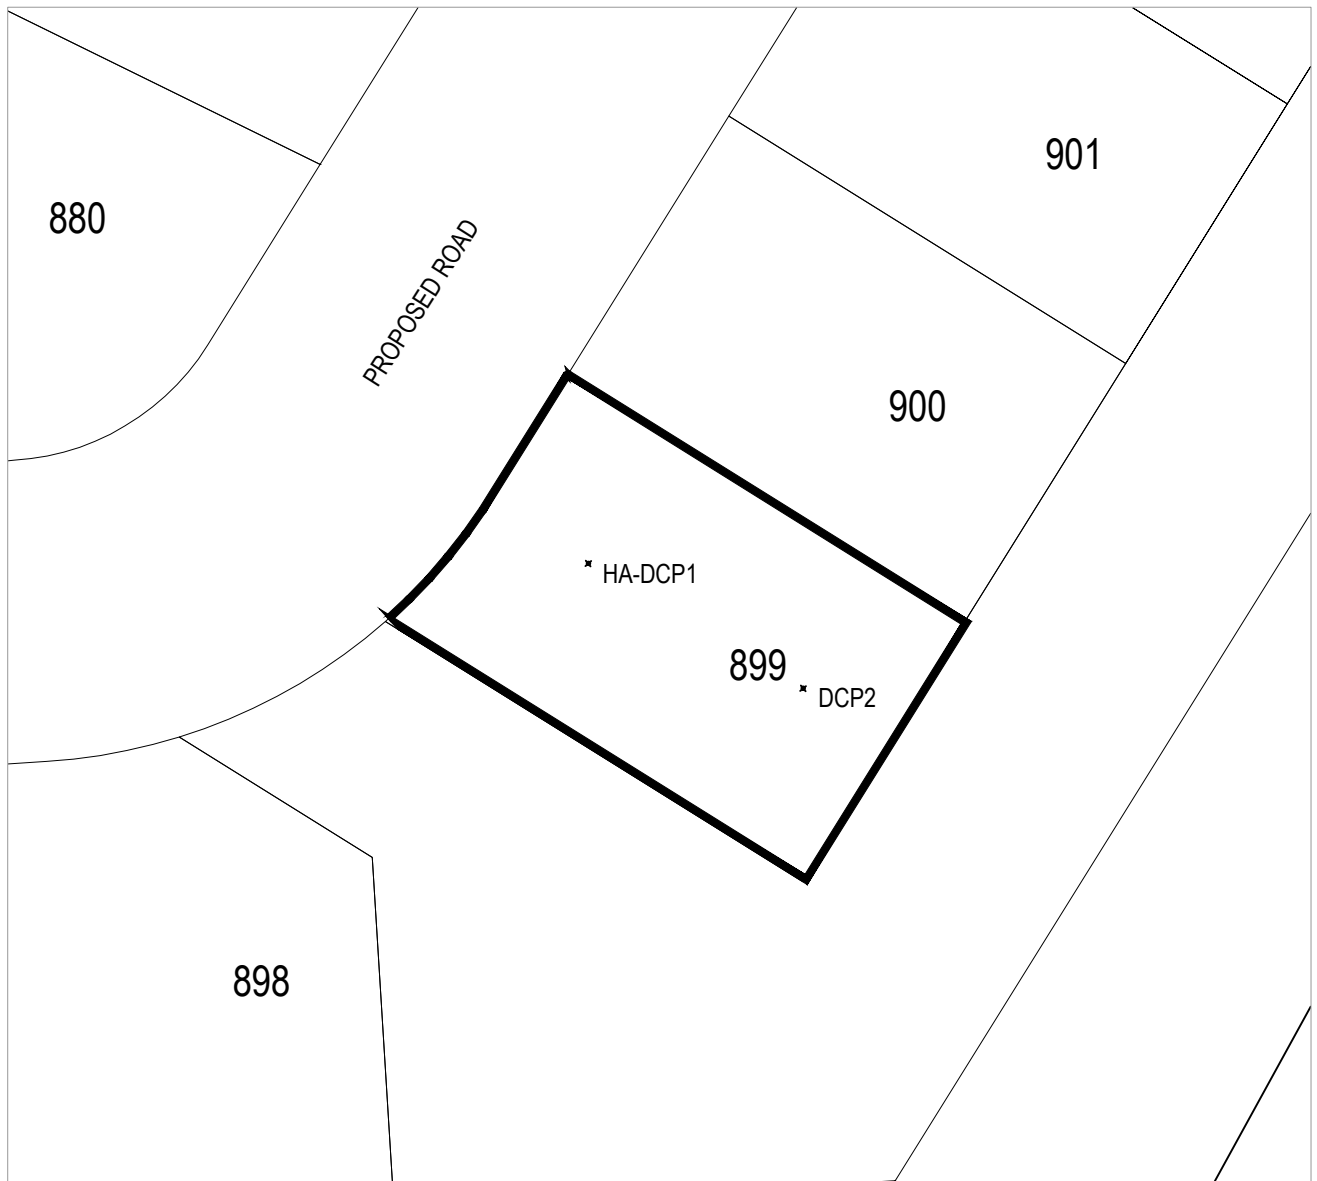
This building consent report is for Lot 899 which is located in Stage 4 of the Prestons South Subdivision development (refer Figure 1 in Appendix A). The lot is bordered by a residential lot to the north-west, an access road to the south-west and a local purpose reserve (utility) to the east.

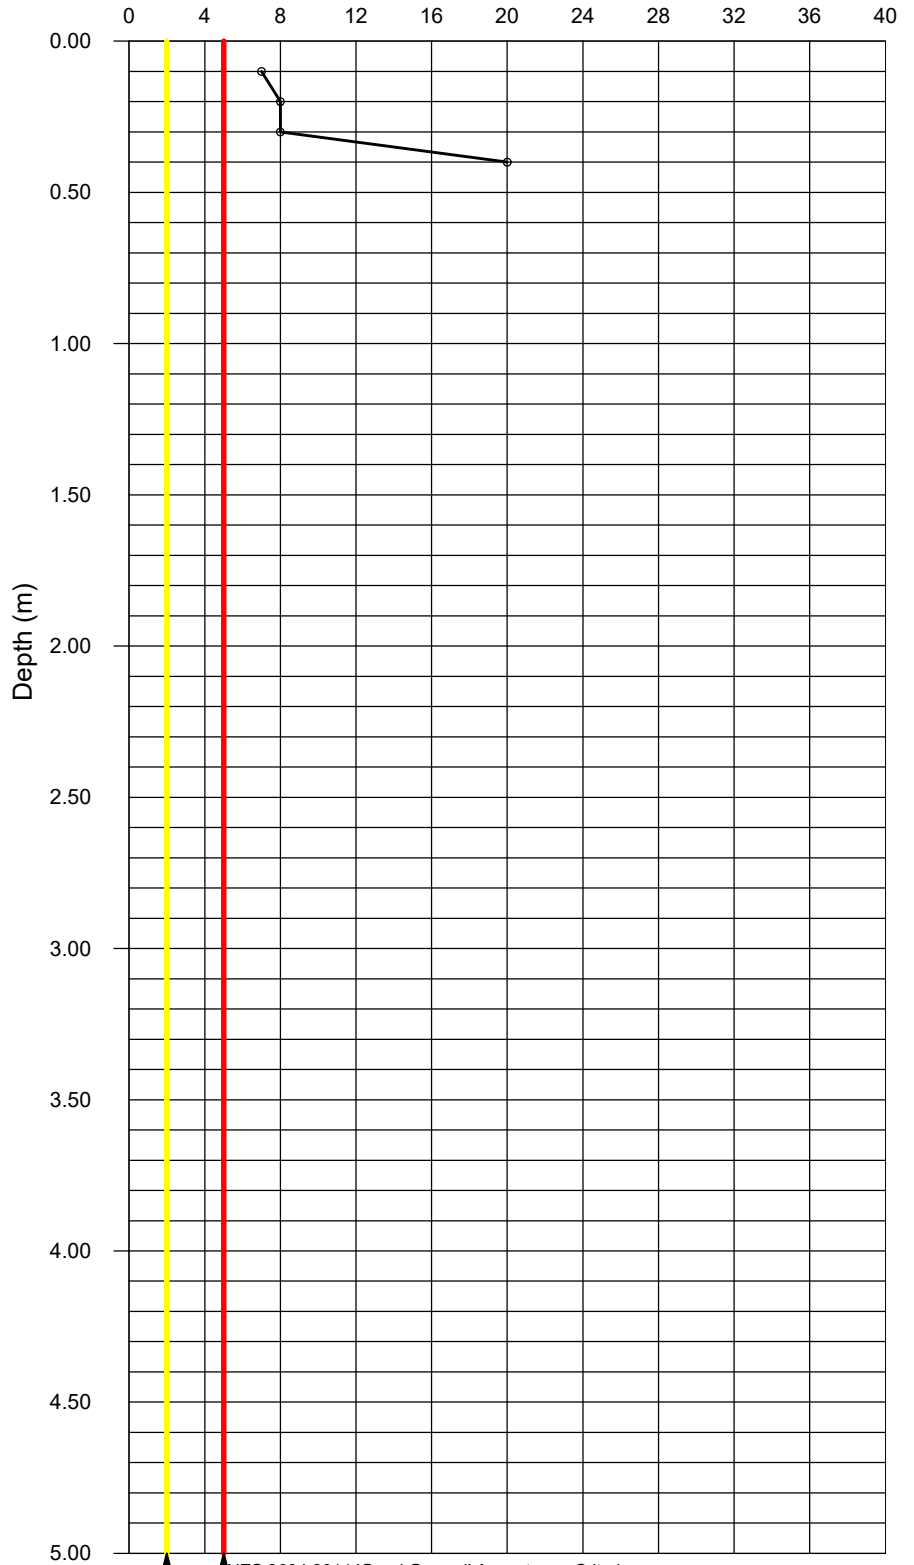
Depth (m)	Blows per 100 mm	Depth (m)	Blows per 100 mm
0.0	7	3.5	
0.1	8		
0.2	8		
0.3	20		
0.4			
0.5			
1.0			
1.5			
2.0			
2.5			
3.0			
3.5

20 blows for 100mm in the last increment.
Co-ordinates and elevation data from site survey.
Elevation based on Christchurch Drainage Datum.
Effective refusal on gravel, 20+ blows per 100mm

NZS 3604:2011 'Good Ground' Acceptance Criteria
MBIE '200kPa geotechnical ultimate bearing capacity' Acceptance Criteria

Two DCPs were carried out with the locations and results uploaded to the NZGD. The DCP test results are attached in Appendix B. One of the DCPs was located adjacent to the hand auger borehole, with the second DCP located on the opposite half of the lot.

DCP logs indicate two blows per 100mm penetration, which is equivalent to an ultimate bearing capacity of 200kPa, was consistently encountered from a shallow depth.

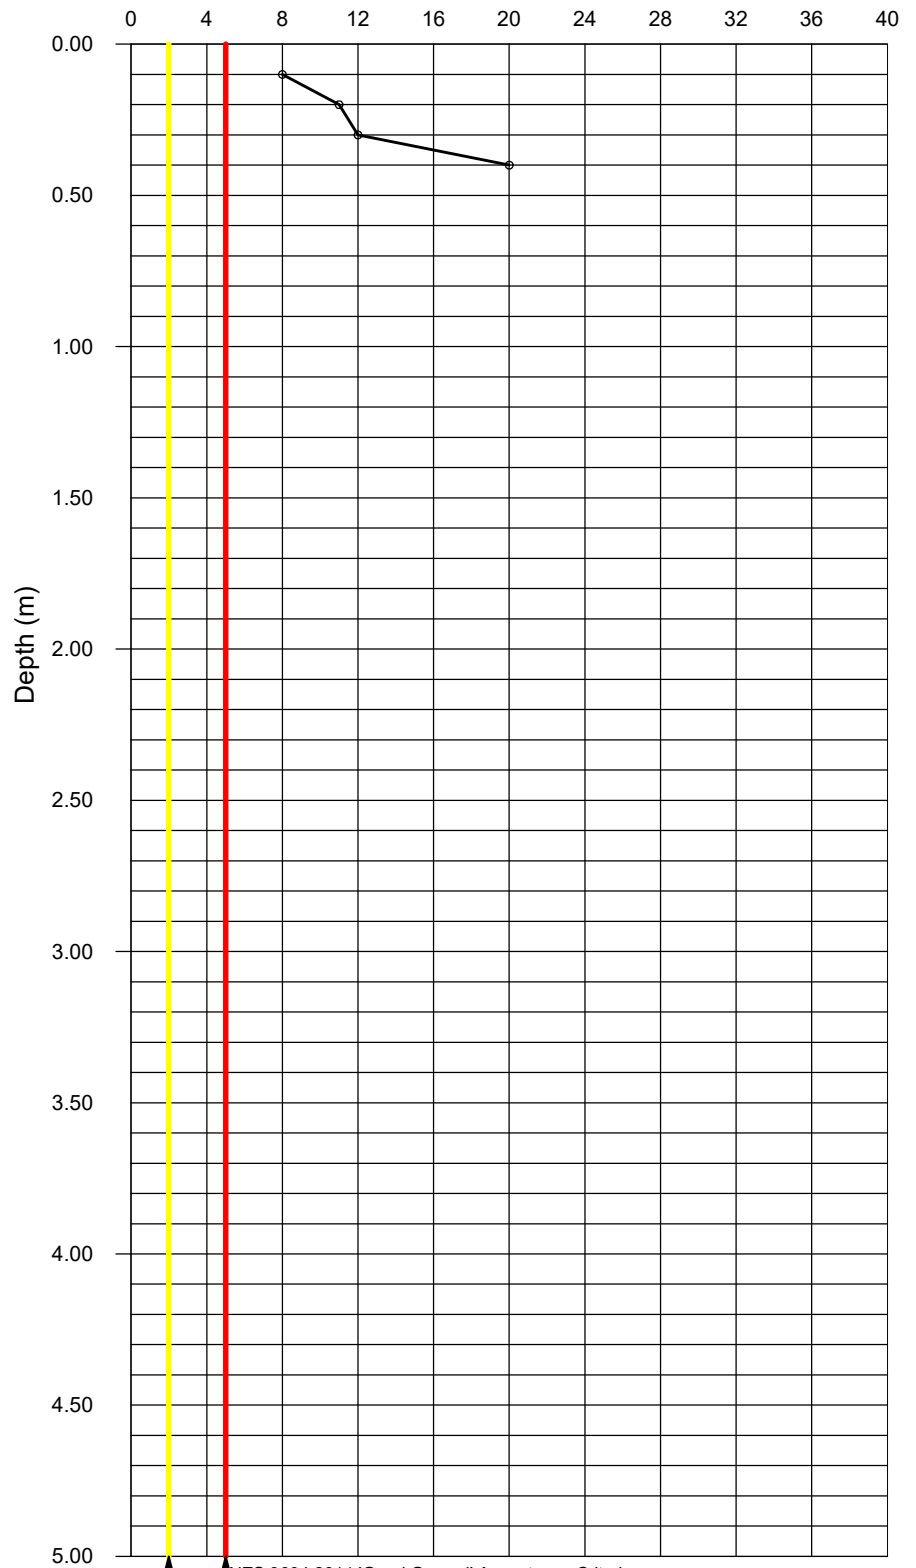
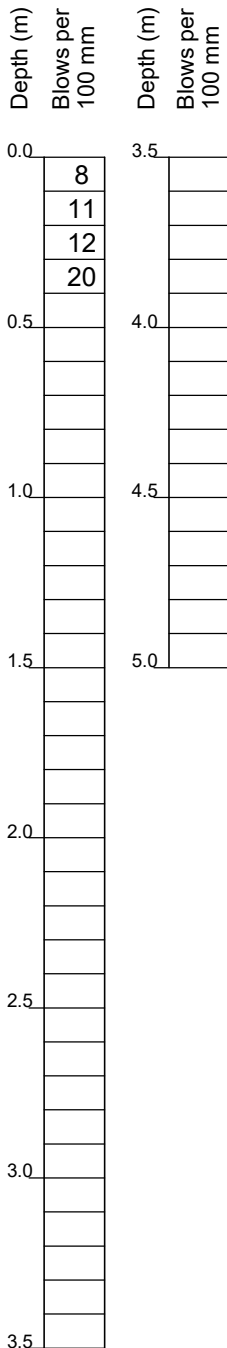
20 blows for 100mm in the last increment.
Co-ordinates and elevation data from site survey.
Elevation based on Christchurch Drainage Datum.
Effective refusal on gravel, 20+ blows per 100mm

NZS 3604:2011 'Good Ground' Acceptance Criteria
MBIE '200kPa geotechnical ultimate bearing capacity' Acceptance Criteria
