**Prestons Park Subdivision**  
**GEOTECHNICAL REPORT FOR LOT 900**  
**CDL Land NZ Limited**

**23 April 2021**  
**Revision: 1**  
**Reference: 235361**

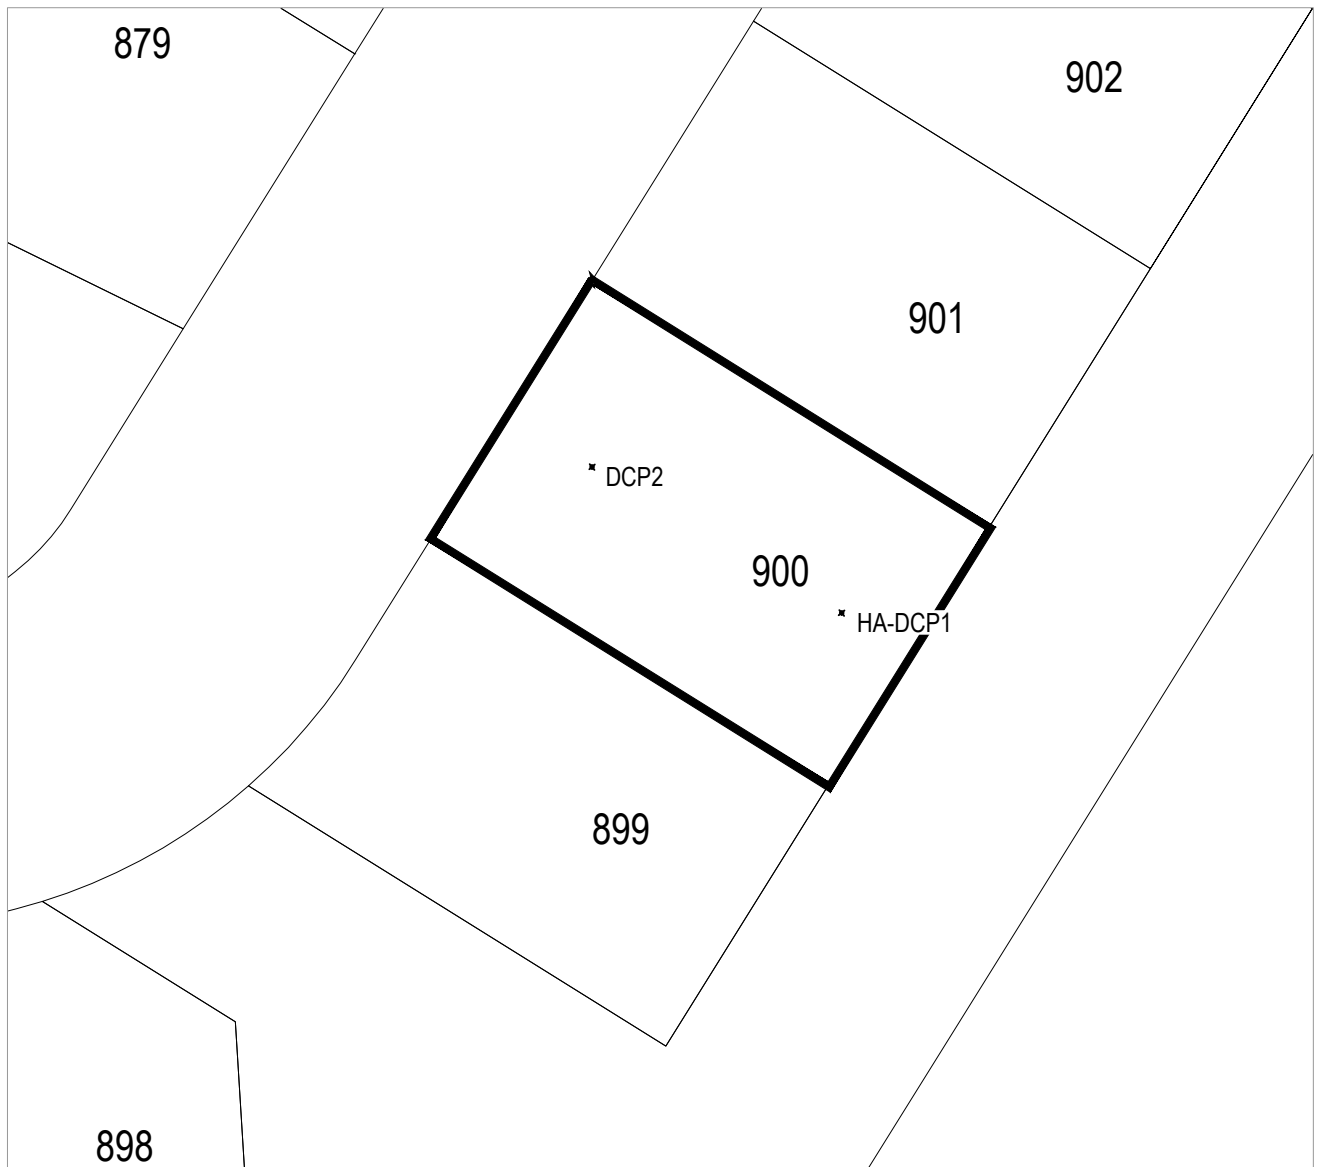
LOT 900  
SITE LOCATION PLAN  
FIGURE 1

This building consent report is for Lot 900 which is located in Stage 4 of the Prestons South Subdivision development (refer Figure 1 in Appendix A). The lot is bordered by residential lots to the north-west and south-east, an access road to the south and a local purpose reserve (utility) to the north.
