**Prestons Park Subdivision**  
**GEOTECHNICAL REPORT FOR LOT 901**  
**CDL Land NZ Limited**

**23 April 2021**  
**Revision: 1**  
**Reference: 235361**

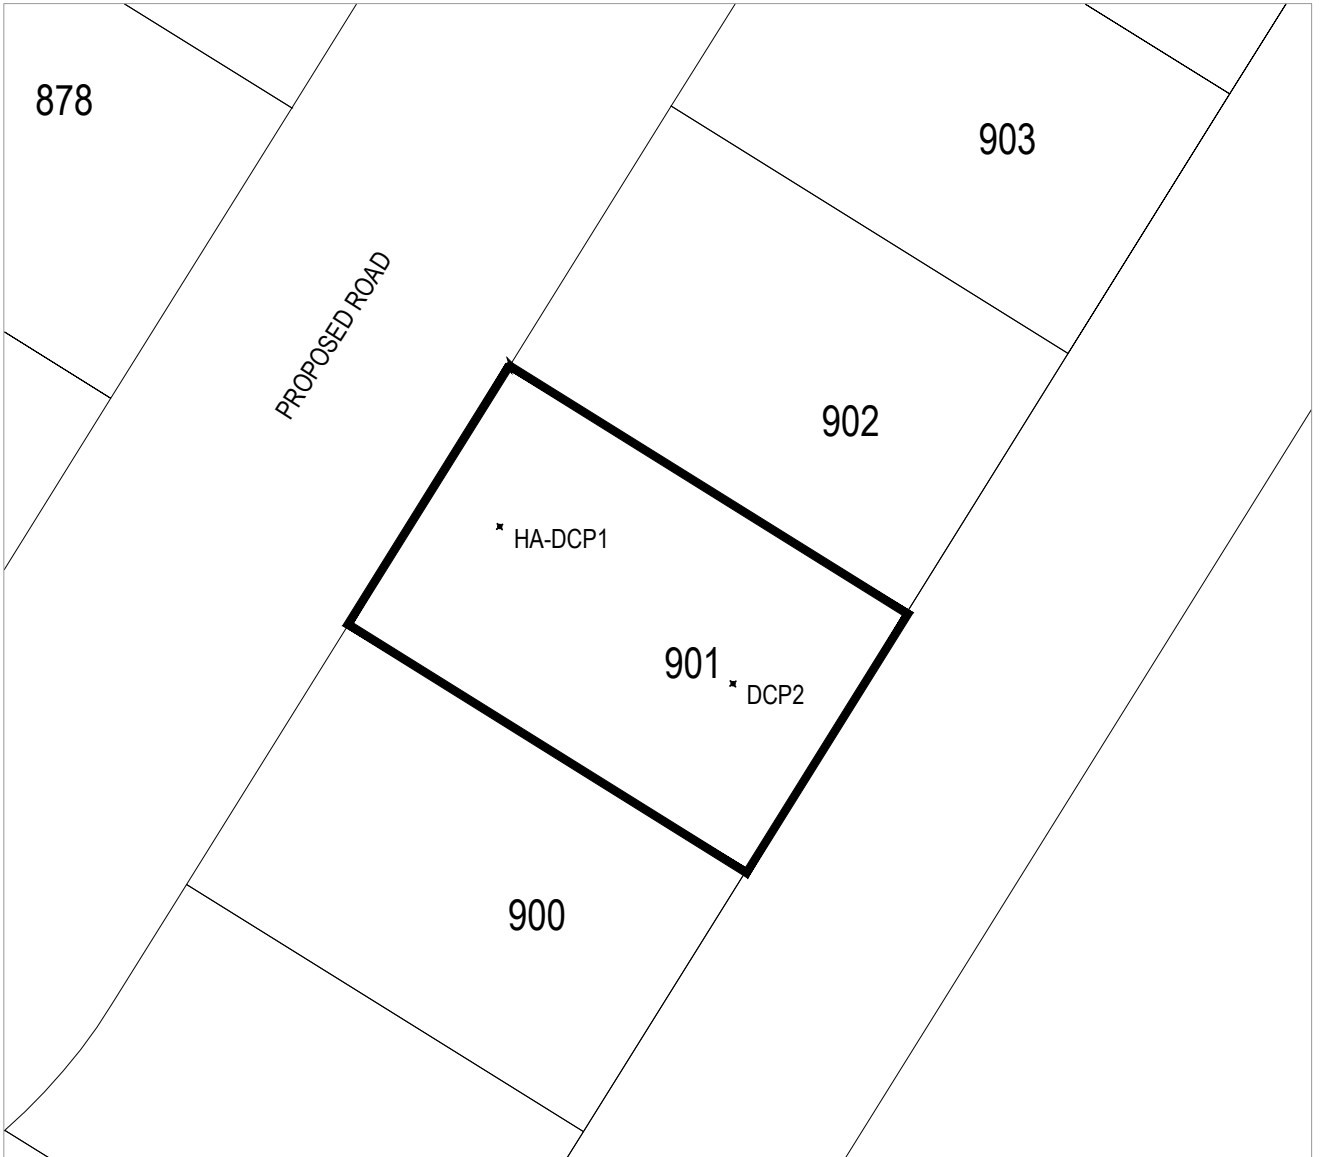
This building consent report is for Lot 901 which is located in Stage 4 of the Prestons South Subdivision development (refer Figure 1 in Appendix A). The lot is bordered by residential lots to the north-west and south-east, an access road to the south and a local purpose reserve (utility) to the north.
