Prestons Park Subdivision
GEOTECHNICAL REPORT FOR LOT 902
CDL Land NZ Limited

23 April 2021
Revision: 1
Reference: 235361

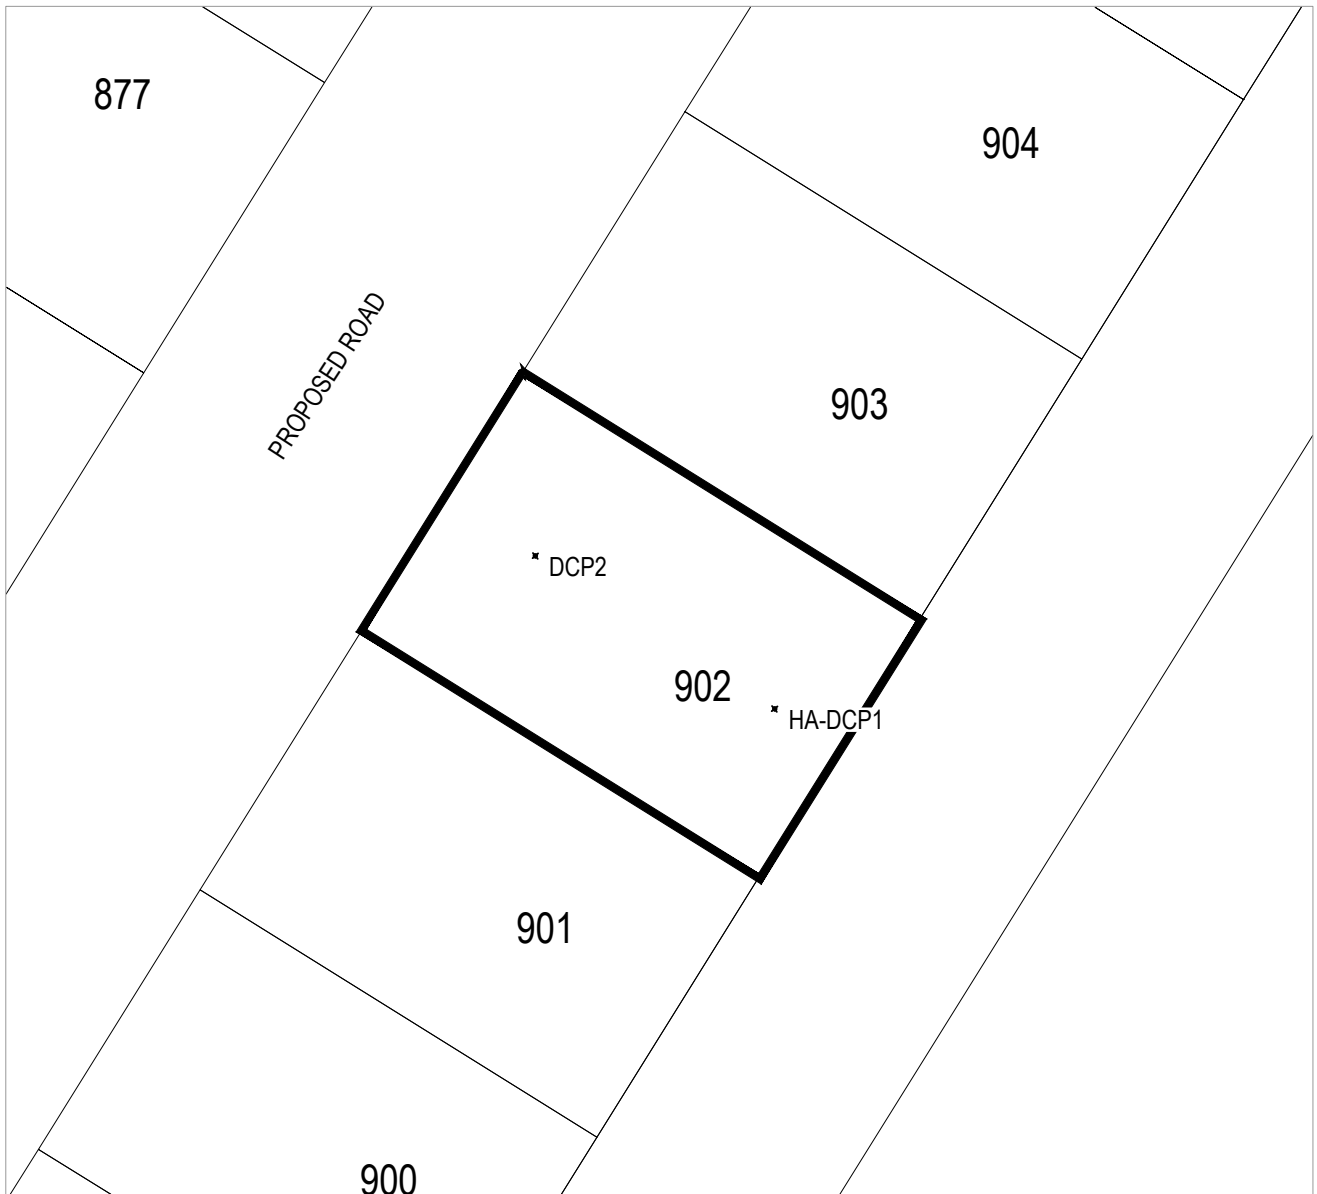
PROJECT
PRESTONS PARK
TITLE
LOT 902 SITE LOCATION PLAN FIGURE 1

This building consent report is for Lot 902 which is located in Stage 4 of the Prestons South Subdivision development (refer Figure 1 in Appendix A). The lot is bordered by residential lots to the north-west and south-east, an access road to the south and a local purpose reserve (utility) to the north.

Two DCPs were carried out with the locations and results uploaded to the NZGD. The DCP test results are attached in Appendix B. One of the DCPs was located adjacent to the hand auger borehole, with the second DCP located on the opposite half of the lot.

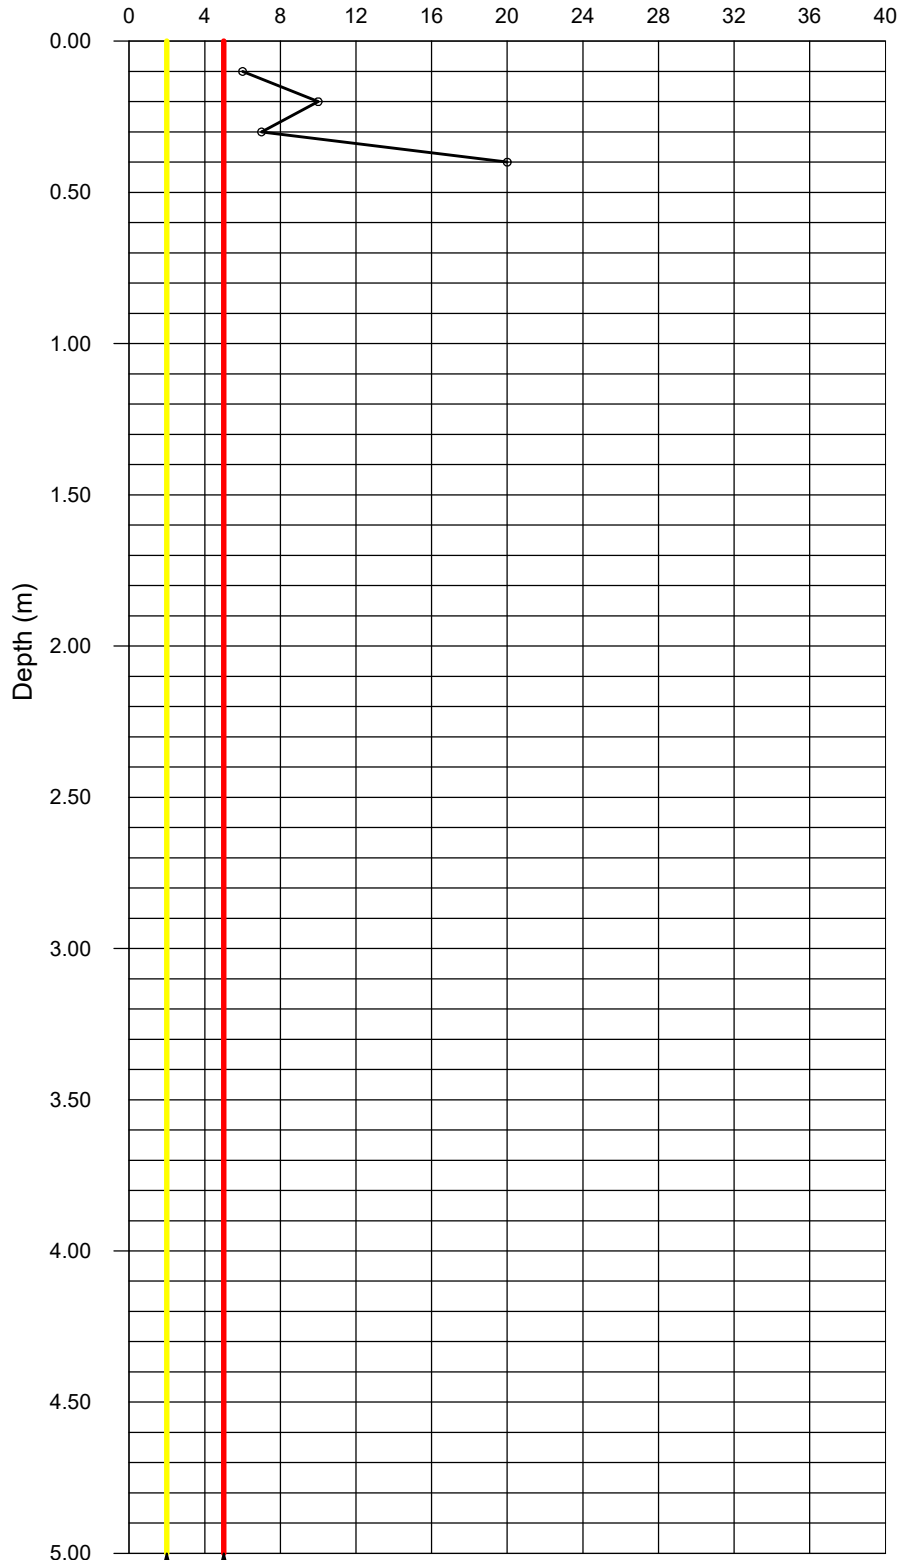
Depth (m)	Blows per 100 mm	Depth (m)	Blows per 100 mm
0.0	6	3.5	
0.1	10		
0.2	7		
0.3	20		
0.4		4.0	
0.5			
1.0		4.5	
1.5		5.0	
2.0			
2.5			
3.0			
3.5

20 blows for 100mm in the last increment.
Co-ordinates and elevation data from site survey.
Elevation based on Christchurch Drainage Datum.
Effective refusal on gravel, 20+ blows per 100mm

NZS 3604:2011 'Good Ground' Acceptance Criteria
MBIE '200kPa geotechnical ultimate bearing capacity' Acceptance Criteria

DCP logs indicate two blows per 100mm penetration, which is equivalent to an ultimate bearing capacity of 200kPa, was consistently encountered from a shallow depth.

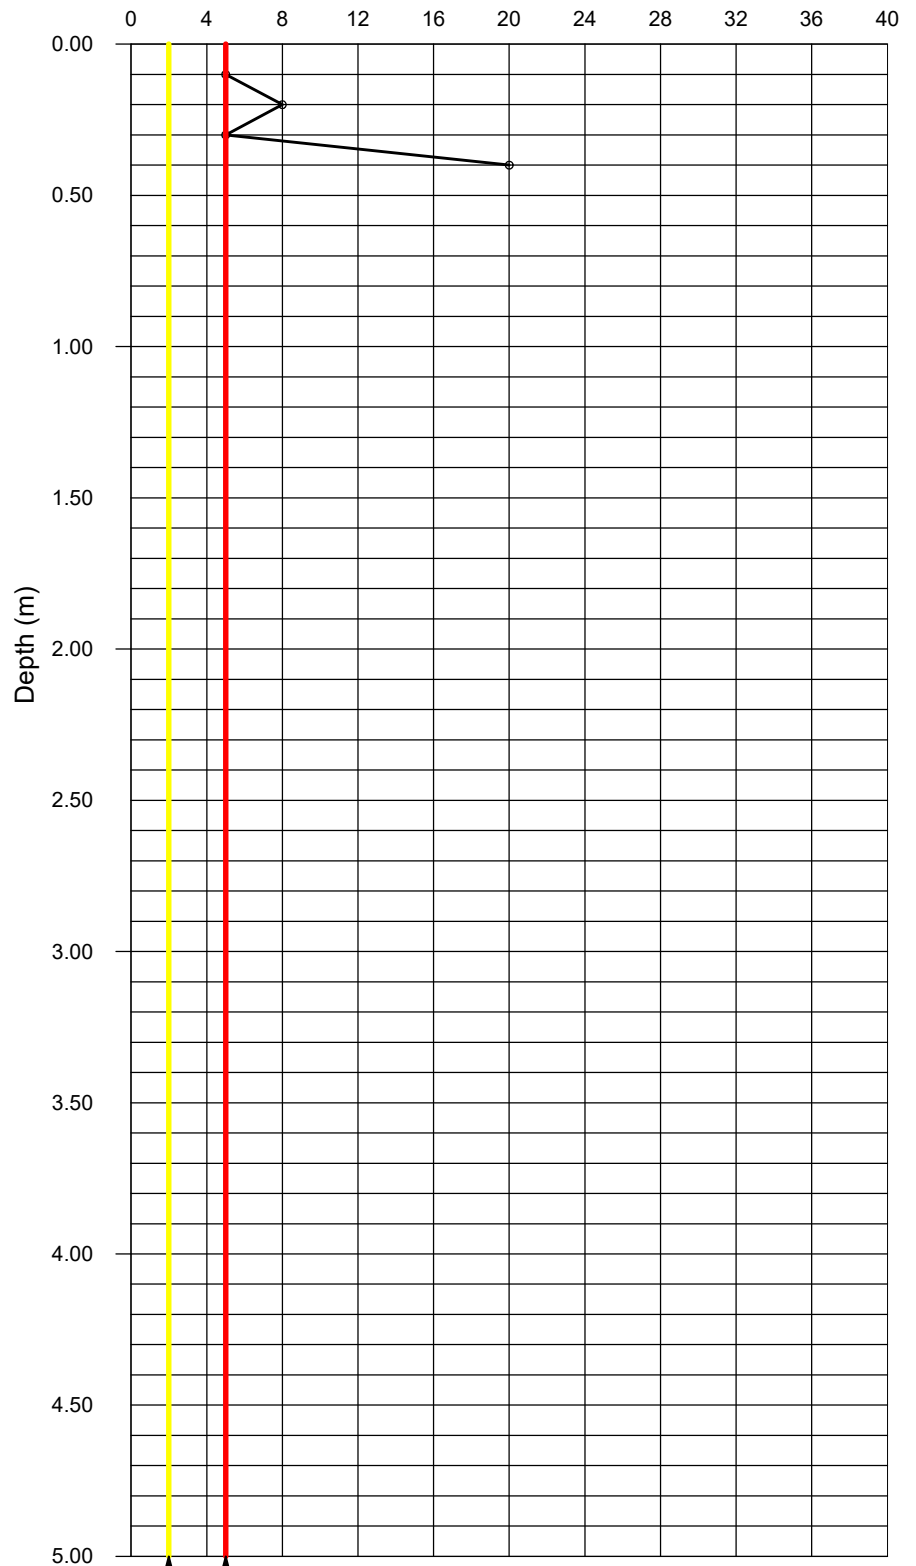
Depth (m)	Blows per 100 mm	Depth (m)	Blows per 100 mm
0.0	5	3.5	
0.1	8		
0.2	5		
0.3	20		
0.4		4.0	
0.5			
1.0		4.5	
1.5		5.0	
2.0			
2.5			
3.0			
3.5

20 blows for 100mm in the last increment.
Co-ordinates and elevation data from site survey.
Elevation based on Christchurch Drainage Datum.
Effective refusal on gravel, 20+ blows per 100mm

NZS 3604:2011 'Good Ground' Acceptance Criteria
MBIE '200kPa geotechnical ultimate bearing capacity' Acceptance Criteria
