Prestons Park Subdivision
GEOTECHNICAL REPORT FOR LOT 904
CDL Land NZ Limited

12 February 2021
Revision: 1
Reference: 235361

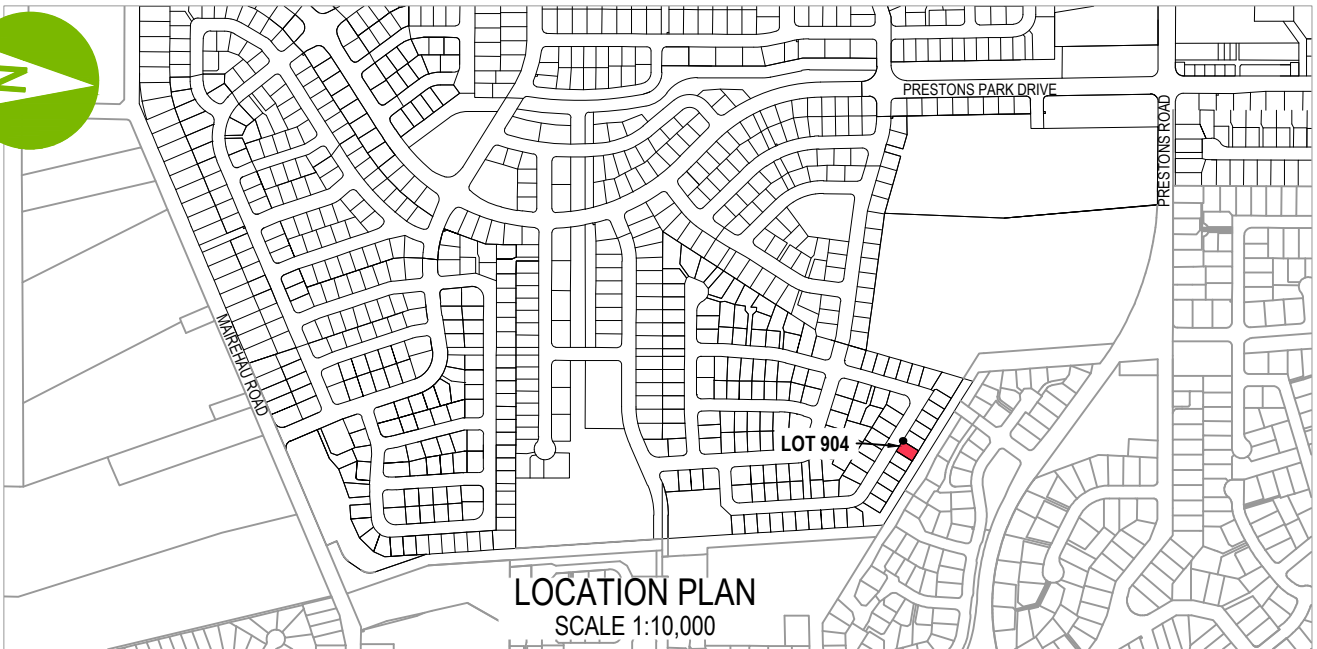
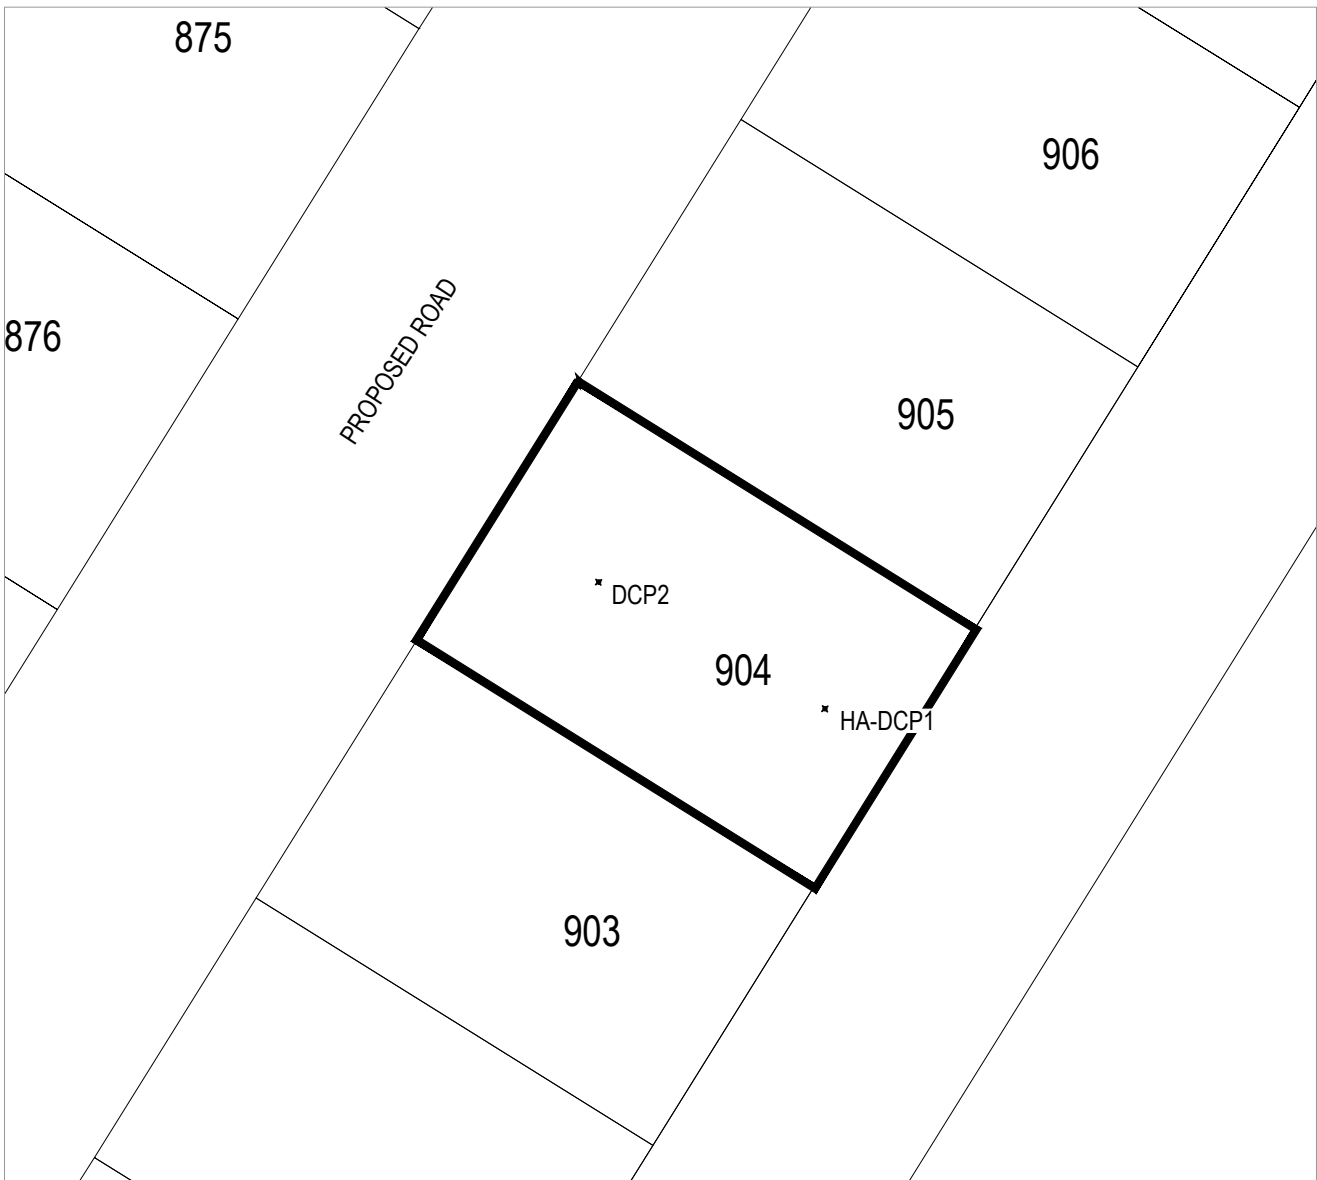
PROJECT
PRESTONS PARK
TITLE
LOT 904 SITE LOCATION PLAN FIGURE 1

This building consent report is for Lot 904 which is located in Stage 4 of the Prestons South Subdivision development (refer Figure 1 in Appendix A). The lot is bordered by residential lots to the north-west and south-east, an access road to the south and a local purpose reserve (utility) to the north.

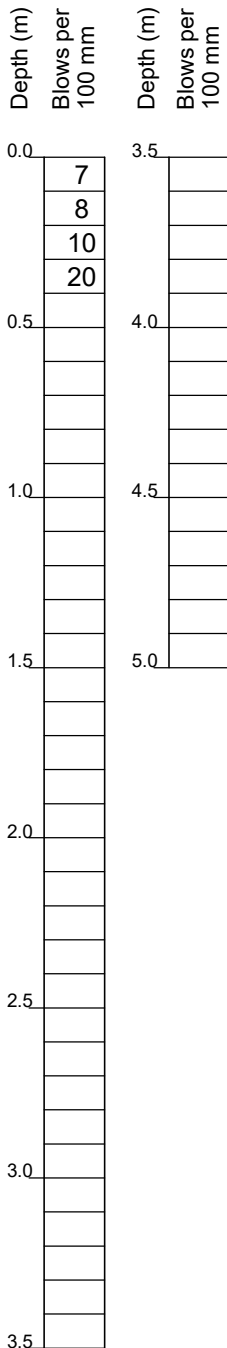
HAND AUGER RECORD

Sandy SILT with trace rootlets; brown. Moist, non-plastic; sand, fine to medium. (TOPSOIL)
				+13.03	0.30

End of Hand Auger at 0.30m, on 05/02/2021 <i>Termination Reason: Refusal on gravel</i>

LOGGED C. SCOTT
 DATE 05/02/2021
 CHECKED A. HILLS
 DATE 19/02/2021
REMARKS
 Groundwater not encountered.
 Co-ordinates and elevation data from site survey.
 Elevation based on Christchurch Drainage Datum.

One hand auger borehole was undertaken on the lot as part of the geotechnical investigation to assess the upper soil profile and the groundwater level. The test location and the borehole log have been uploaded to the New Zealand Geotechnical Database (NZGD). The borehole log is attached in Appendix B.

The hand auger borehole was terminated when soil samples became too dense to auger.

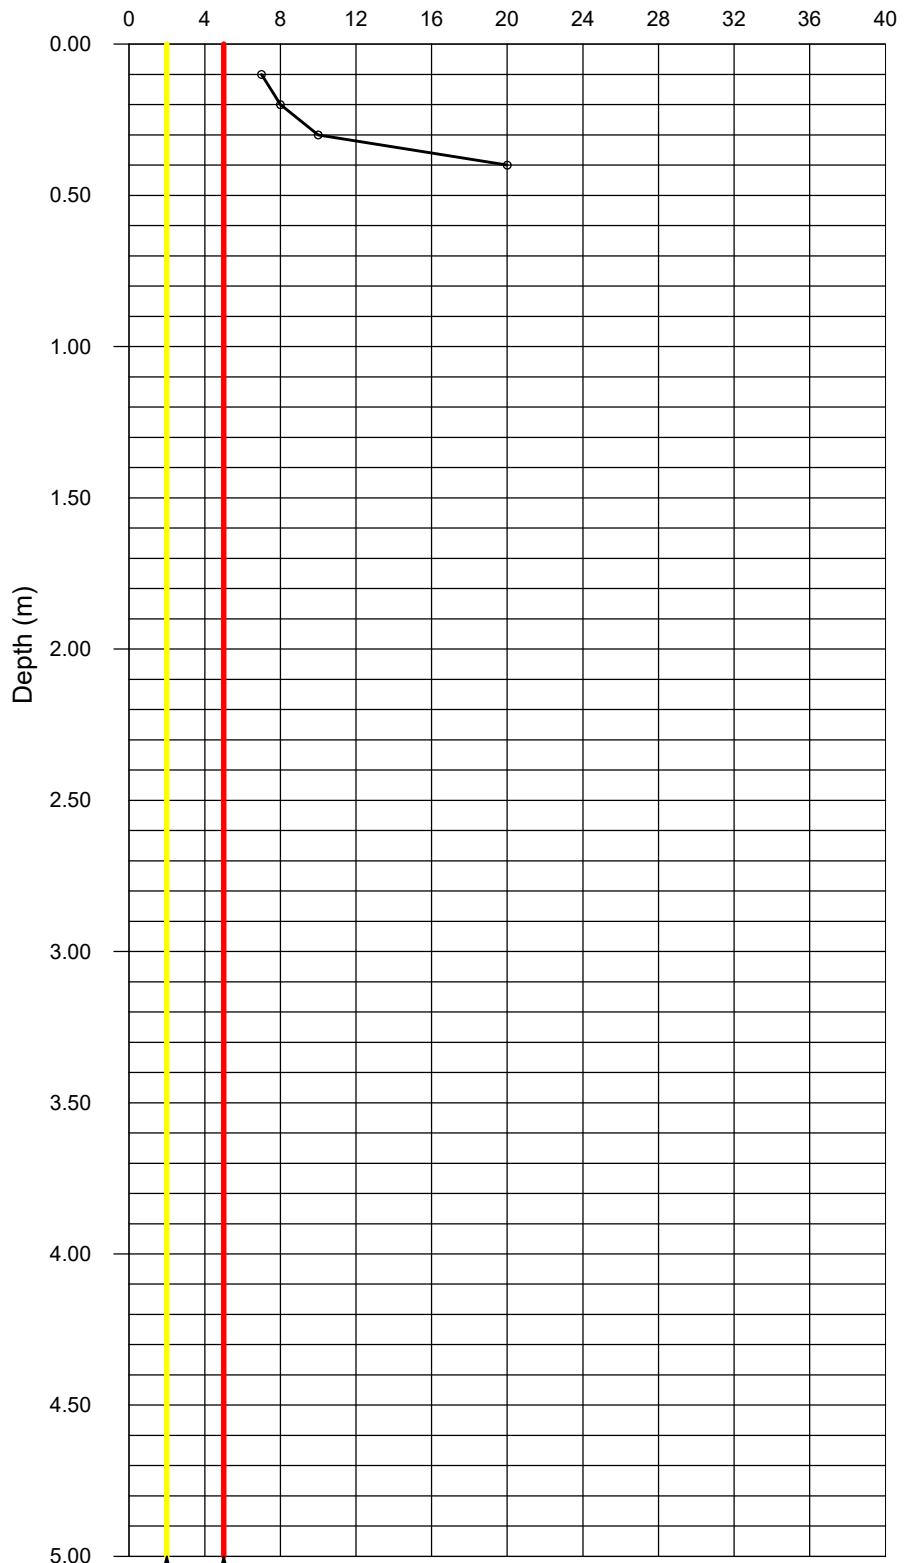
Number of blows per 100mm

20 blows for 100mm in the last increment.
Co-ordinates and elevation data from site survey.
Elevation based on Christchurch Drainage Datum.
Effective refusal on gravel, 20+ blows per 100mm

NZS 3604:2011 'Good Ground' Acceptance Criteria
MBIE '200kPa geotechnical ultimate bearing capacity' Acceptance Criteria

Two DCPs were carried out with the locations and results uploaded to the NZGD. The DCP test results are attached in Appendix B. One of the DCPs was located adjacent to the hand auger borehole, with the second DCP located on the opposite half of the lot.

DCP logs indicate two blows per 100mm penetration, which is equivalent to an ultimate bearing capacity of 200kPa, was consistently encountered from a shallow depth.

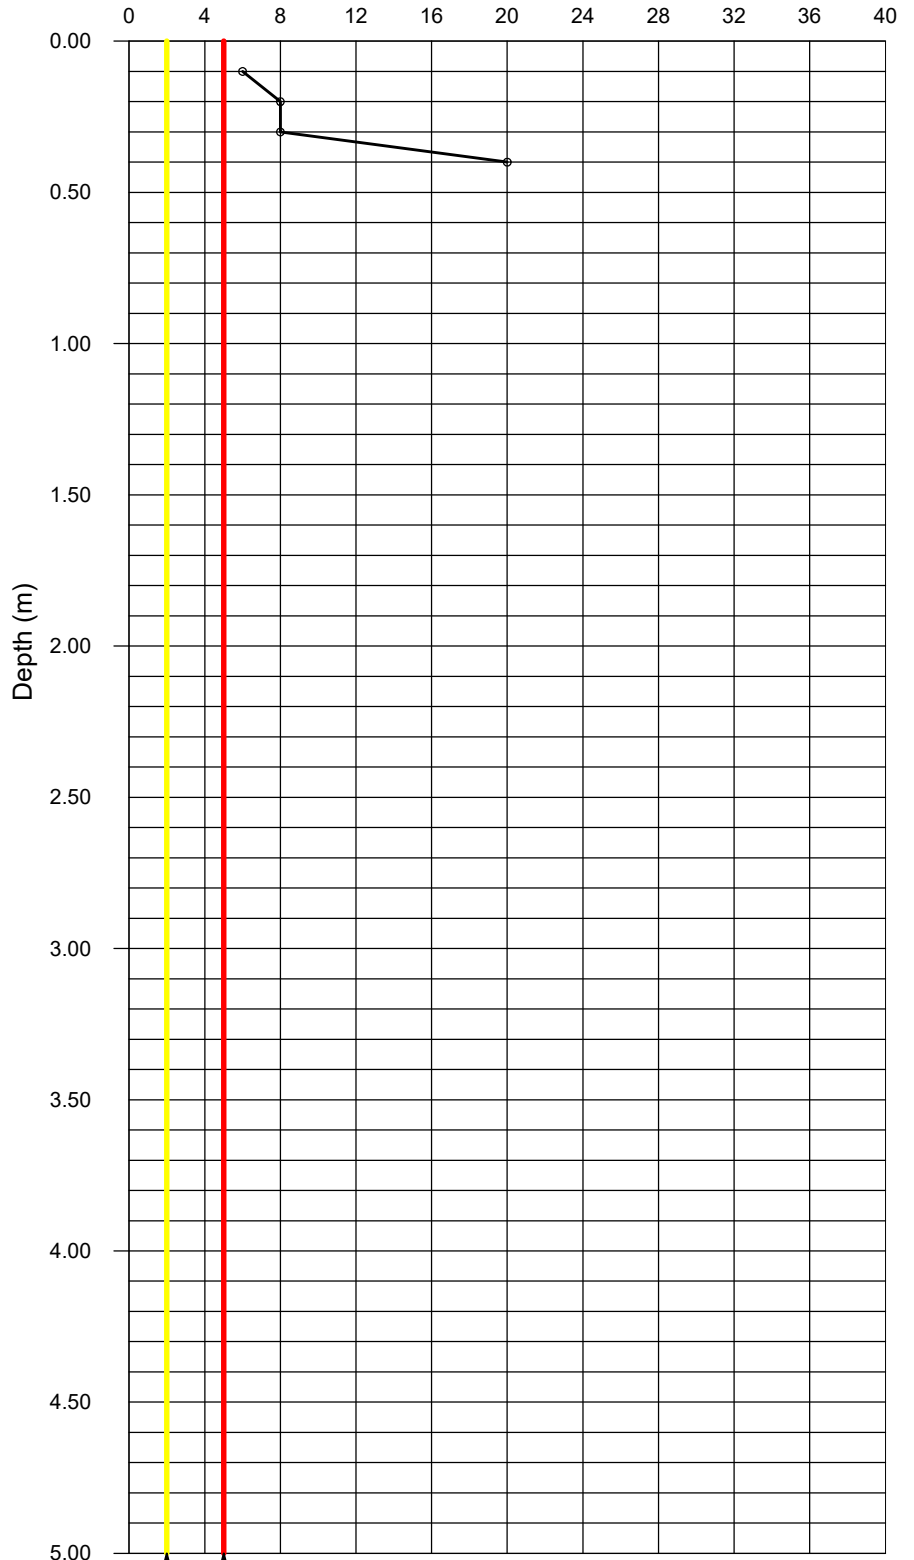
Depth (m)	Blows per 100 mm	Depth (m)	Blows per 100 mm
0.0	6	3.5	
0.1	8		
0.2	8		
0.3	20		
0.4		4.0	
0.5			
1.0		4.5	
1.5		5.0	
2.0			
2.5			
3.0			
3.5

Number of blows per 100mm

20 blows for 100mm in the last increment.
Co-ordinates and elevation data from site survey.
Elevation based on Christchurch Drainage Datum.
Effective refusal on gravel, 20+ blows per 100mm

NZS 3604:2011 'Good Ground' Acceptance Criteria
MBIE '200kPa geotechnical ultimate bearing capacity' Acceptance Criteria
