Prestons Park Subdivision
GEOTECHNICAL REPORT FOR LOT 905
CDL Land NZ Limited

21 October 2021
Revision: 1
Reference: 235361

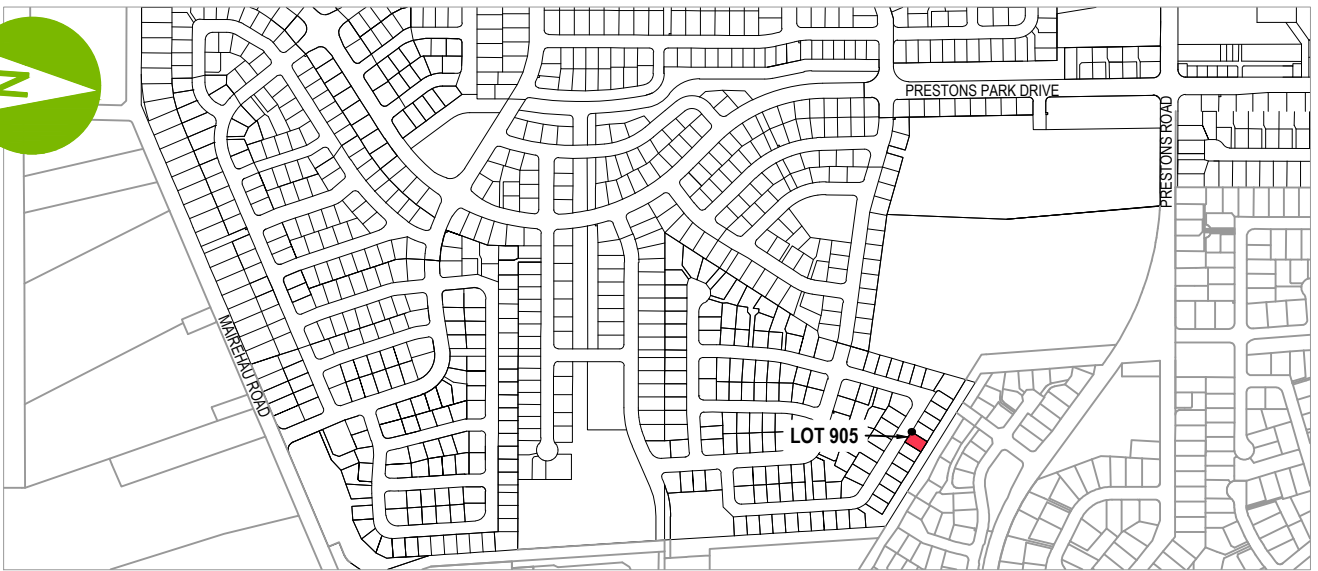
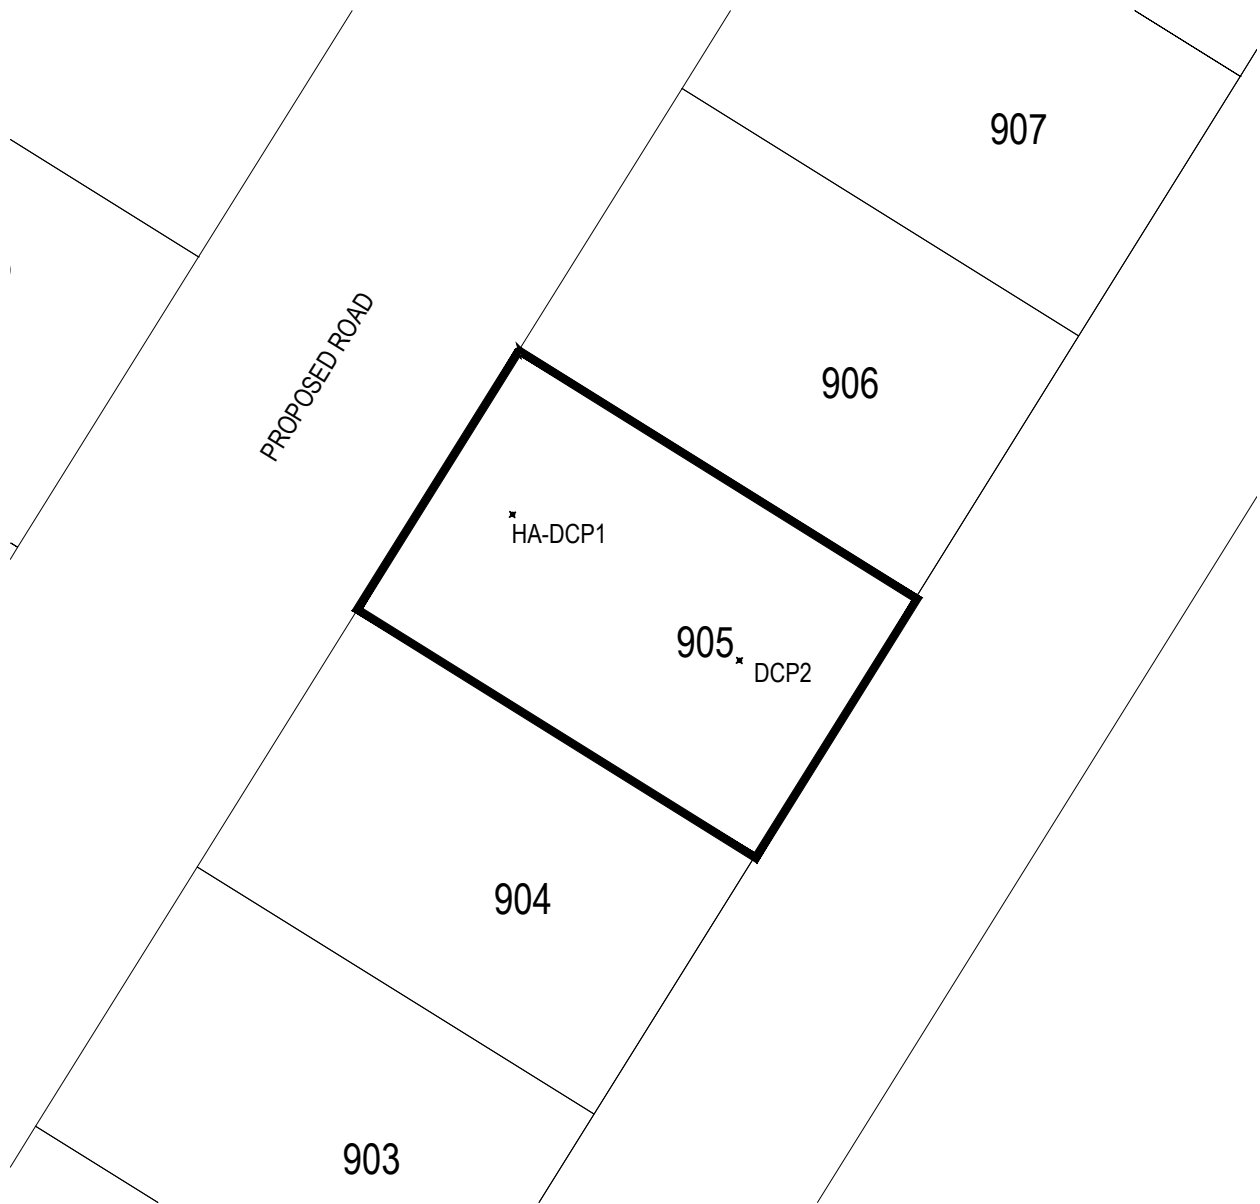
This building consent report is for Lot 905 which is located in Stage 4 of the Prestons South Subdivision development (refer Figure 1 in Appendix A). The lot is bordered by residential lots to the east and west, an access road to the south and a local purpose reverse (utility) to the north.
