Prestons Park Subdivision
GEOTECHNICAL REPORT FOR LOT 906
CDL Land NZ Limited

21 October 2021
Revision: 1
Reference: 235361

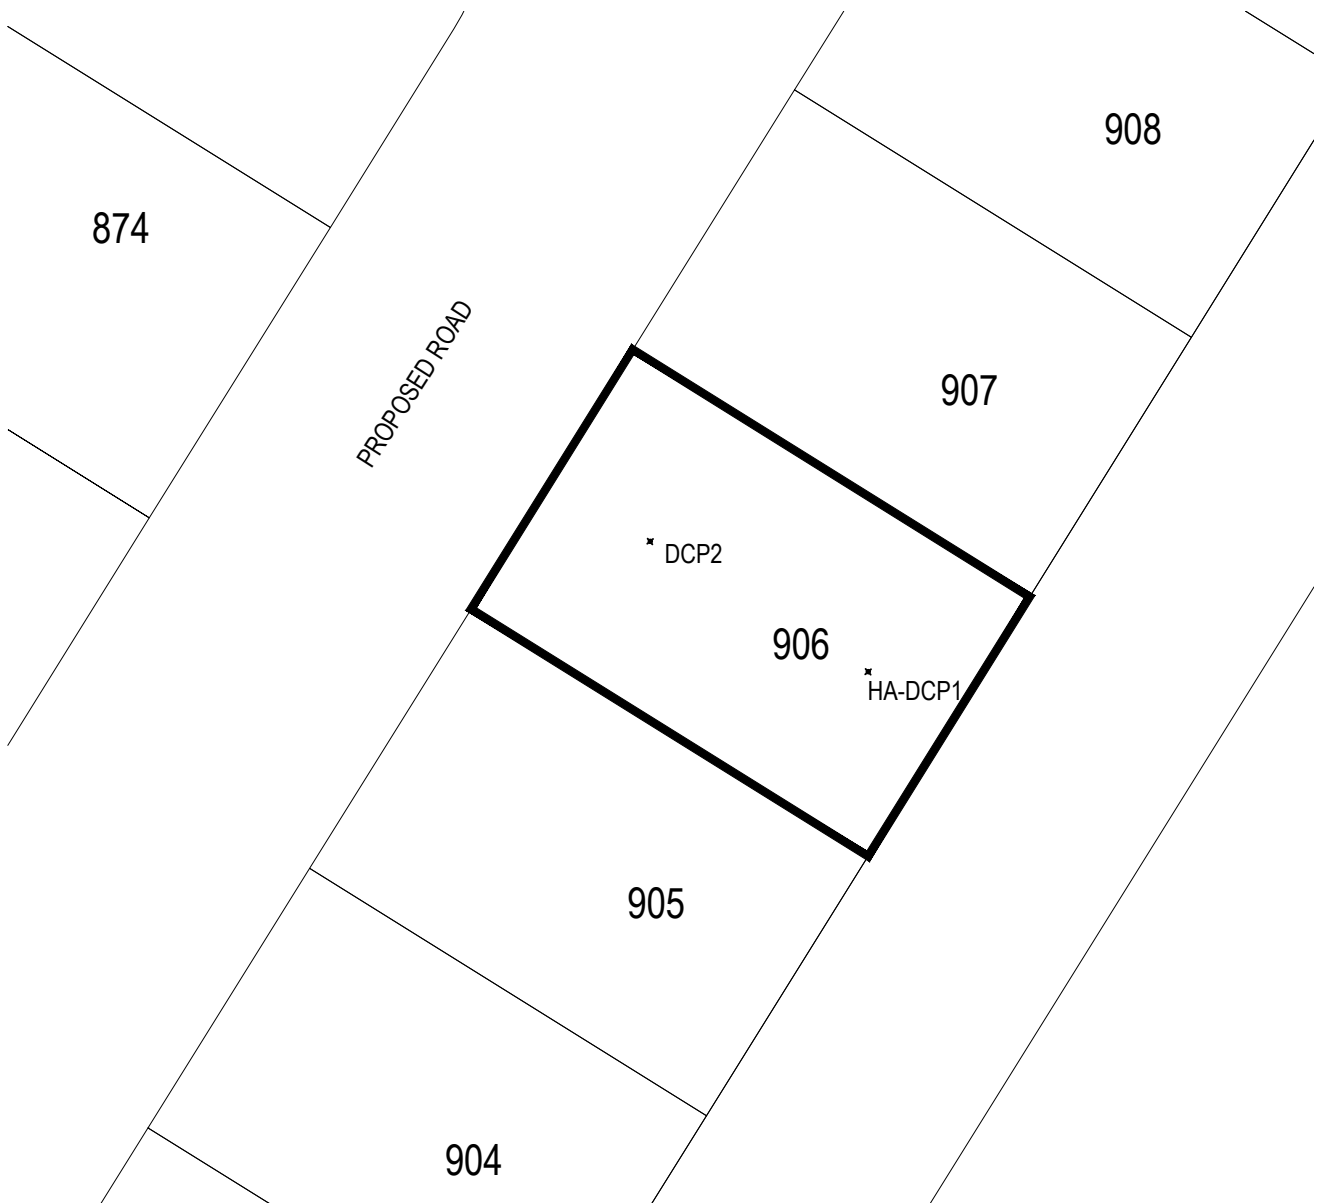
PROJECT
PRESTONS PARK
TITLE
LOT 906
SITE LOCATION PLAN
FIGURE 1

This building consent report is for Lot 906 which is located in Stage 4 of the Prestons South Subdivision development (refer Figure 1 in Appendix A). The lot is bordered by residential lots to the east and west, an access road to the south and a local purpose reserve (utility) to the north.
