Prestons Park Subdivision  
GEOTECHNICAL REPORT FOR LOT 907  
CDL Land NZ Limited

21 October 2021  
Revision: 1  
Reference: 235361

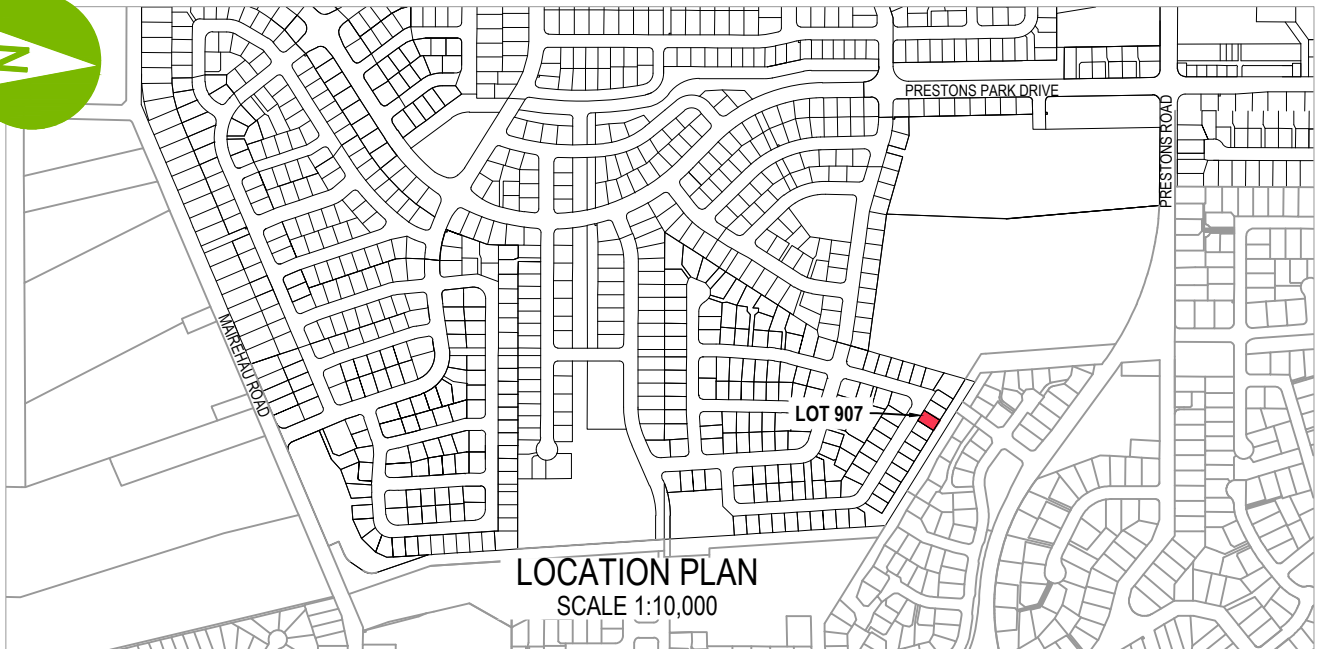
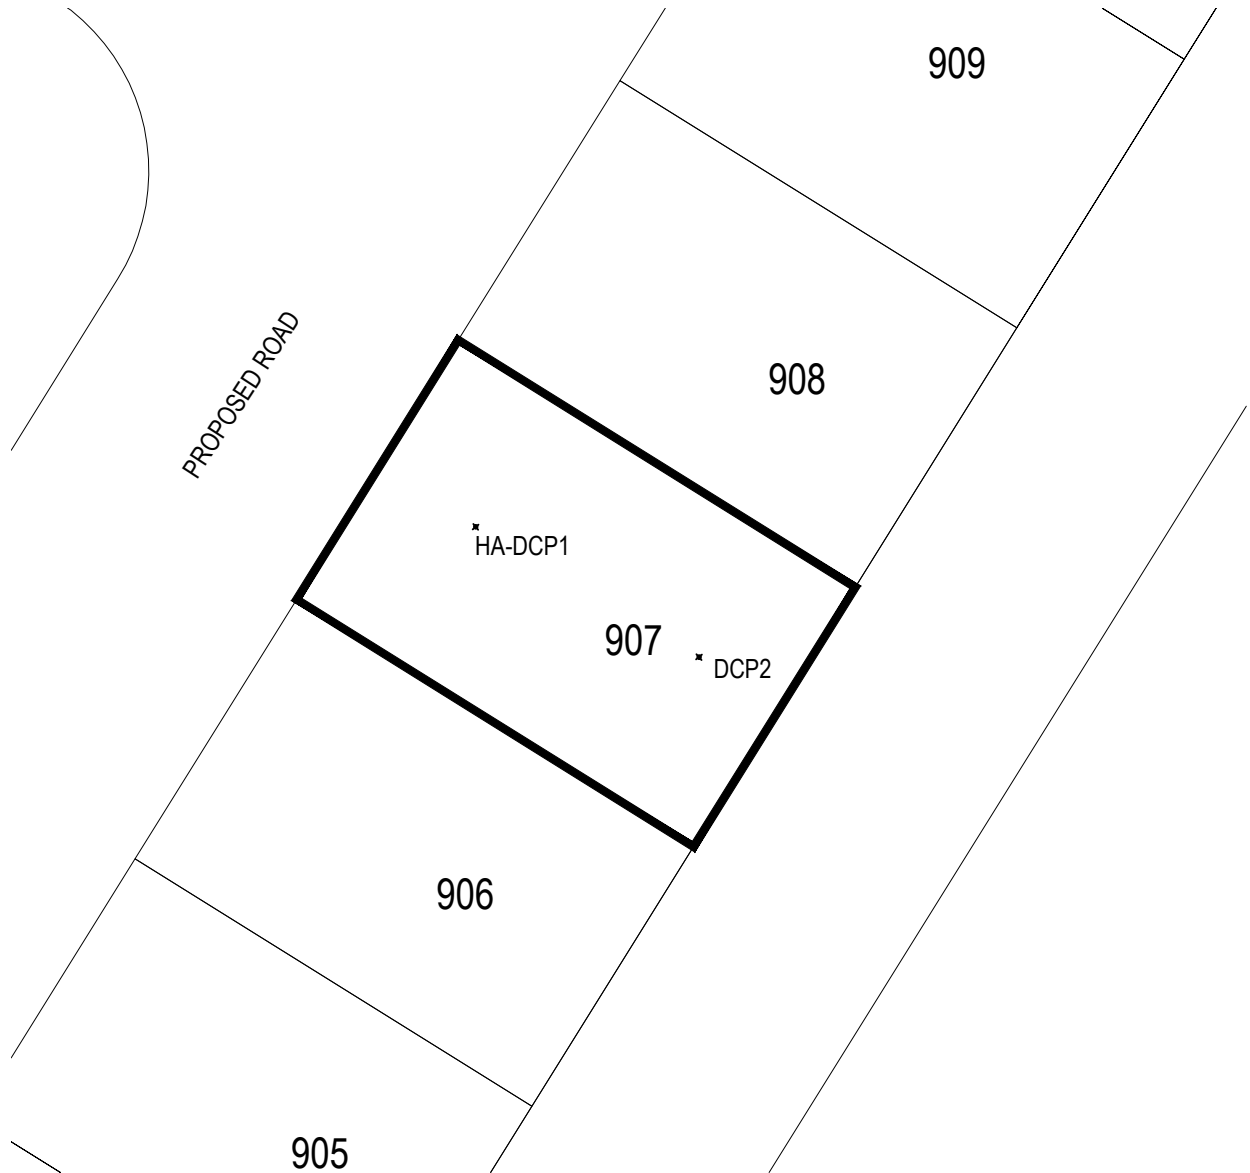
PROJECT
PRESTONS PARK
TITLE
LOT 907 SITE LOCATION PLAN FIGURE 1

This building consent report is for Lot 907 which is located in Stage 4 of the Prestons South Subdivision development (refer Figure 1 in Appendix A). The lot is bordered by residential lots to the east and west, an access road to the south and a local purpose reserve (utility) to the north.
