Prestons Park Subdivision
GEOTECHNICAL REPORT FOR LOT 909
CDL Land NZ Limited

21 October 2021
Revision: 1
Reference: 235361

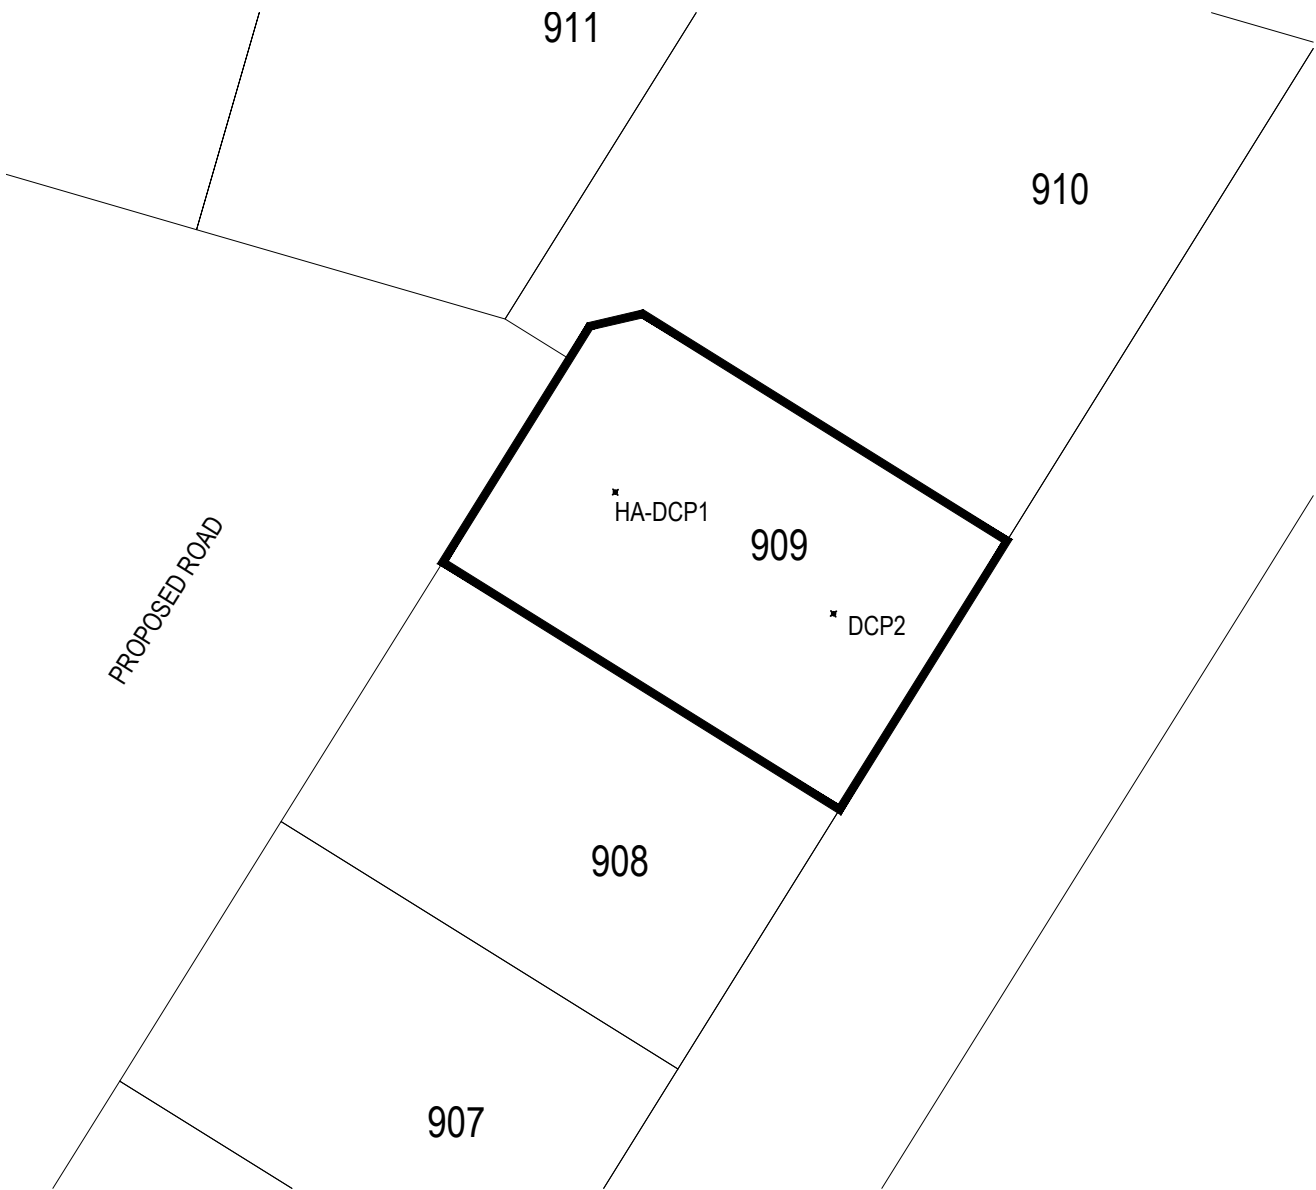
This building consent report is for Lot 909 which is located in Stage 4 of the Prestons South Subdivision development (refer Figure 1 in Appendix A). The lot is bordered by residential lots to the east and west, an access road to the south and a local purpose reverse (utility) to the north.

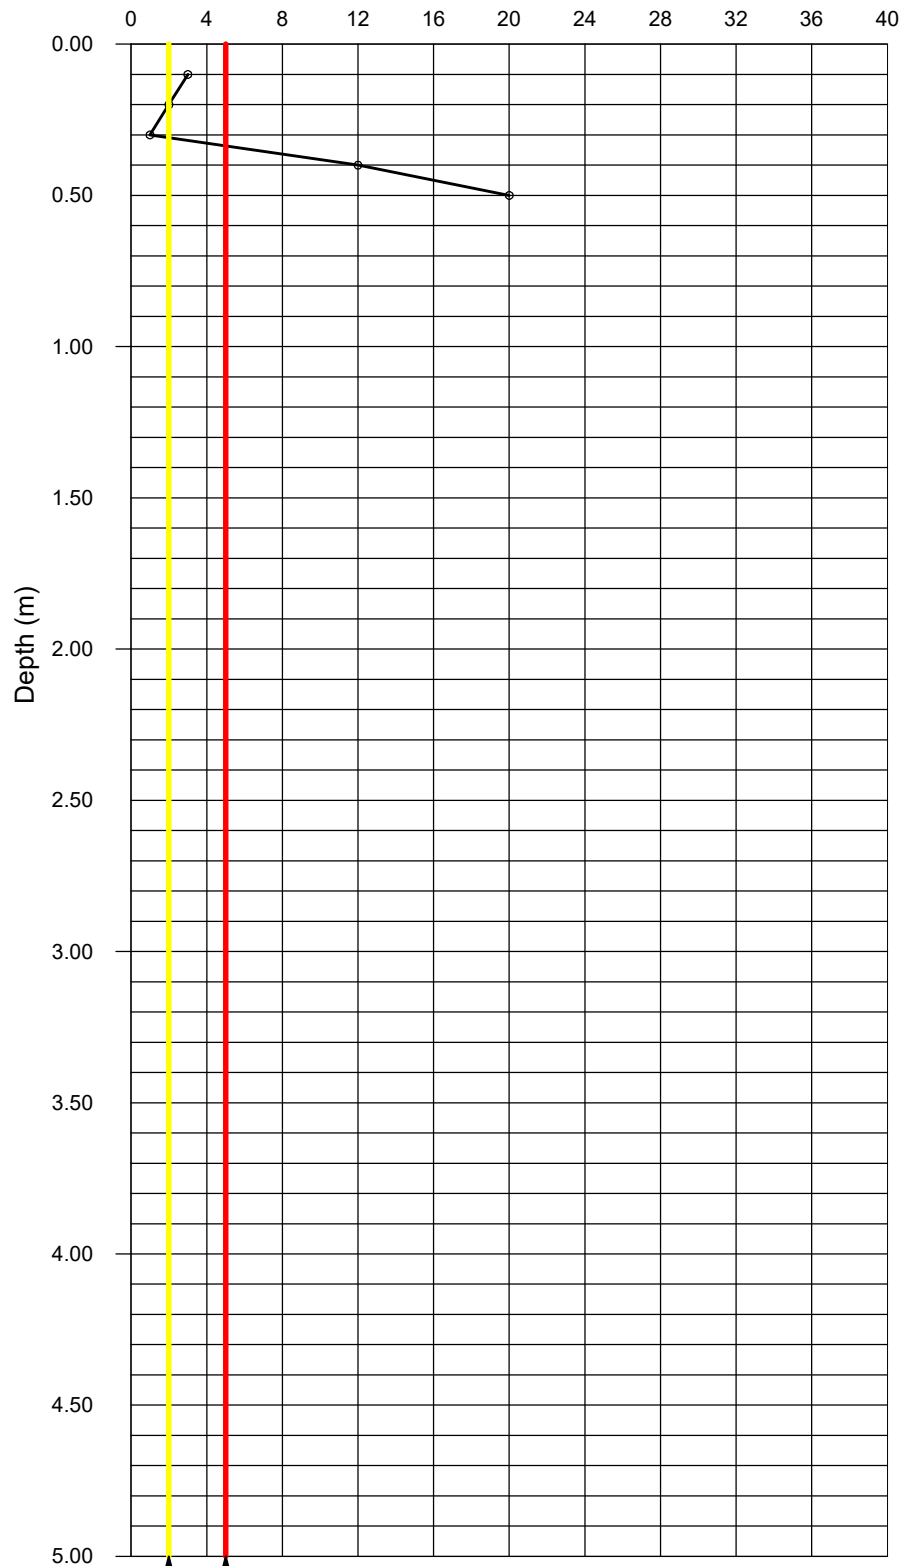
Results

Depth (m)	Blows per 100 mm	Depth (m)	Blows per 100 mm
0.0	3	3.5	
0.1	2	4.0	
0.2	1	4.5	
0.3	12	5.0	
0.4	20		
0.5			
1.0			
1.5			
2.0			
2.5			
3.0			
3.5

Number of blows per 100mm

Remarks:

20 blows for 100mm in the last increment.
Co-ordinates and elevation data from site survey.
Elevation based on Christchurch Drainage Datum.
Effective refusal on gravel, 20+ blows per 100mm

NZS 3604:2011 'Good Ground' Acceptance Criteria
MBIE '200kPa geotechnical ultimate bearing capacity' Acceptance Criteria

Two DCPs were carried out with the locations and results uploaded to the NZGD. The DCP test results are attached in Appendix B. One of the DCPs was located adjacent to the hand auger borehole, with the second DCP located on the opposite half of the lot.

DCP logs indicate two blows per 100mm penetration, which is equivalent to an ultimate bearing capacity of 200kPa, was consistently encountered from a shallow depth.

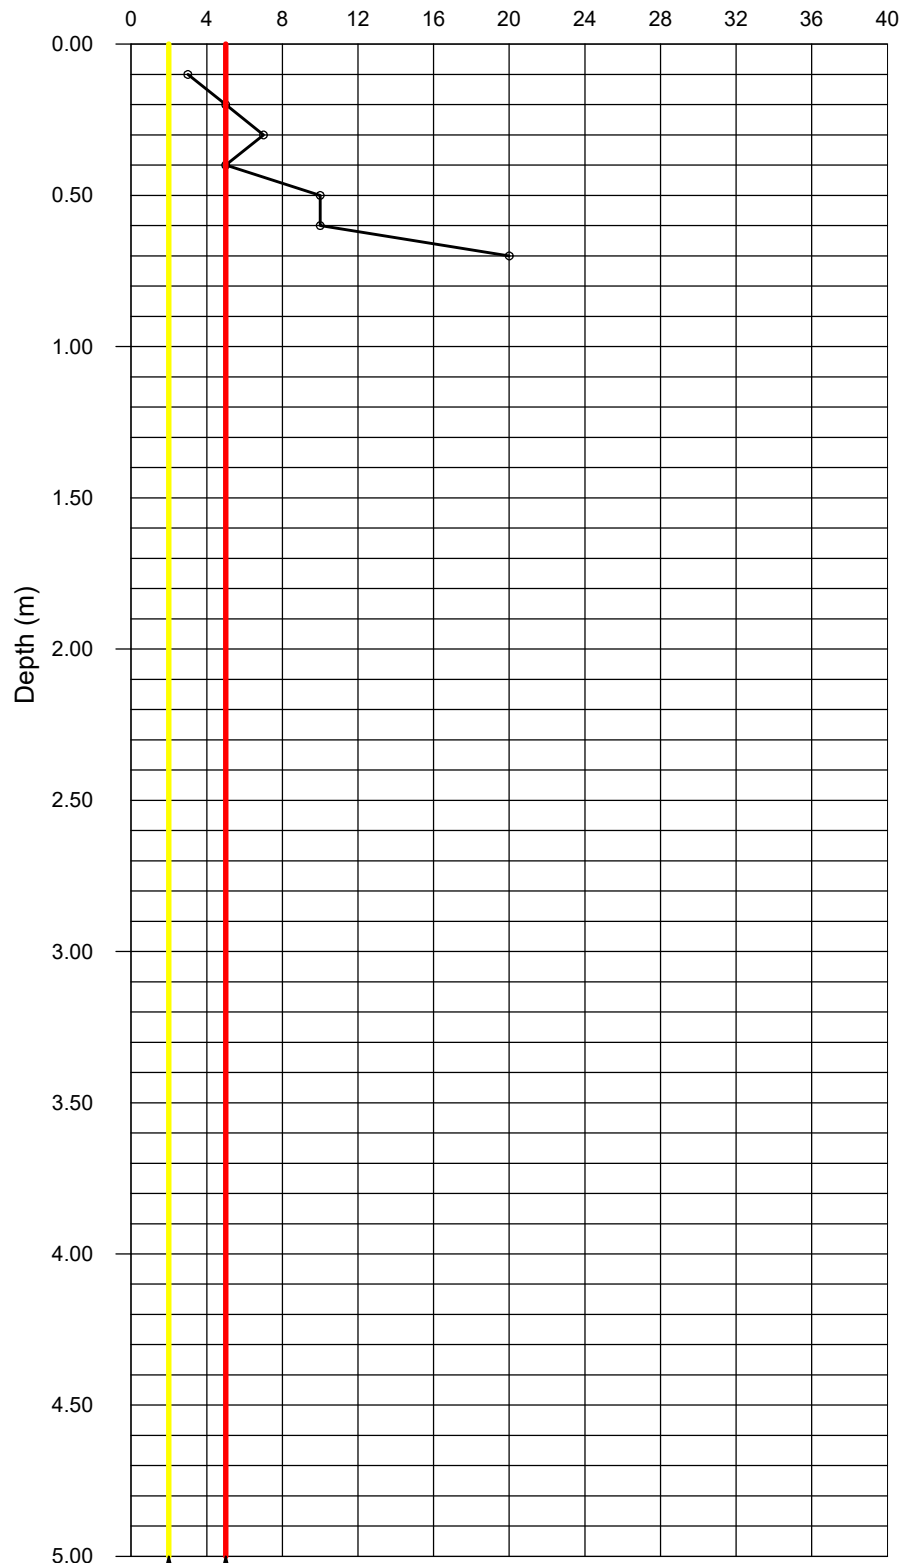
Results

Depth (m)	Blows per 100 mm	Depth (m)	Blows per 100 mm
0.0	3	3.5	
	5		
	7		
	5		
0.5	10	4.0	
	10		
	20		
1.0		4.5	
1.5		5.0	
2.0			
2.5			
3.0			
3.5

Number of blows per 100mm

Remarks:

20 blows for 100mm in the last increment.
Co-ordinates and elevation data from site survey.
Elevation based on Christchurch Drainage Datum.
Effective refusal on gravel, 20+ blows per 100mm

NZS 3604:2011 'Good Ground' Acceptance Criteria
MBIE '200kPa geotechnical ultimate bearing capacity' Acceptance Criteria
