Prestons Park Subdivision
GEOTECHNICAL REPORT FOR LOT 910
CDL Land NZ Limited

21 October 2021
Revision: 1
Reference: 235361

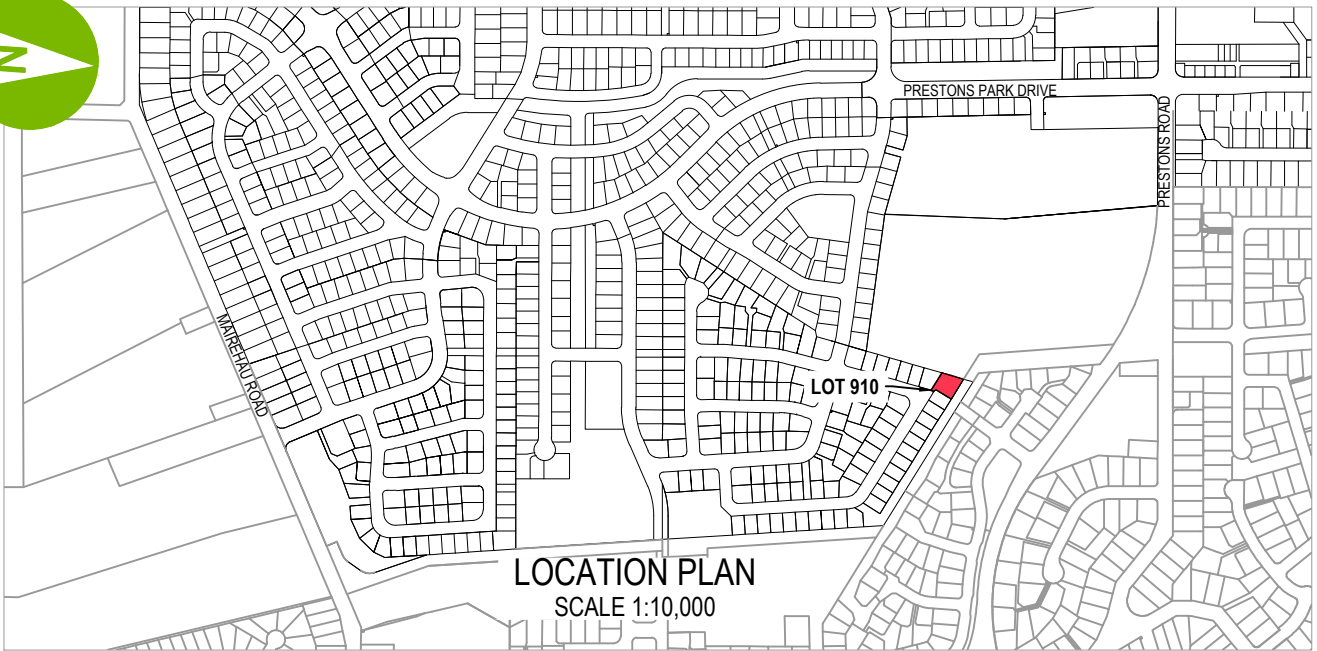
| | | | | | | | FIGURE 1 | GO-PS-S4-IN-910 | A |

This building consent report is for Lot 910 which is located in Stage 4 of the Prestons South Subdivision development (refer Figure 1 in Appendix A). The lot is bordered by residential lots to the east and south, a local purpose reverse (utility) to the north and a stormwater basin for the neighbouring retirement village to the west.

Aurecon recommends that shallow foundations constructed on Lot 910 are set back by a minimum of 3H from the base of the retaining wall, where H is the height of the wall. The recommended exclusion zone is presented in Appendix A, which is based on this set back distance. Foundations that fall within this exclusion zone shall undergo specific foundation design by a suitably qualified foundation design professional.
