Prestons Subdivision
GEOTECHNICAL REPORT FOR LOT 1050
CDL Land NZ Limited

24 August 2021
Revision: 1
Reference: 235361

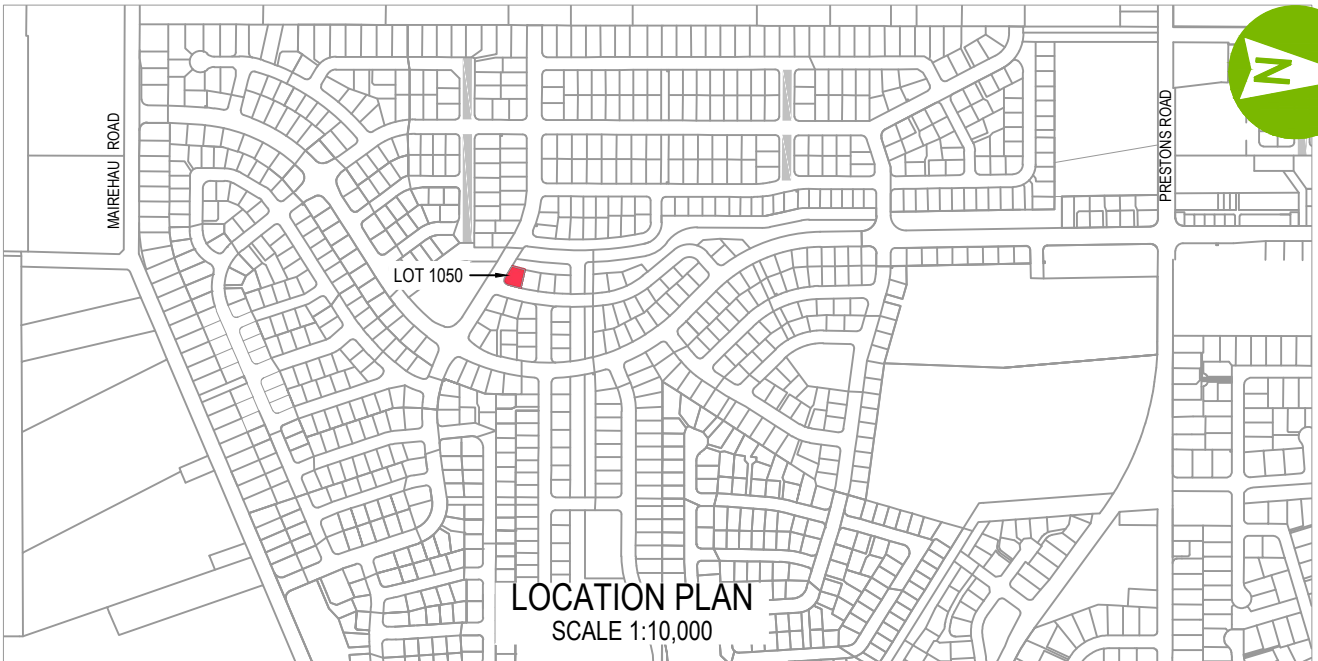
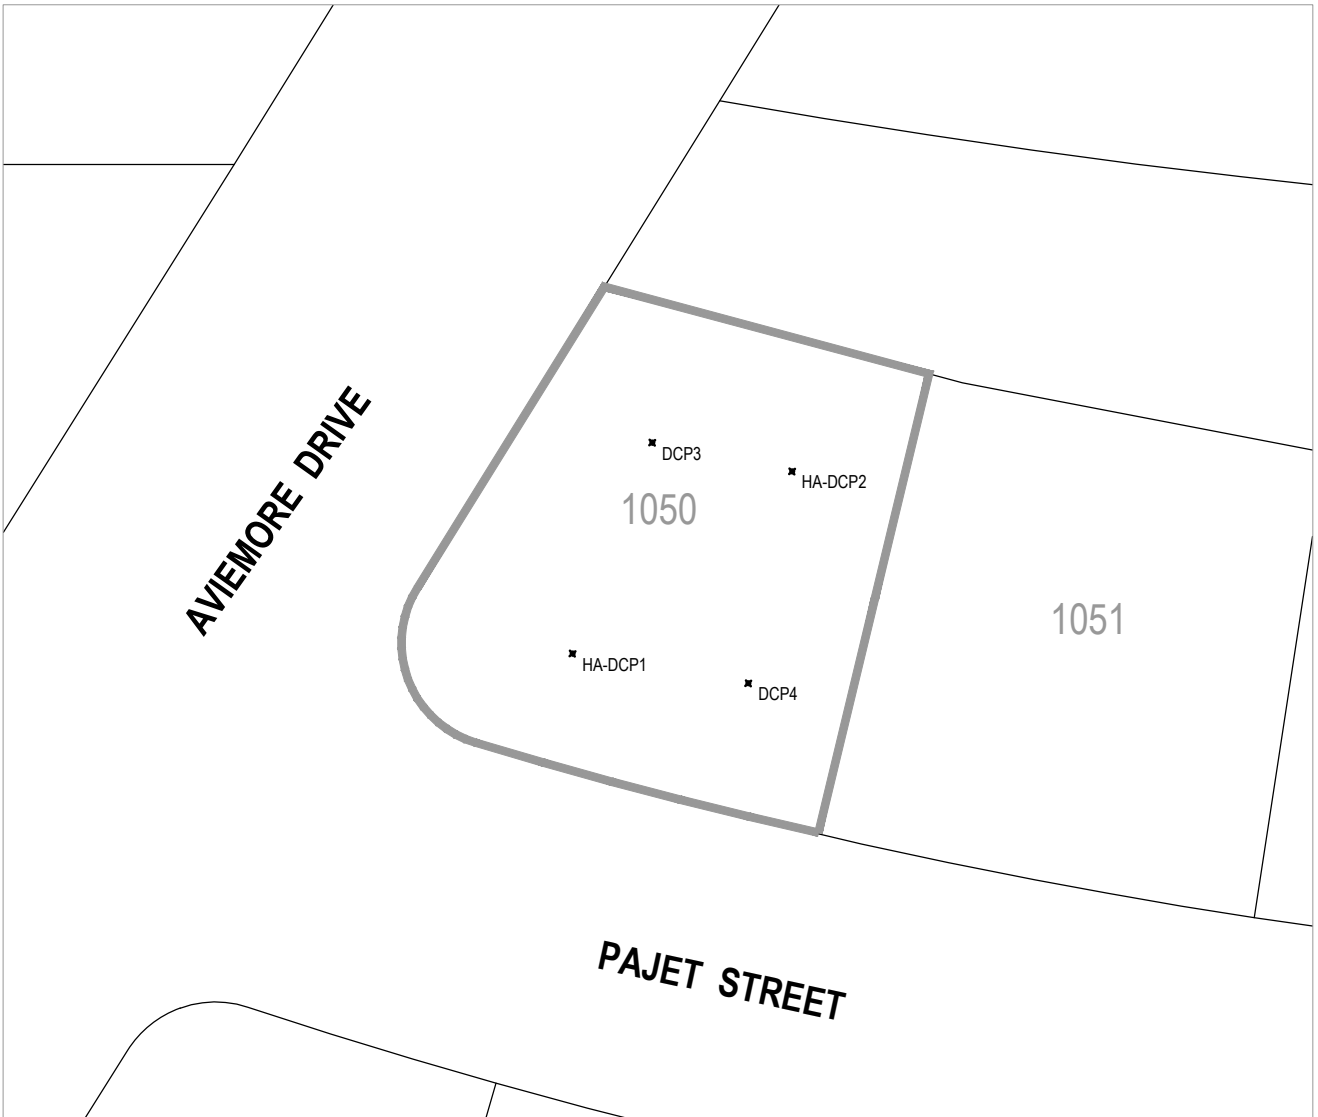
PROJECT
PRESTONS
TITLE
LOT 1050 SITE LOCATION PLAN FIGURE 1

This building consent report is for Lot 1050 which is located in Stage 2 of the Prestons South Subdivision development (refer Figure 1 in Appendix A). The lot is bordered by a residential lot to the north, access roads to the east and south and an open storm water channel to the west.

Two hand auger boreholes were undertaken on the lot as part of the geotechnical investigation to assess the upper soil profile and the groundwater level. The test location and the borehole log have been uploaded to the New Zealand Geotechnical Database (NZGD). The borehole log is attached in Appendix B. The hand held testing was undertaken at an earlier date, however it is still considered suitable for the purposes of building consent as no further earthworks or site modifications have been undertaken.

Four DCPs were carried out with the locations and results uploaded to the NZGD. The DCP test results are attached in Appendix B. Two of the DCPs were located adjacent to the hand auger boreholes, with the other DCPs being located on the opposite half of the lot. The DCPs were undertaken at an earlier date, however they are still considered suitable for the purposes of building consent as no further earthworks or site modifications have been undertaken.

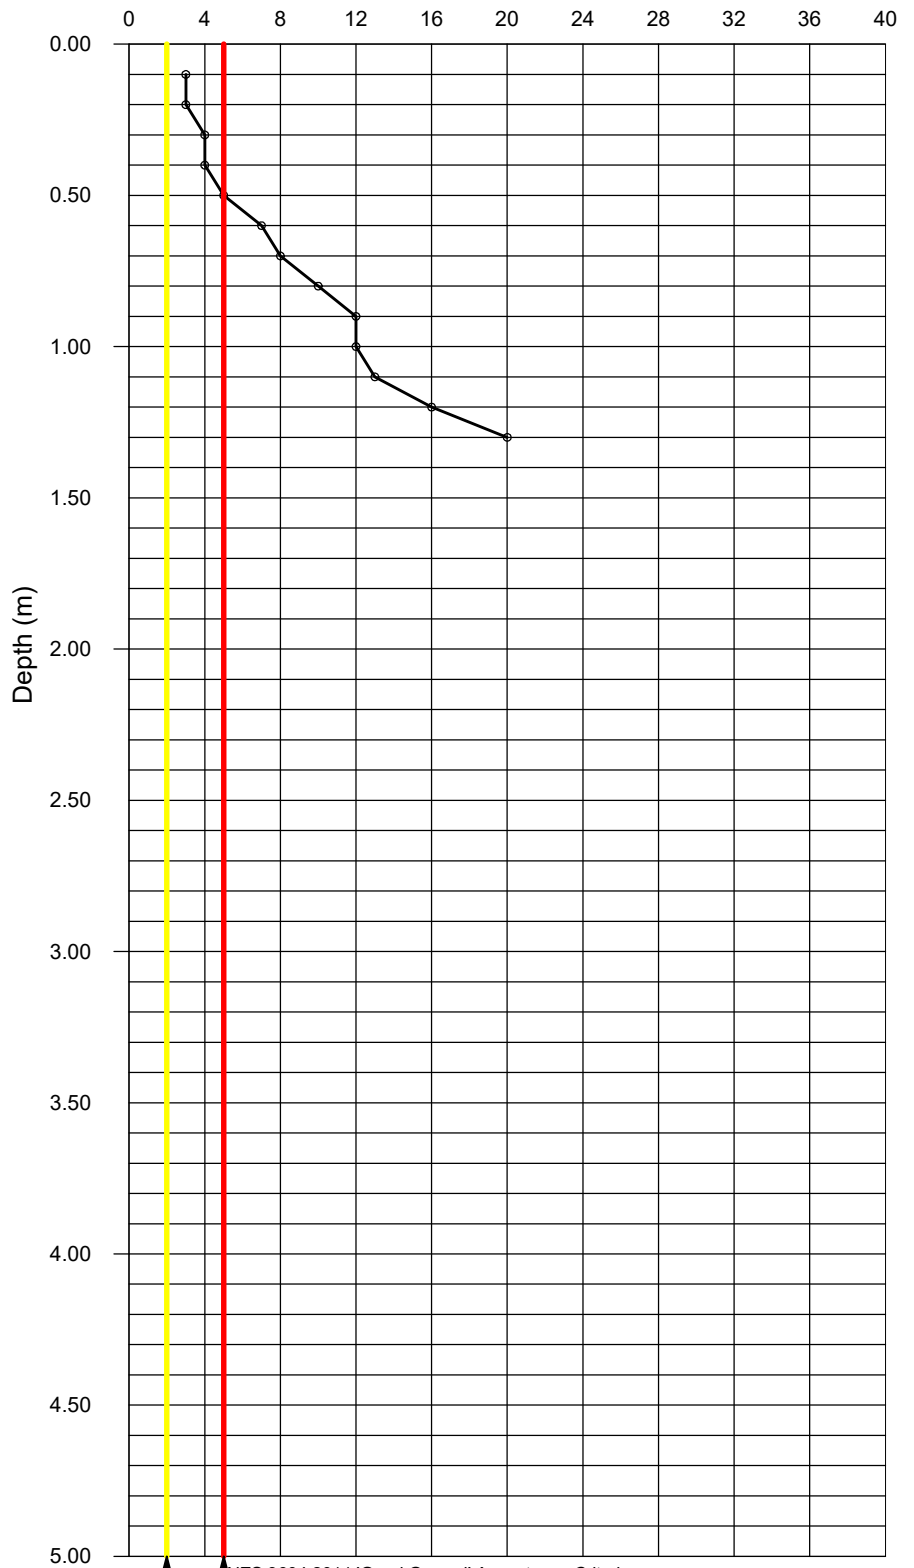
Depth (m)	Blows per 100 mm	Depth (m)	Blows per 100 mm
0.0	3	3.5	
0.1	3		
0.2	4		
0.3	4		
0.4	5	4.0	
0.5	7		
0.6	8		
0.7	10		
0.8	12		
0.9	12	4.5	
1.0	13		
1.1	16		
1.2	20		
1.3			
1.4			
1.5		5.0	
1.6			
1.7			
1.8			
1.9			
2.0			
2.1			
2.2			
2.3			
2.4			
2.5			
2.6			
2.7			
2.8			
2.9			
3.0			
3.1			
3.2			
3.3			
3.4			
3.5

20 blows for 100mm in the last increment.
Co-ordinates and elevation data from site survey.
Elevation based on Lyttelton Vertical Datum.
Effective refusal, 20+ blows per 100mm penetration.

DCP logs indicate 5 blows per 100mm penetration, which is equivalent to an ultimate bearing capacity of 300kPa, was consistently encountered from a depth of 0.4m to 0.5m.

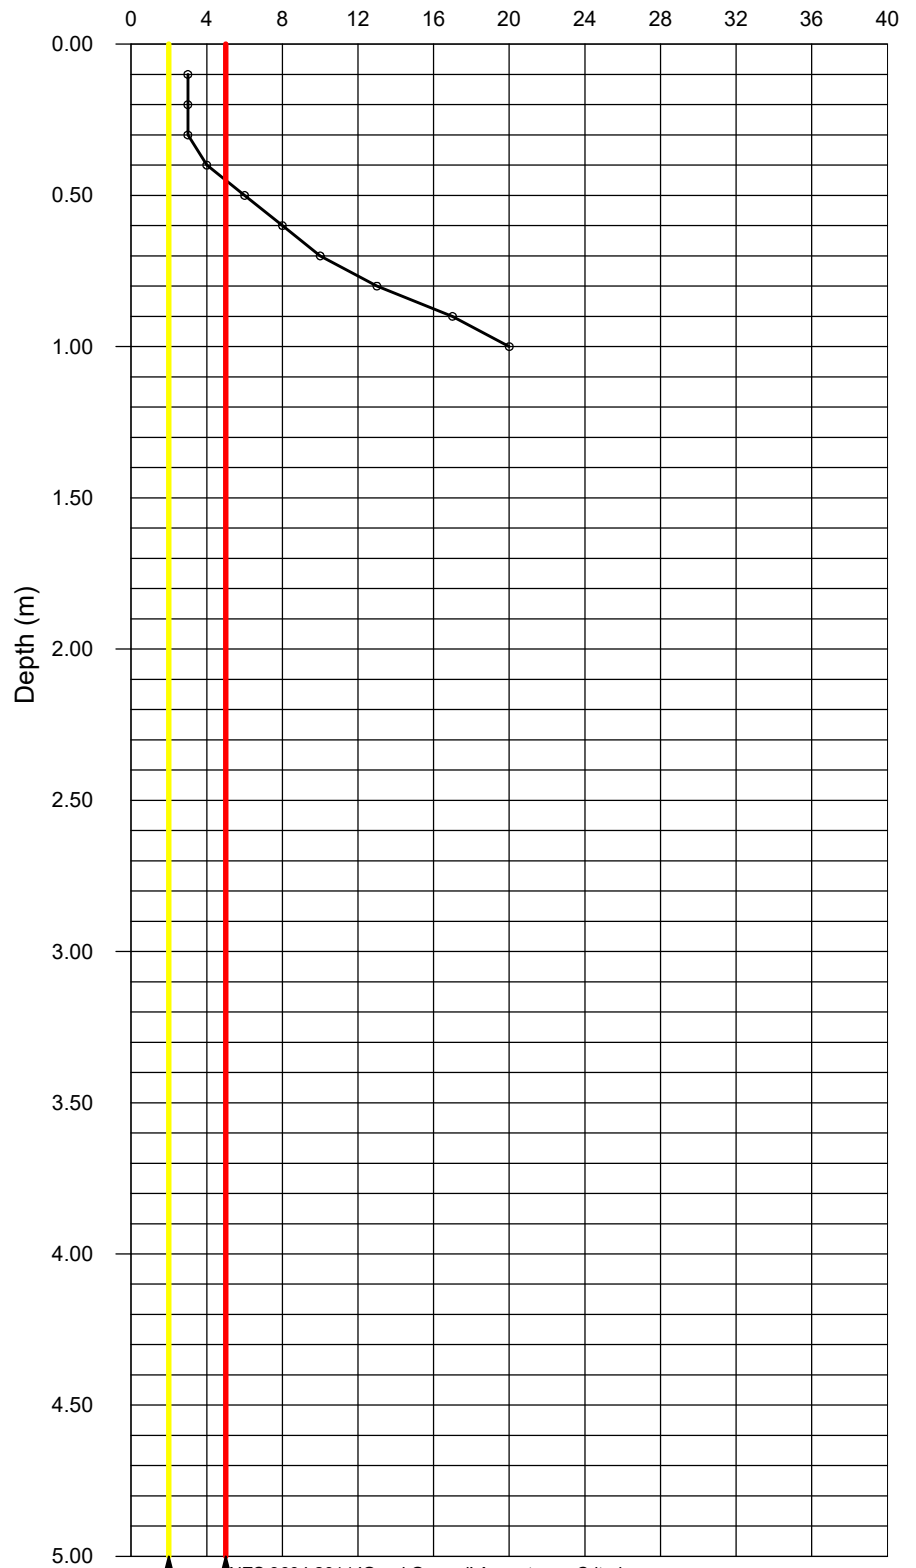
Depth (m)	Blows per 100 mm	Depth (m)	Blows per 100 mm
0.0	3	3.5	
0.1	3		
0.2	3		
0.3	4		
0.4	6	4.0	
0.5	8		
0.6	10		
0.7	13		
0.8	17		
0.9	20	4.5	
1.0			
1.1			
1.2			
1.3			
1.4			
1.5		5.0	
1.6			
1.7			
1.8			
1.9			
2.0			
2.1			
2.2			
2.3			
2.4			
2.5			
2.6			
2.7			
2.8			
2.9			
3.0			
3.1			
3.2			
3.3			
3.4			
3.5

20 blows for 100mm in the last increment.
Co-ordinates and elevation data from site survey.
Elevation based on Lyttelton Vertical Datum.
Effective refusal, 20+ blows per 100mm penetration.

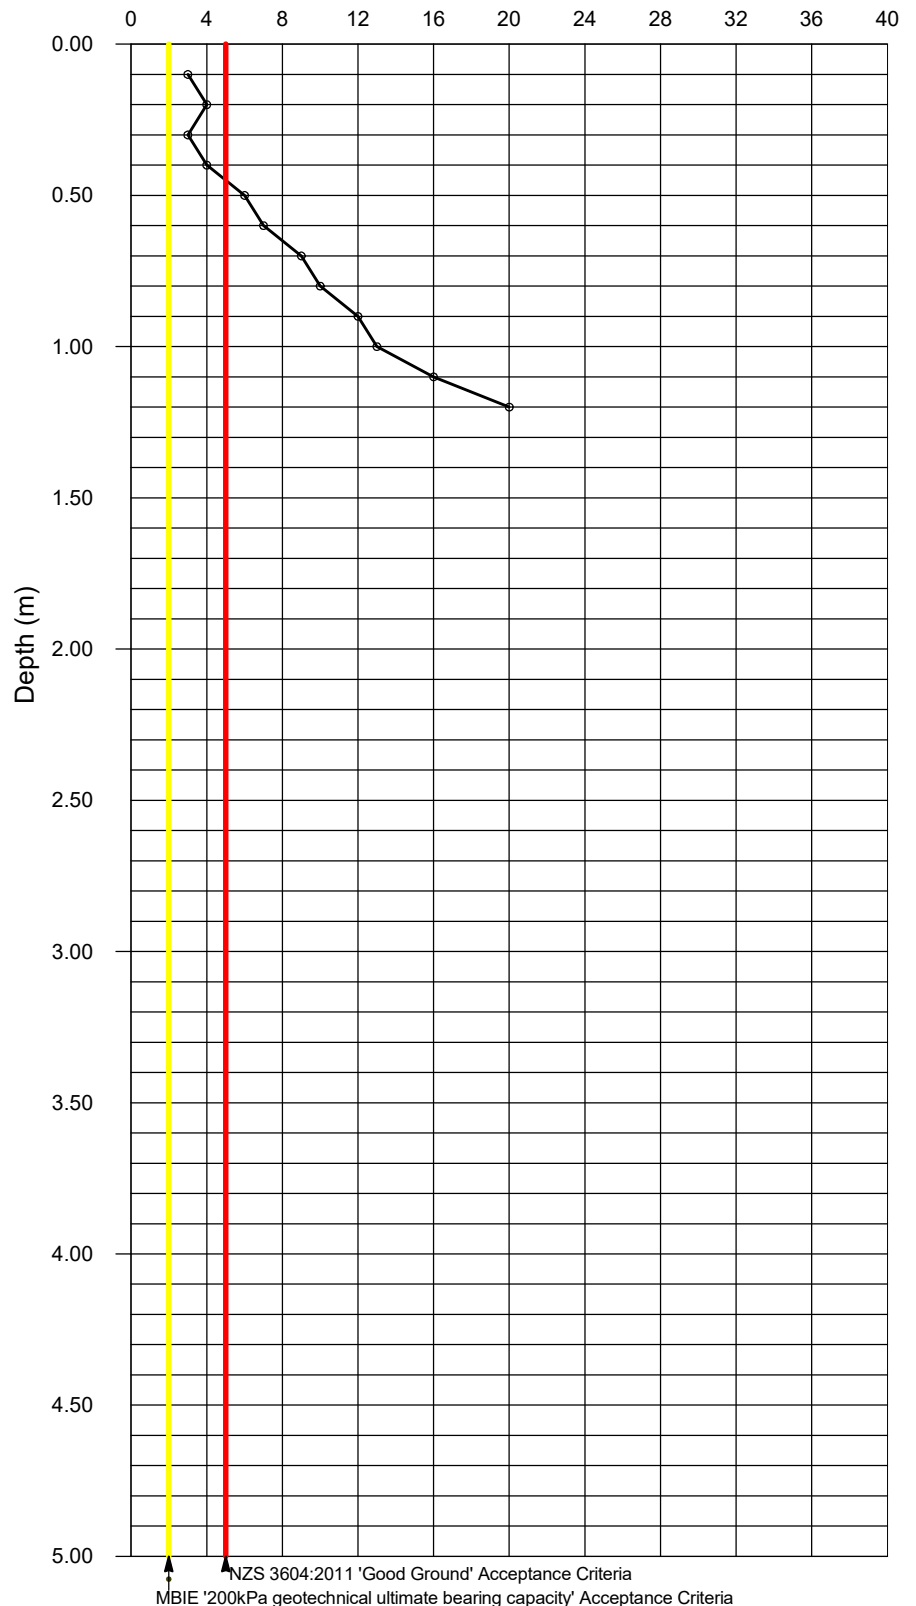
Depth (m)	Blows per 100 mm	Depth (m)	Blows per 100 mm
0.0	3	3.5	
0.1	4		
0.2	3		
0.3	4		
0.4	6	4.0	
0.5	7		
0.6	9		
0.7	10		
0.8	12		
0.9	13	4.5	
1.0	16		
1.1	20		
1.2			
1.3			
1.4			
1.5		5.0	
1.6			
1.7			
1.8			
1.9			
2.0			
2.1			
2.2			
2.3			
2.4			
2.5			
2.6			
2.7			
2.8			
2.9			
3.0			
3.1			
3.2			
3.3			
3.4			
3.5

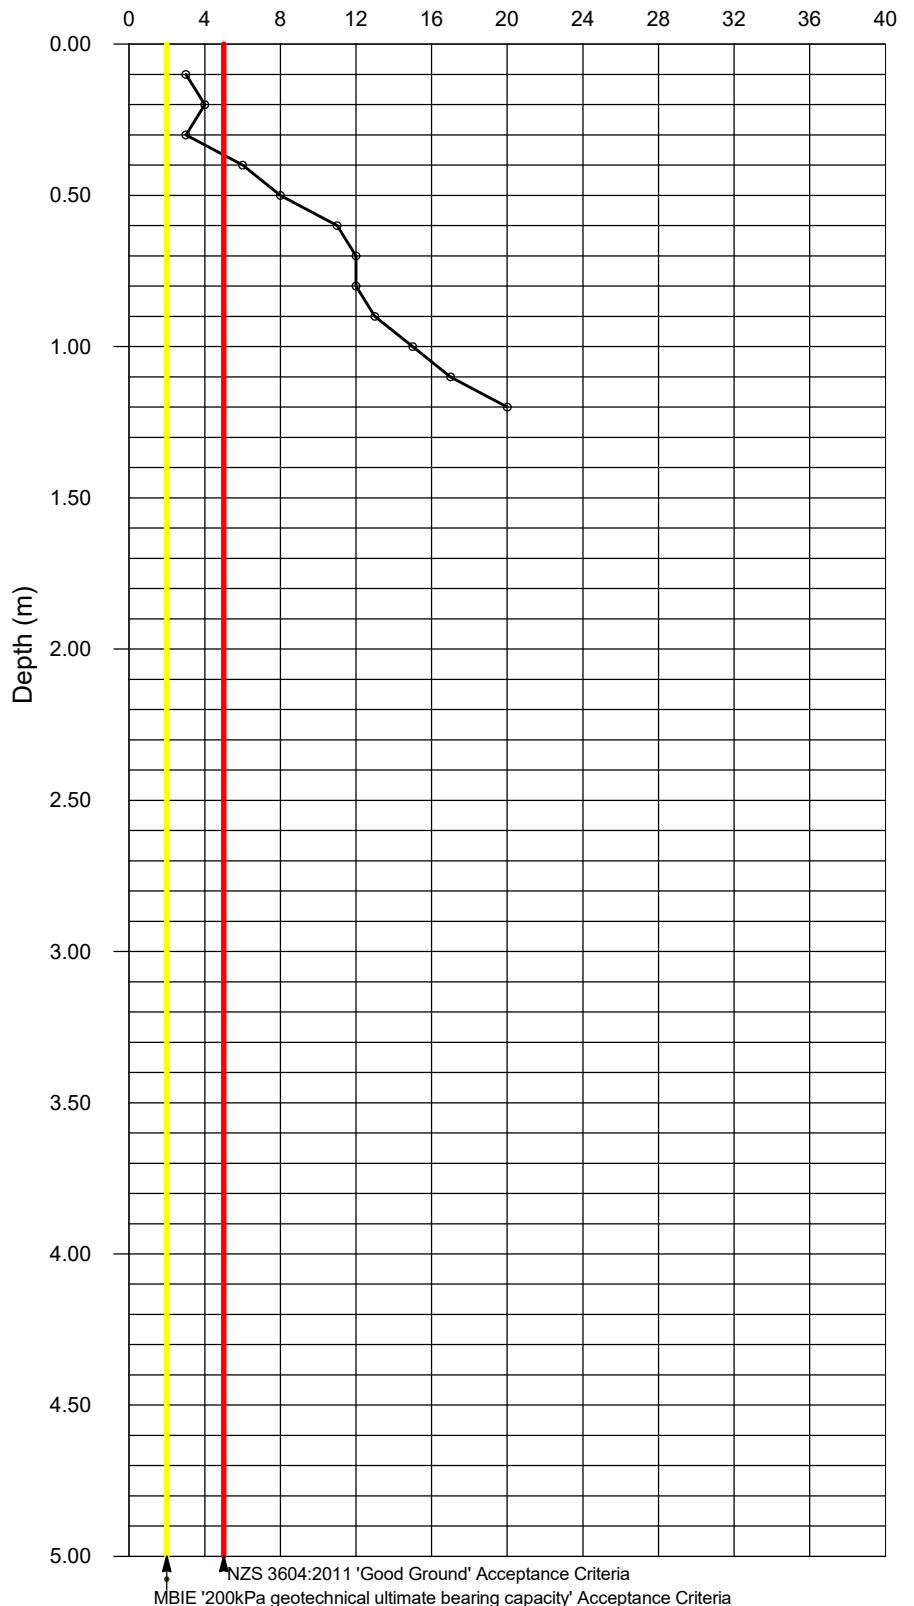
Depth (m)	Blows per 100 mm	Depth (m)	Blows per 100 mm
0.0	3	3.5	
0.1	4		
0.2	3		
0.3	6		
0.4	8		
0.5	11	4.0	
0.6	12		
0.7	12		
0.8	13		
0.9	15	4.5	
1.0	17		
1.1	20		
1.2			
1.3			
1.4			
1.5		5.0	
1.6			
1.7			
1.8			
1.9			
2.0			
2.1			
2.2			
2.3			
2.4			
2.5			
2.6			
2.7			
2.8			
2.9			
3.0			
3.1			
3.2			
3.3			
3.4			
3.5
