Prestons Subdivision
GEOTECHNICAL REPORT FOR LOT 1055
CDL Land NZ Limited

30 August 2021
Revision: 1
Reference: 235361

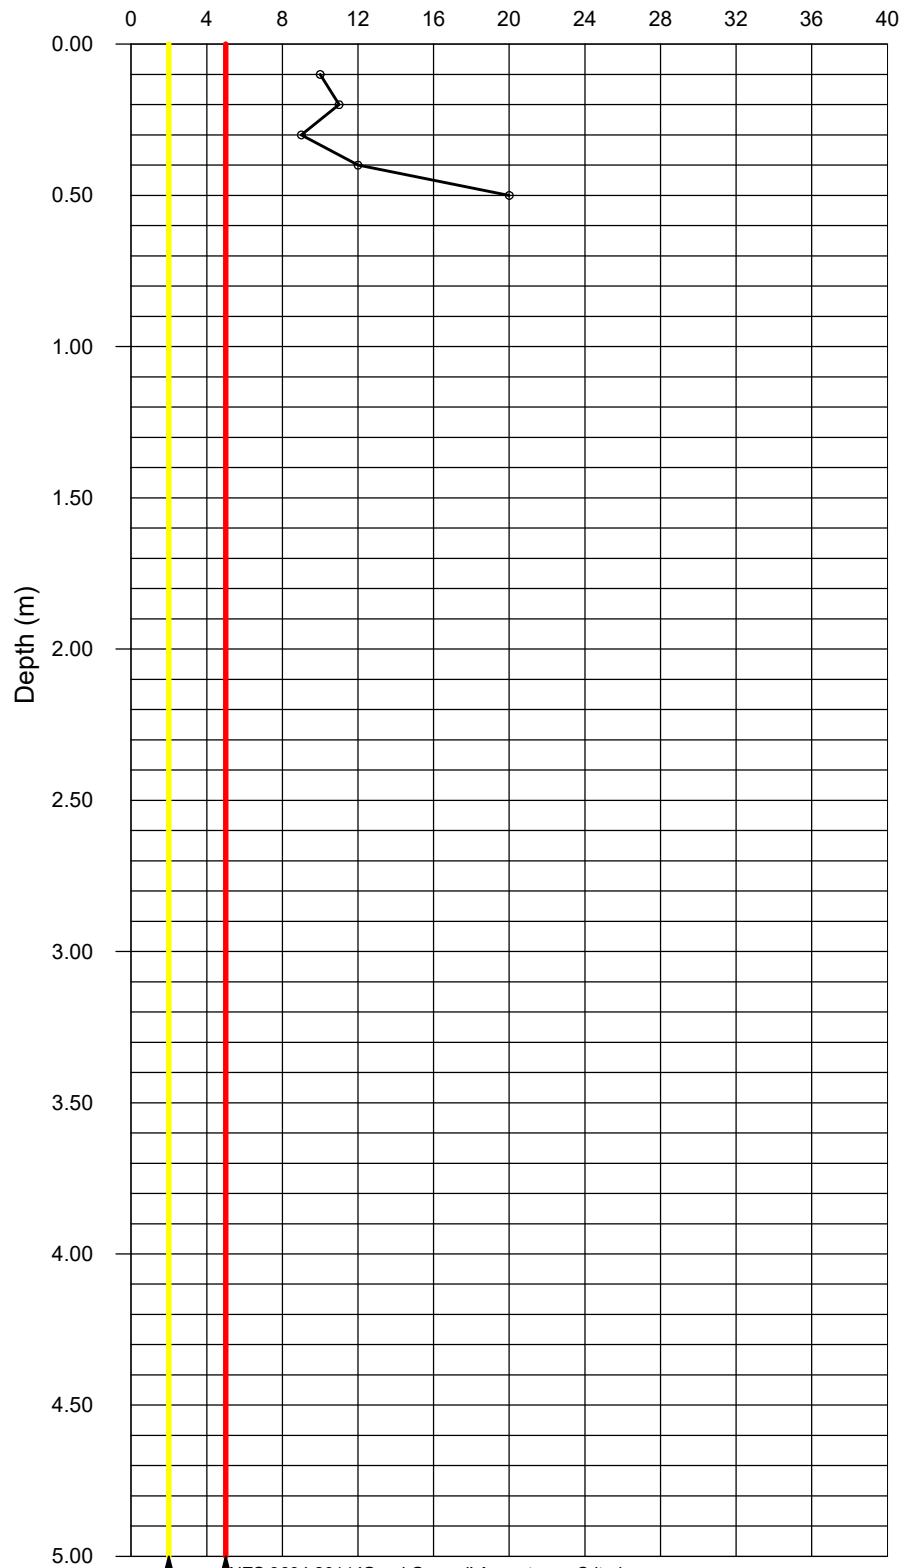
Number of blows per 100mm

10 blows for 50mm in the last increment.
Co-ordinates and elevation data from site survey.
Elevation based on Lyttelton Vertical Datum.
Effective refusal, 20+ blows per 100mm of penetration.

NZS 3604:2011 'Good Ground' Acceptance Criteria
MBIE '200kPa geotechnical ultimate bearing capacity' Acceptance Criteria

Four DCPs were carried out with the locations and results uploaded to the NZGD. The DCP test results are attached in Appendix B. Two of the DCPs were located adjacent to the hand auger boreholes, with the other DCPs being located on the opposite half of the lot. The DCPs were undertaken at an earlier date, however they are still considered suitable for the purposes of building consent as no further earthworks or site modifications have been undertaken.

DCP logs indicate 5 blows per 100mm penetration, which is equivalent to an ultimate bearing capacity of 300kPa, was consistently encountered from a shallow depth.

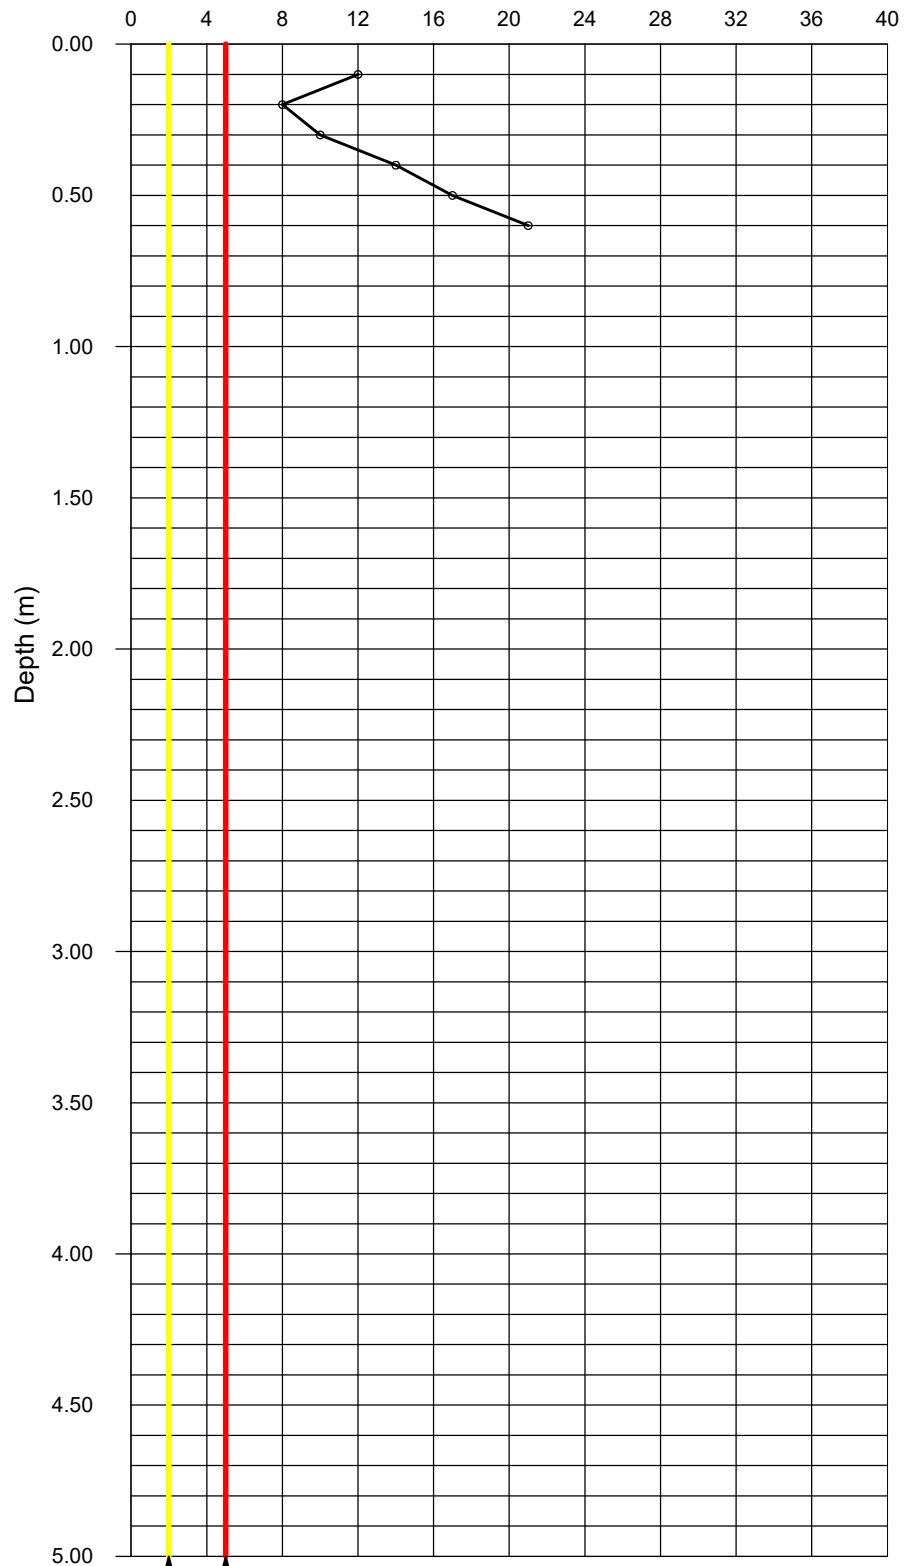
Depth (m)	Blows per 100 mm	Depth (m)	Blows per 100 mm
0.0	12	3.5	
0.1	8		
0.2	10		
0.3	14		
0.4	17		
0.5	21		
0.6			
0.7			
0.8			
0.9			
1.0			
1.1			
1.2			
1.3			
1.4			
1.5			
1.6			
1.7			
1.8			
1.9			
2.0			
2.1			
2.2			
2.3			
2.4			
2.5			
2.6			
2.7			
2.8			
2.9			
3.0			
3.1			
3.2			
3.3			
3.4			
3.5

Number of blows per 100mm

21 blows for 100mm in the last increment.
Co-ordinates and elevation data from site survey.
Elevation based on Lyttelton Vertical Datum.
Effective refusal, 20+ blows per 100mm of penetration.

NZS 3604:2011 'Good Ground' Acceptance Criteria
MBIE '200kPa geotechnical ultimate bearing capacity' Acceptance Criteria

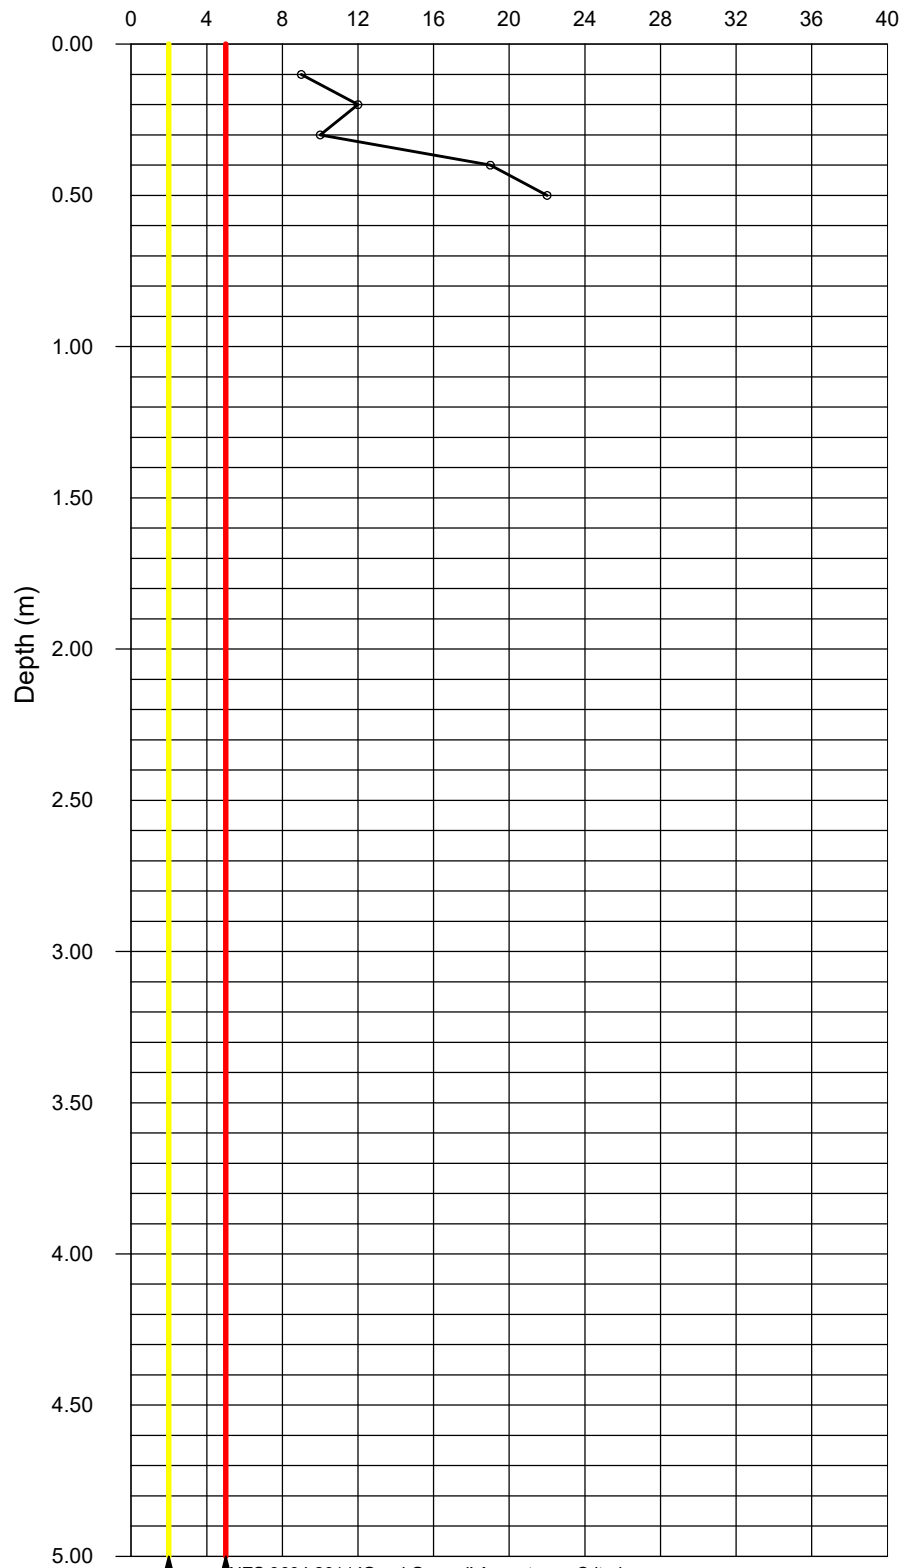
Depth (m)	Blows per 100 mm	Depth (m)	Blows per 100 mm
0.0	9	3.5	
0.1	12		
0.2	10		
0.3	19		
0.4	22		
0.5		4.0	
1.0		4.5	
1.5		5.0	
2.0			
2.5			
3.0			
3.5

Number of blows per 100mm

22 blows for 100mm in the last increment.
Co-ordinates and elevation data from site survey.
Elevation based on Lyttelton Vertical Datum.
Effective refusal, 20+ blows per 100mm of penetration.

NZS 3604:2011 'Good Ground' Acceptance Criteria
MBIE '200kPa geotechnical ultimate bearing capacity' Acceptance Criteria

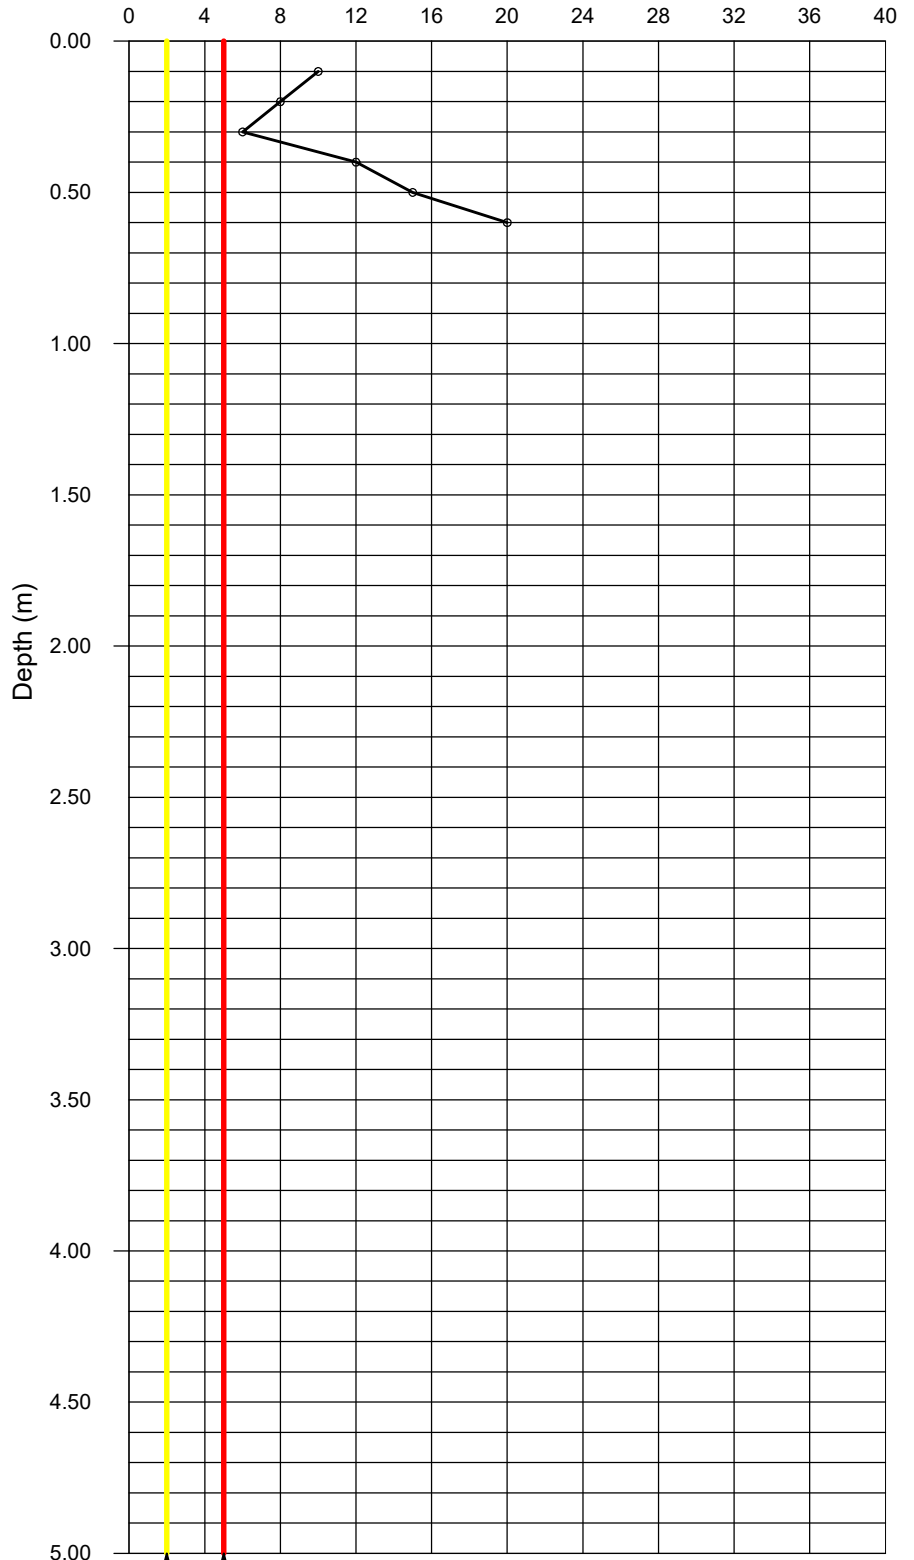
Number of blows per 100mm

20 blows for 100mm in the last increment.
Co-ordinates and elevation data from site survey.
Elevation based on Lyttelton Vertical Datum.
Effective refusal, 20+ blows per 100mm of penetration.

NZS 3604:2011 'Good Ground' Acceptance Criteria
 MBIE '200kPa geotechnical ultimate bearing capacity' Acceptance Criteria
