Prestons Subdivision
GEOTECHNICAL REPORT FOR LOT 4003
CDL Land NZ Limited

30 August 2021
Revision: 1
Reference: 235361

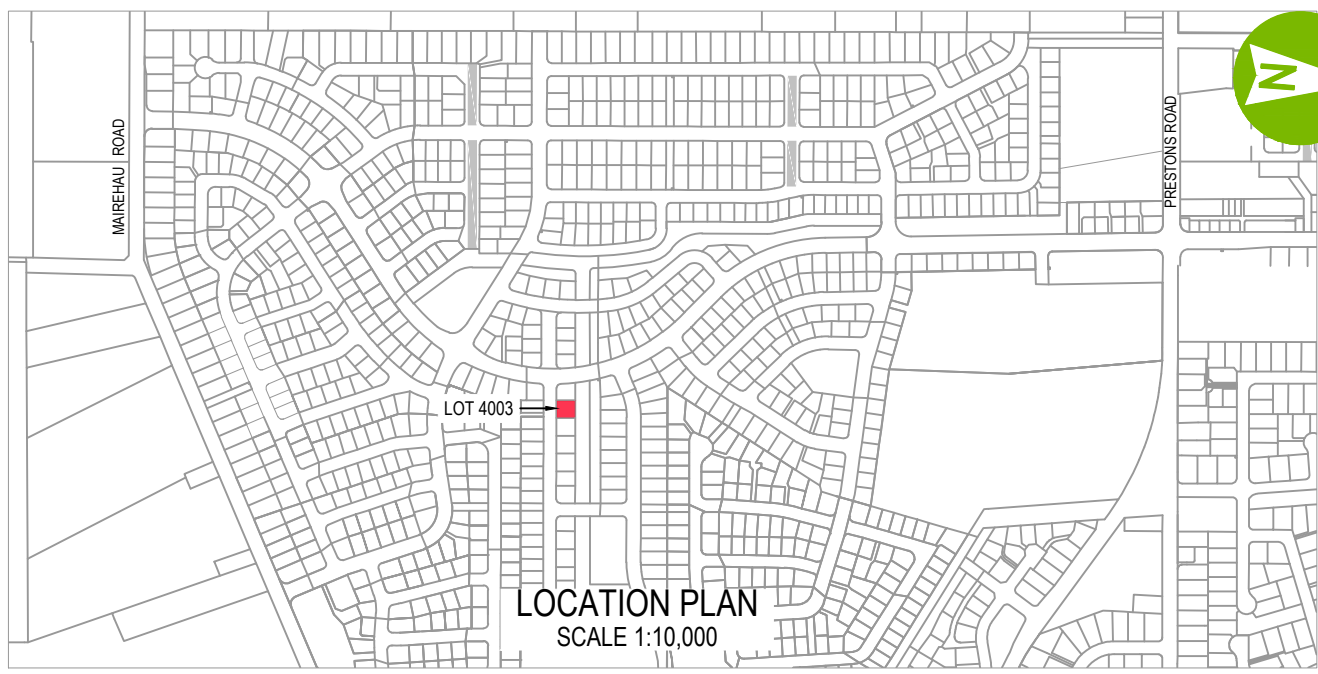
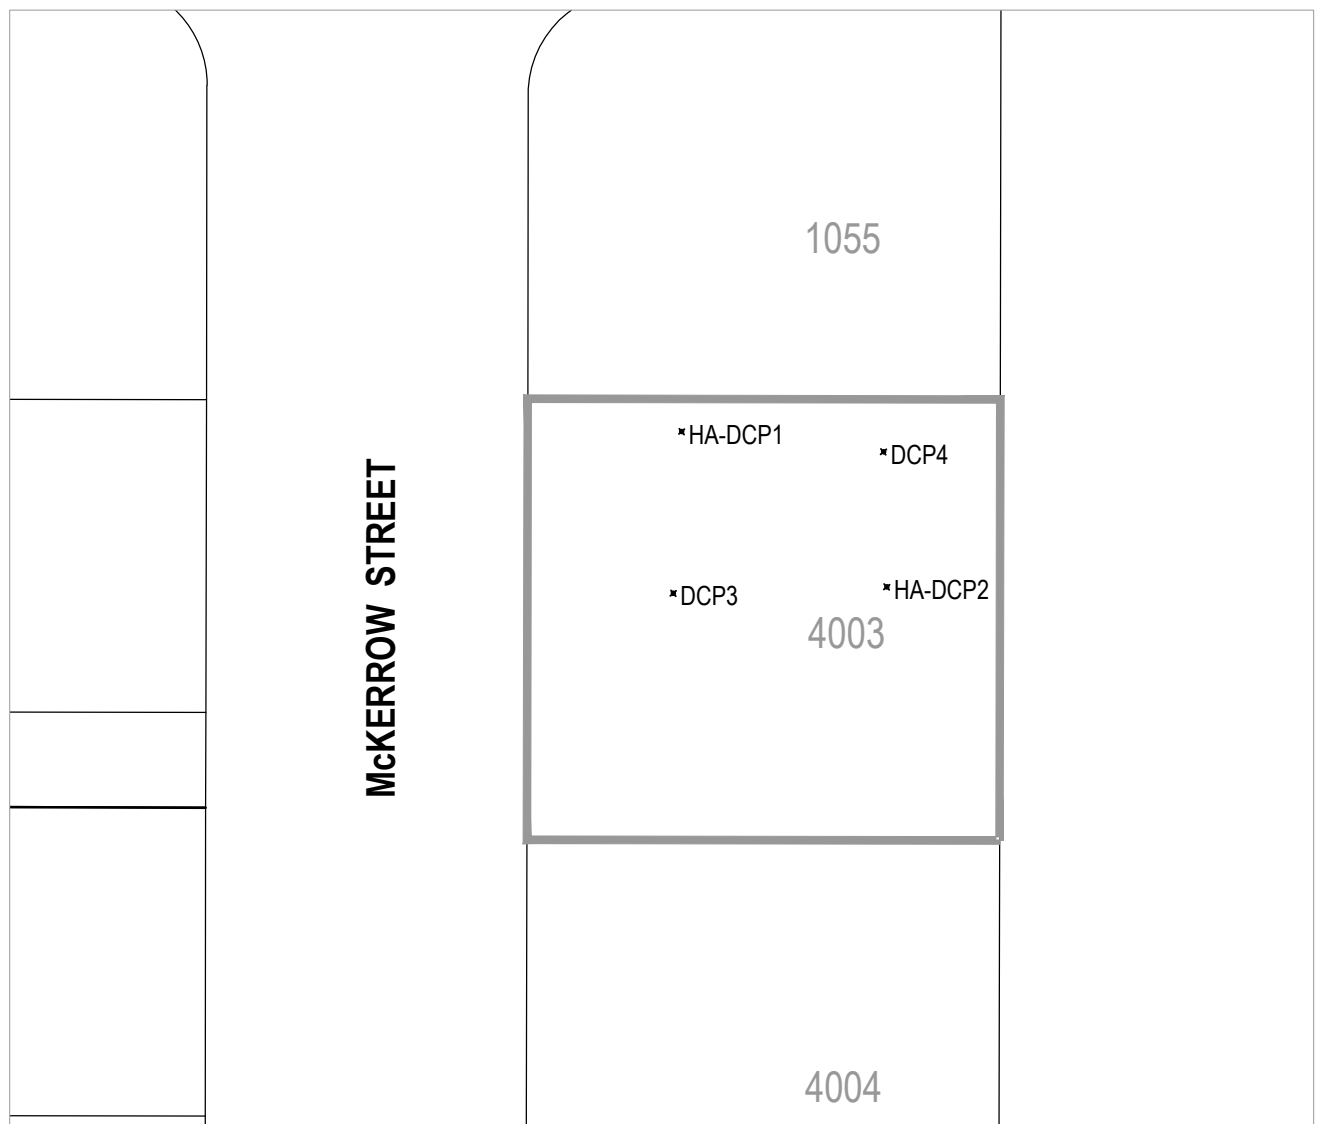
This building consent report is for Lot 4003 which is located in Stage 2 of the Prestons South Subdivision development (refer Figure 1 in Appendix A). The lot is bordered by residential lots to the east and west, an access road to the south and an open storm water channel to the north.

Two hand auger boreholes were undertaken on the lot as part of the geotechnical investigation to assess the upper soil profile and the groundwater level. The test location and the borehole log have been uploaded to the New Zealand Geotechnical Database (NZGD). The borehole log is attached in Appendix B. The hand held testing was undertaken at an earlier date, however it is still considered suitable for the purposes of building consent as no further earthworks or site modifications have been undertaken.

Two DCPs were carried out with the locations and results uploaded to the NZGD. The DCP test results are attached in Appendix B. One of the DCPs was located adjacent to the hand auger borehole, with the second DCP located on the opposite half of the lot. The DCPs were undertaken at an earlier date, however they are still considered suitable for the purposes of building consent as no further earthworks or site modifications have been undertaken.
