Prestons Subdivision
GEOTECHNICAL REPORT FOR LOT 4004
CDL Land NZ Limited

30 August 2021
Revision: 1
Reference: 235361

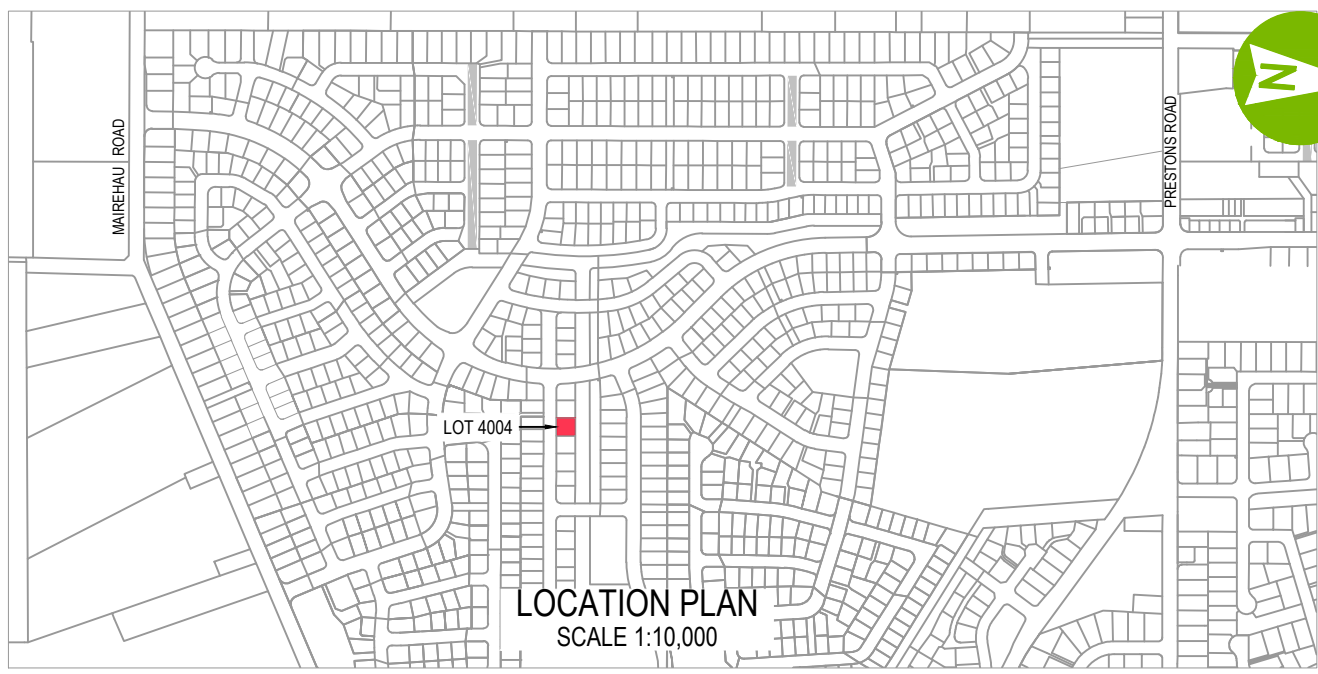
This building consent report is for Lot 4004 which is located in Stage 2 of the Prestons South Subdivision development (refer Figure 1 in Appendix A). The lot is bordered by residential lots to the east and west, an access road to the south and an open storm water channel to the north.

Three hand auger boreholes were undertaken on the lot as part of the geotechnical investigation to assess the upper soil profile and the groundwater level. The test location and the borehole log have been uploaded to the New Zealand Geotechnical Database (NZGD). The borehole log is attached in Appendix B. The hand held testing was undertaken at an earlier date, however it is still considered suitable for the purposes of building consent as no further earthworks or site modifications have been undertaken.

Six DCPs were carried out with the locations and results uploaded to the NZGD. The DCP test results are attached in Appendix B. Three of the DCPs were located adjacent to the hand auger boreholes, with the other DCPs being located on the opposite half of the lot. The DCPs were undertaken at an earlier date, however they are still considered suitable for the purposes of building consent as no further earthworks or site modifications have been undertaken.
