Prestons Subdivision
GEOTECHNICAL REPORT FOR LOT 4007
CDL Land NZ Limited

30 August 2021
Revision: 1
Reference: 235361

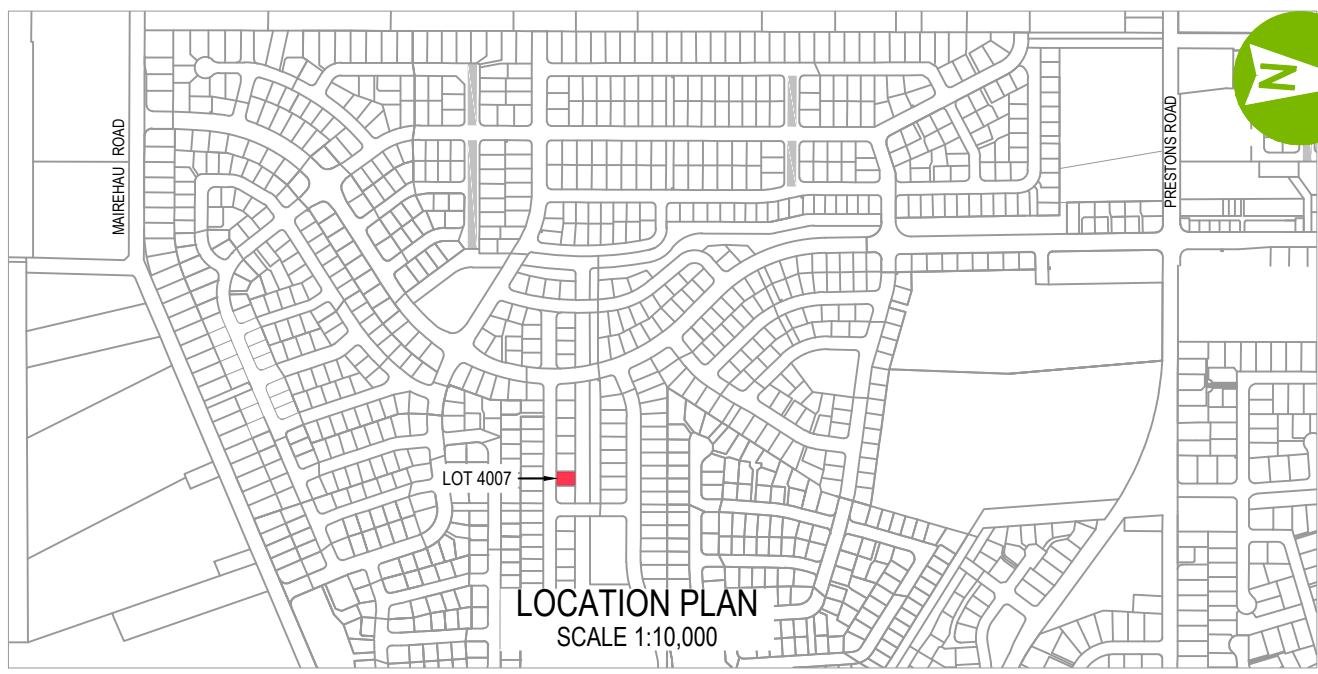
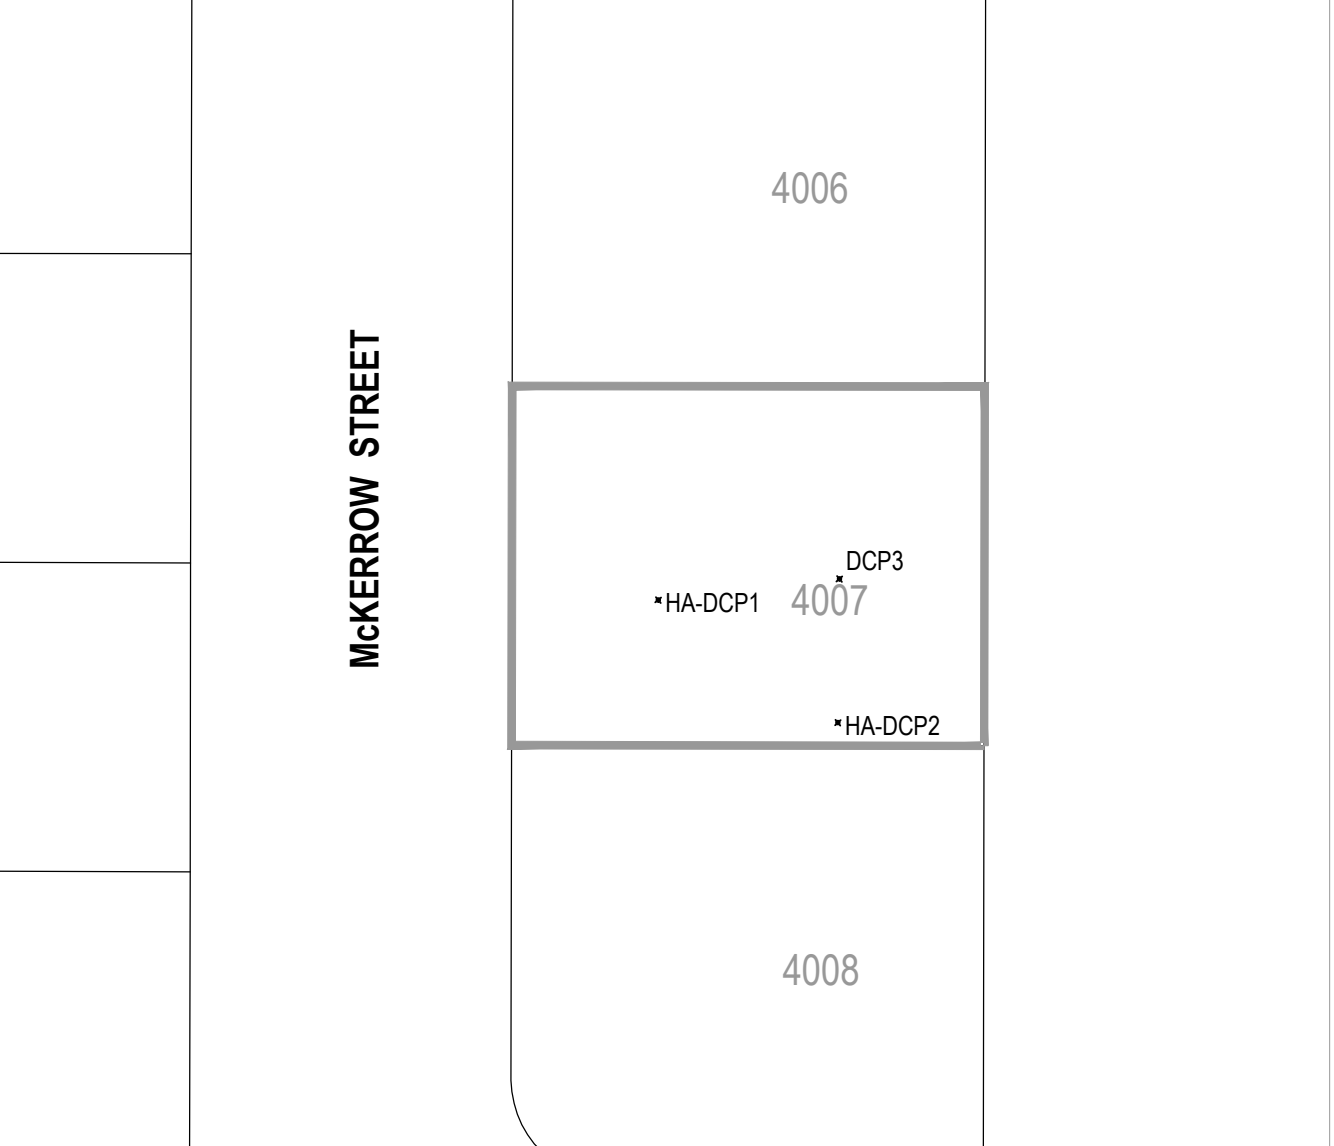
REV		DATE	REVISION DETAILS	APPROVED	DRAWN	DESIGNED	PROJECT		INFORMATION		
A		25/02/21	ISSUE FOR INFORMATION	T BROWNE	R DAWSON	K FOOTE	PRESTONS		PROJECT No. 235361		
				CHECKED J MUIRSON		TITLE LOT 4007 SITE LOCATION PLAN FIGURE 1		SCALE 1:400	SIZE A4		
				APPROVED T BROWNE		DATE 25/02/2021			DRAWING No. GO-PS-DC-IN-4007	REV A

This building consent report is for Lot 4007 which is located in Stage 2 of the Prestons South Subdivision development (refer Figure 1 in Appendix A). The lot is bordered by residential lots to the east and west, an access road to the south and an open storm water channel to the north.

Two hand auger boreholes were undertaken on the lot as part of the geotechnical investigation to assess the upper soil profile and the groundwater level. The test location and the borehole log have been uploaded to the New Zealand Geotechnical Database (NZGD). The borehole log is attached in Appendix B. The hand held testing was undertaken at an earlier date, however it is still considered suitable for the purposes of building consent as no further earthworks or site modifications have been undertaken.

Three DCPs were carried out with the locations and results uploaded to the NZGD. The DCP test results are attached in Appendix B. Two of the DCPs were located adjacent to the hand auger boreholes, with the other DCP being located on the opposite half of the lot. The DCPs were undertaken at an earlier date, however they are still considered suitable for the purposes of building consent as no further earthworks or site modifications have been undertaken.

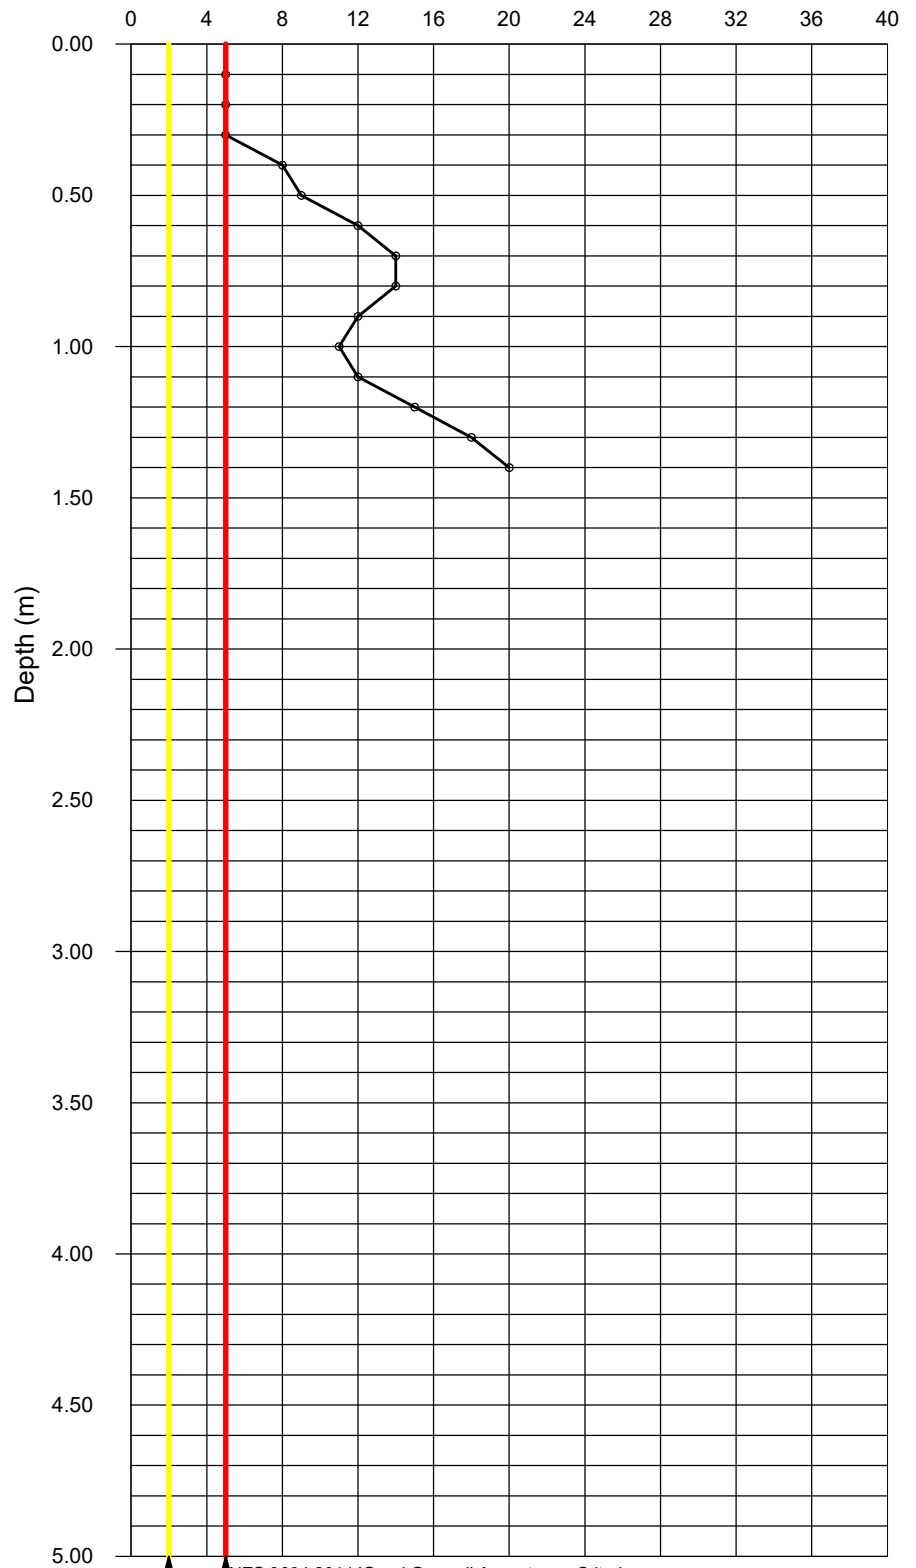
Number of blows per 100mm

20 blows for 100mm in the last increment.
Co-ordinates and elevation data from site survey.
Elevation based on Lyttelton Vertical Datum.
Effective refusal, 20+ blows per 100mm of penetration.

NZS 3604:2011 'Good Ground' Acceptance Criteria

MBIE '200kPa geotechnical ultimate bearing capacity' Acceptance Criteria

DCP logs indicate 5 blows per 100mm penetration, which is equivalent to an ultimate bearing capacity of 300kPa, was consistently encountered from a shallow depth.

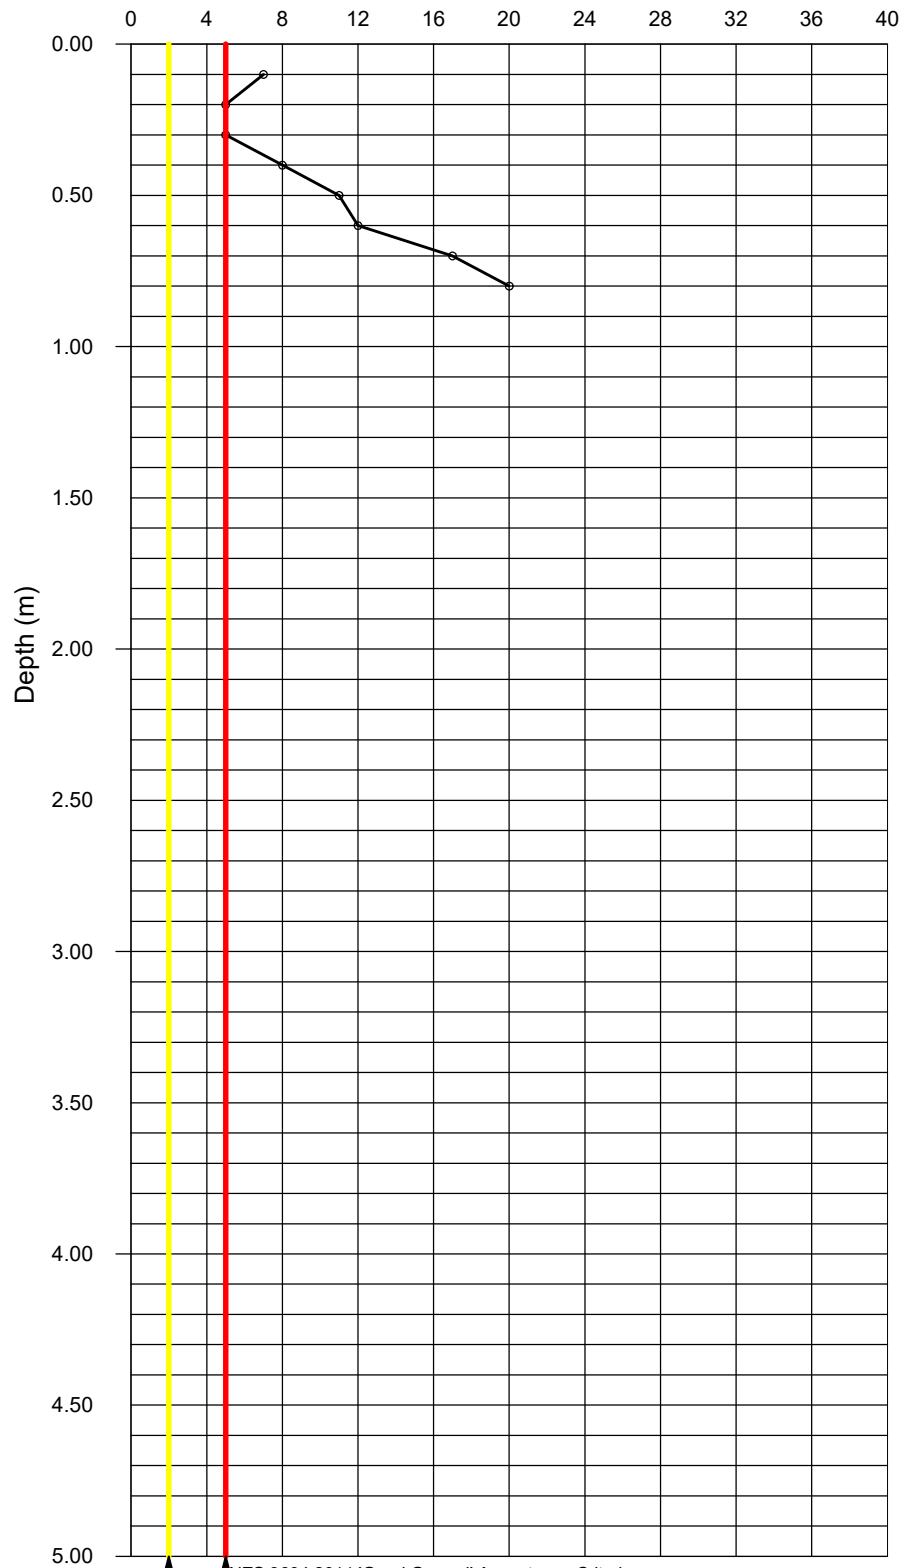
Number of blows per 100mm

20 blows for 100mm in the last increment.
Co-ordinates and elevation data from site survey.
Elevation based on Lyttelton Vertical Datum.
Effective refusal, 20+ blows per 100mm of penetration.

NZS 3604:2011 'Good Ground' Acceptance Criteria
MBIE '200kPa geotechnical ultimate bearing capacity' Acceptance Criteria

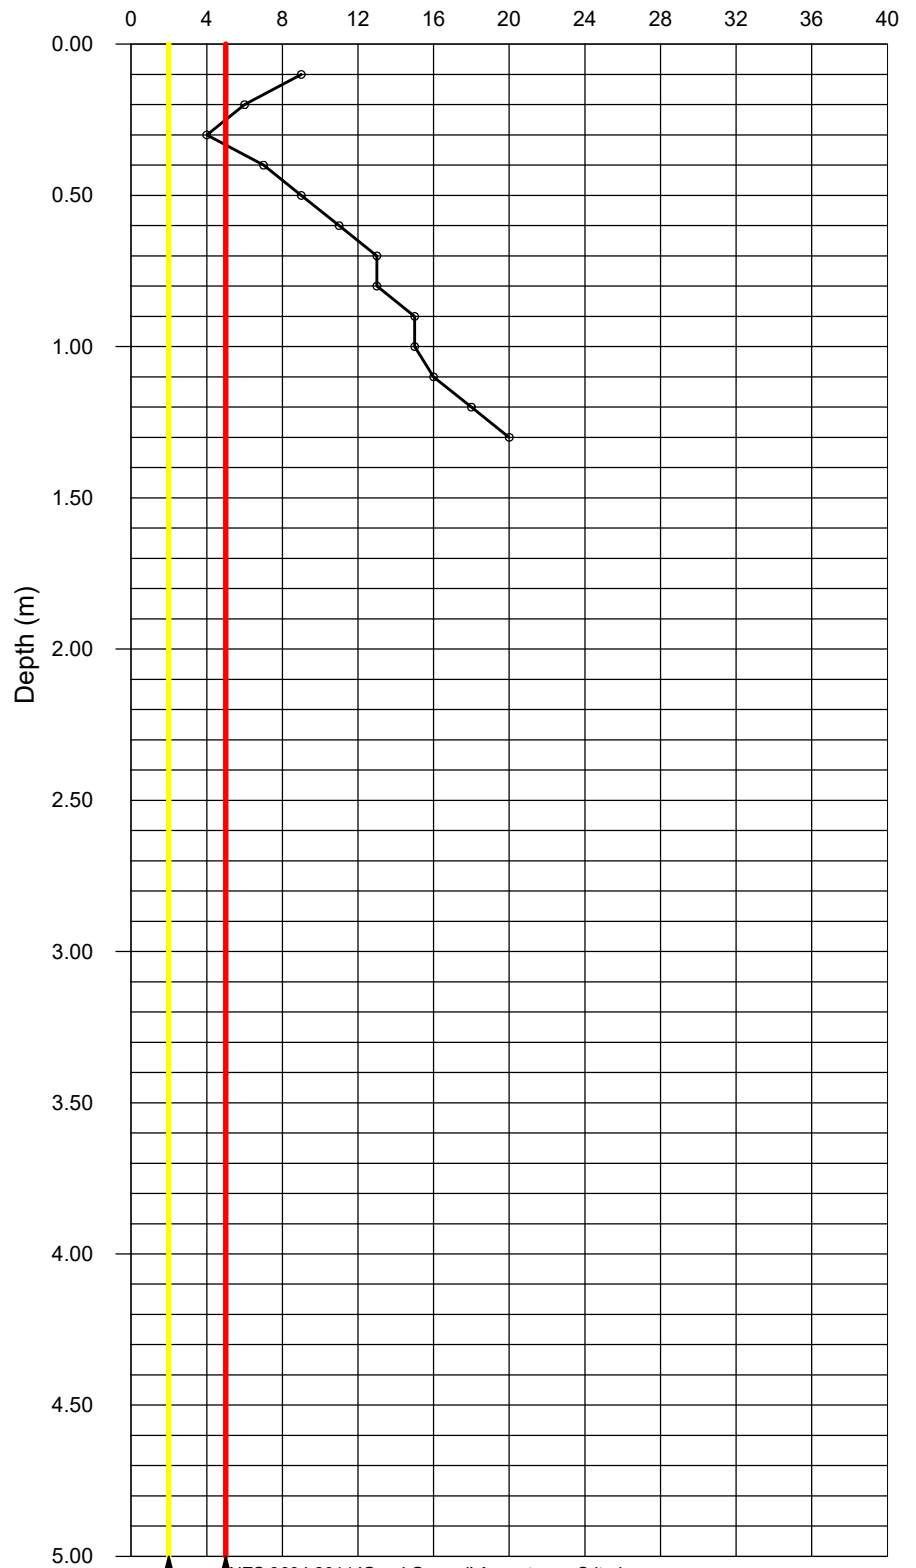
Number of blows per 100mm

10 blows for 50mm in the last increment.
Co-ordinates and elevation data from site survey.
Elevation based on Lyttelton Vertical Datum.
Effective refusal, 20+ blows per 100mm of penetration.

NZS 3604:2011 'Good Ground' Acceptance Criteria
MBIE '200kPa geotechnical ultimate bearing capacity' Acceptance Criteria
