Prestons Subdivision
GEOTECHNICAL REPORT FOR LOT 1057
CDL Land NZ Limited

31 August 2021
Revision: 1
Reference: 235361

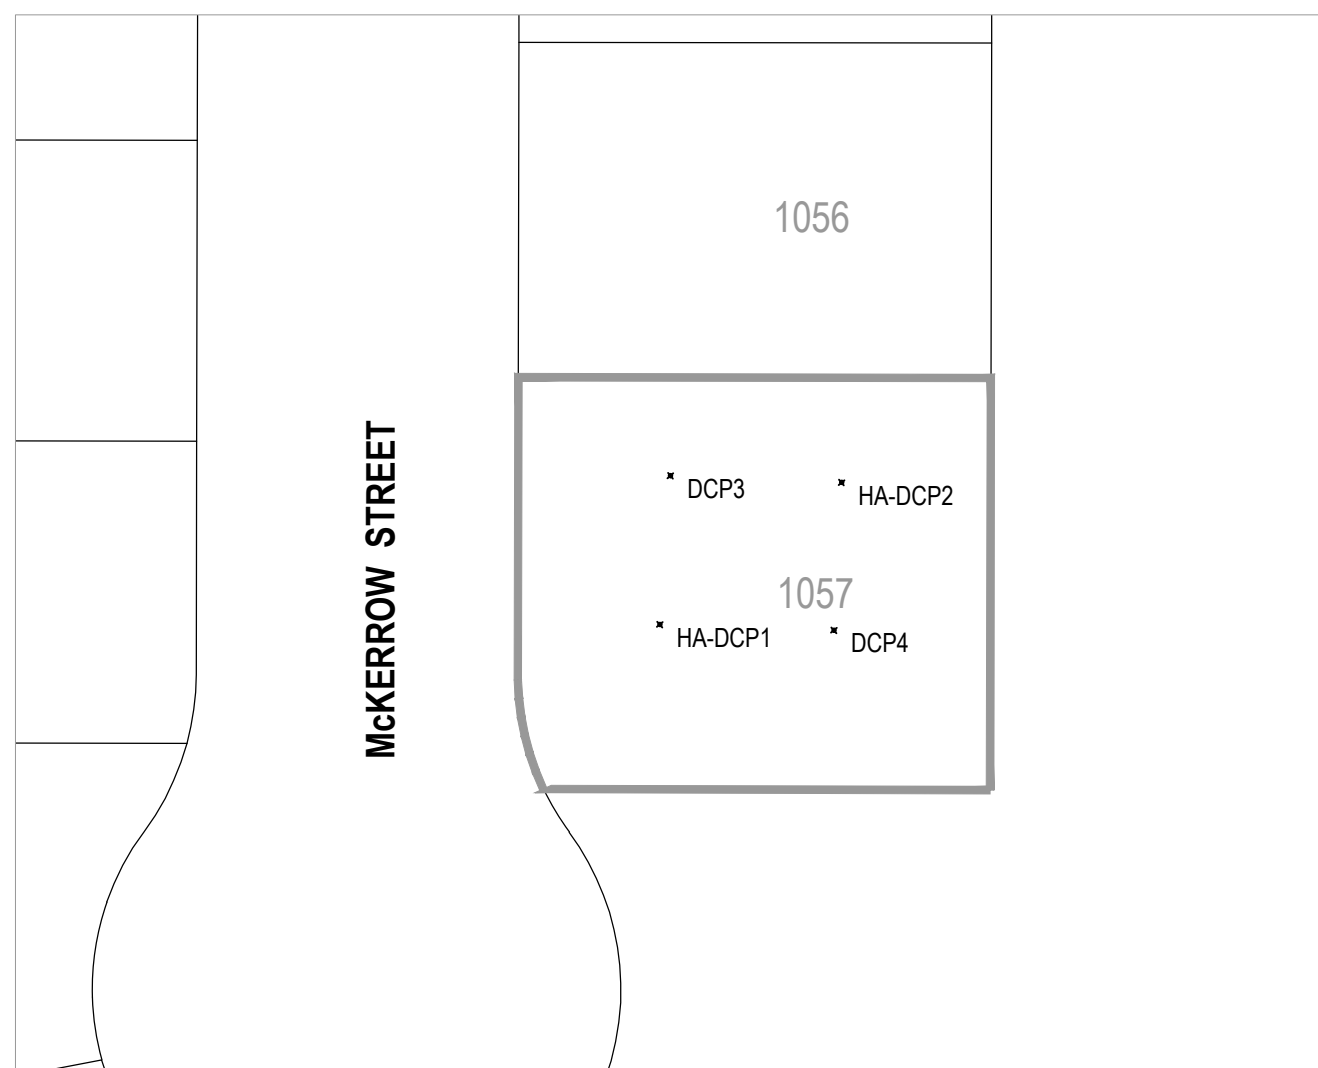
TITLE
LOT 1057
SITE LOCATION PLAN
FIGURE 1

This building consent report is for Lot 1057 which is located in Stage 2 of the Prestons South Subdivision development (refer Figure 1 in Appendix A). The lot is bordered by a residential lot to the west, an access road to the south, an open storm water channel to the north and a local purpose reserve (utility) to the east.

Two hand auger boreholes were undertaken on the lot as part of the geotechnical investigation to assess the upper soil profile and the groundwater level. The test location and the borehole log have been uploaded to the New Zealand Geotechnical Database (NZGD). The borehole log is attached in Appendix B. The hand held testing was undertaken at an earlier date, however it is still considered suitable for the purposes of building consent as no further earthworks or site modifications have been undertaken.

Four DCPs were carried out with the locations and results uploaded to the NZGD. The DCP test results are attached in Appendix B. Two of the DCPs were located adjacent to the hand auger boreholes, with the other DCPs being located on the opposite half of the lot. The DCPs were undertaken at an earlier date, however they are still considered suitable for the purposes of building consent as no further earthworks or site modifications have been undertaken.
