Prestons Subdivision
GEOTECHNICAL REPORT FOR LOT 4009
CDL Land NZ Limited

31 August 2021
Revision: 1
Reference: 235361

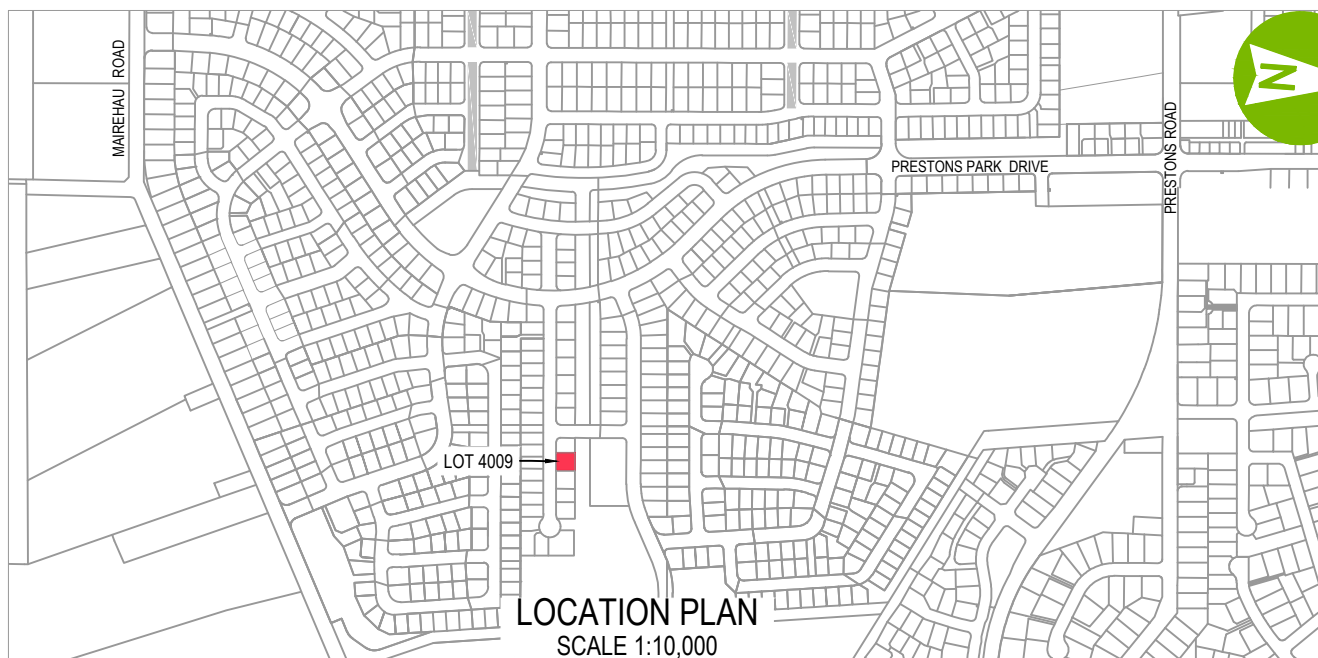
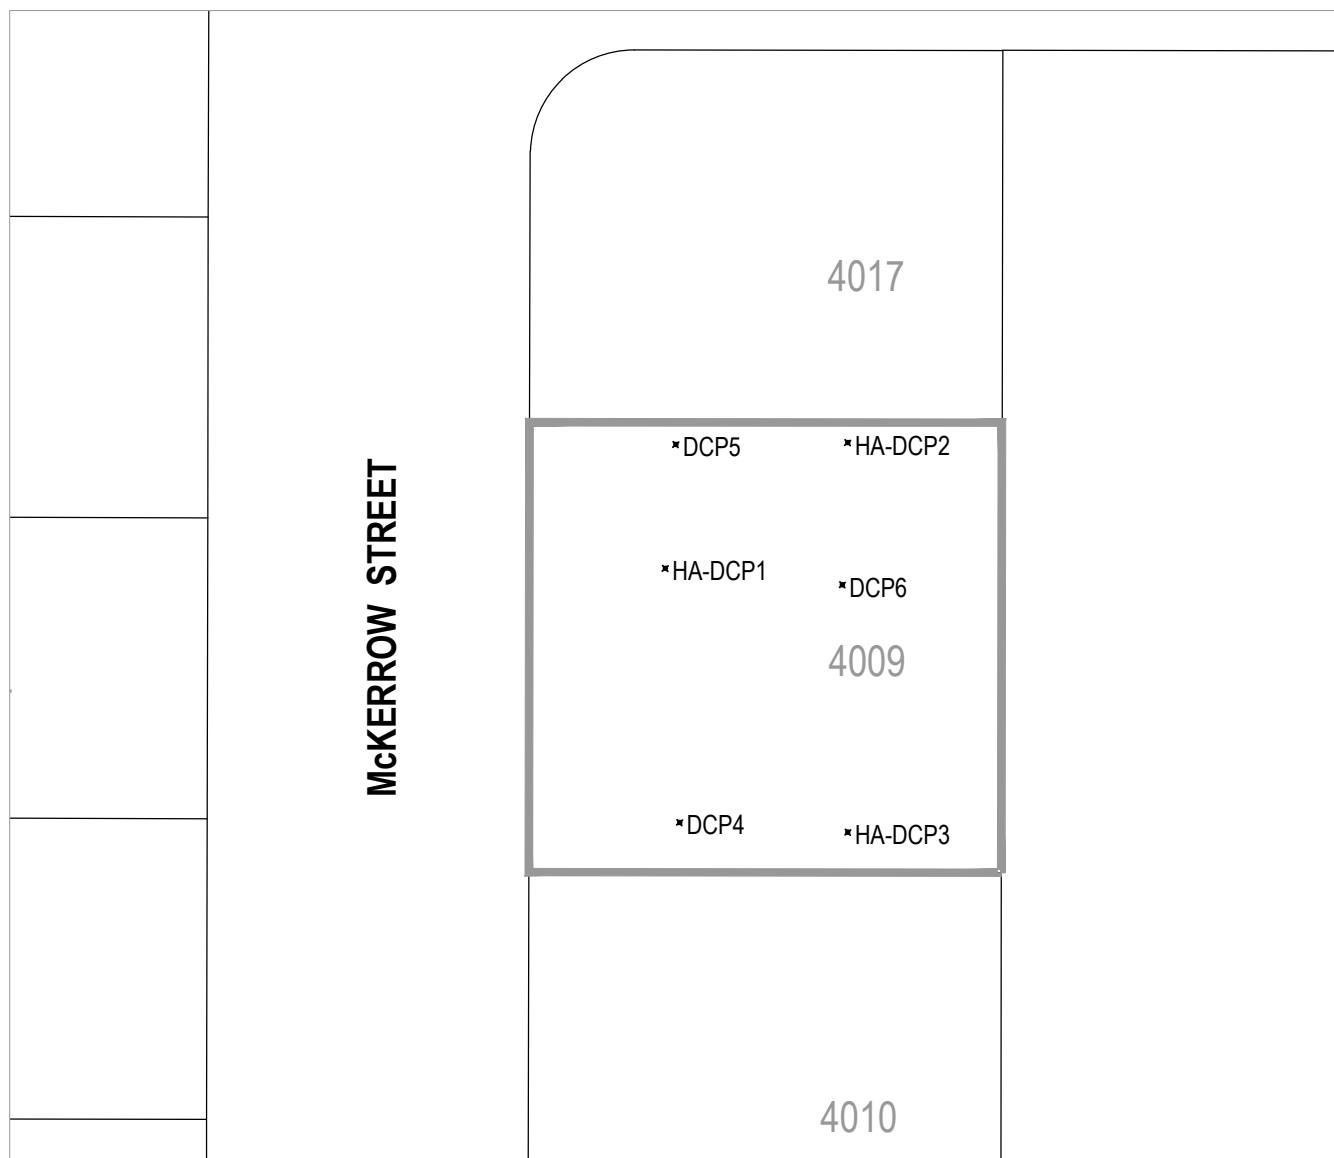
| PROJECT |
|--|
| LOT 4009 SITE LOCATION PLAN FIGURE 1 |

This building consent report is for Lot 4009 which is located in Stage 2 of the Prestons South Subdivision development (refer Figure 1 in Appendix A). The lot is bordered by residential lots to the east and west, an access road to the south and an open storm water channel to the north.

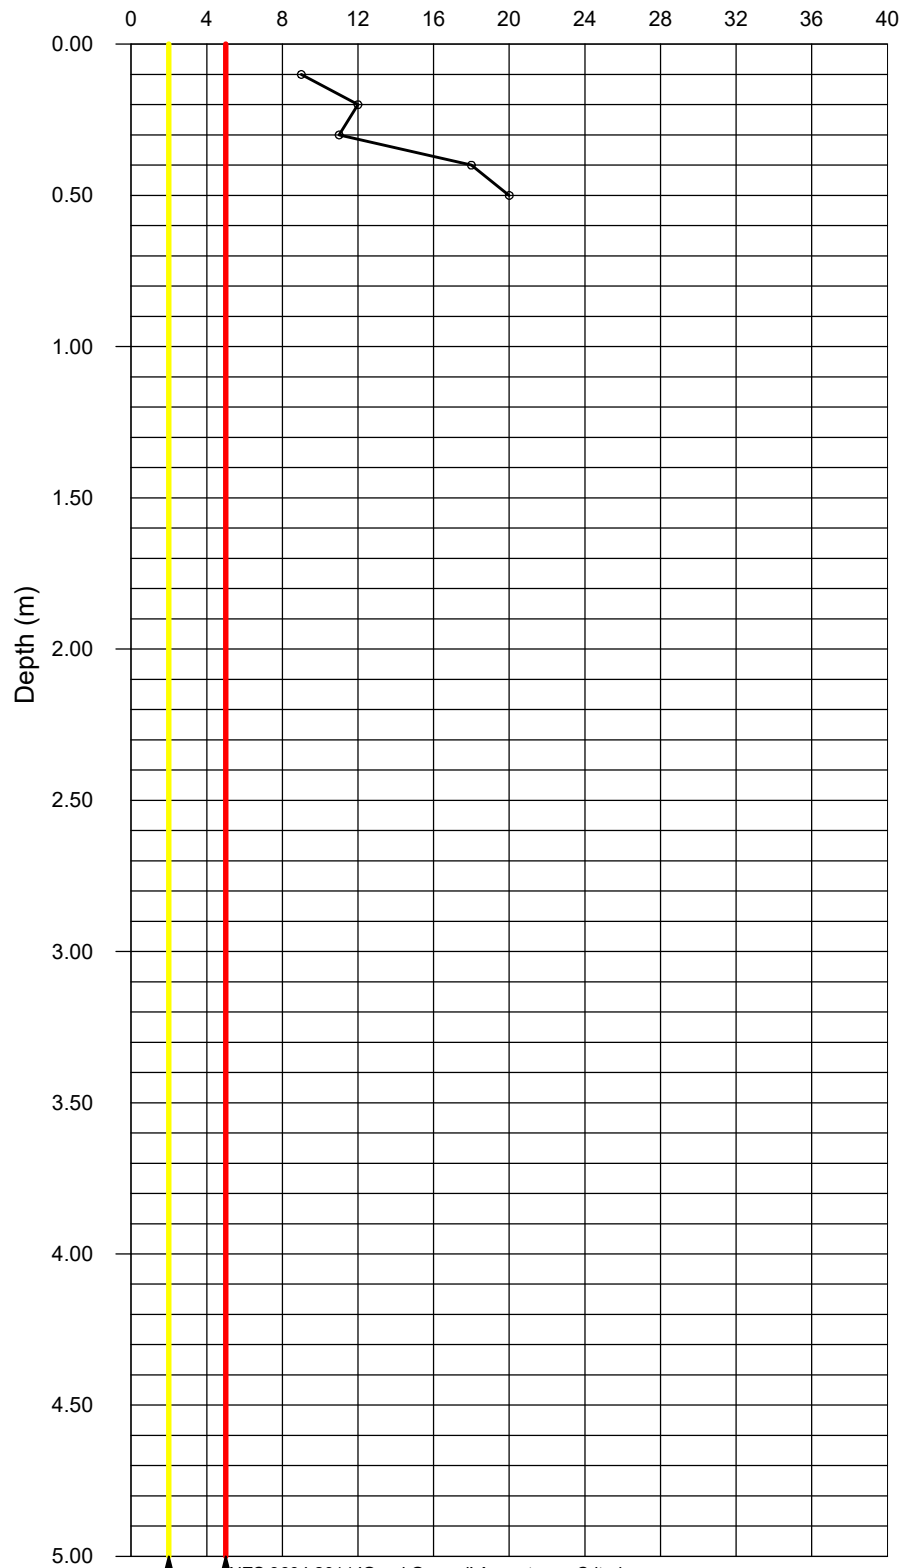
Number of blows per 100mm

20 blows for 100mm in the last increment.
Co-ordinates and elevation data from site survey.
Elevation based on Lyttelton Vertical Datum.
Effective refusal, 20+ blows per 100mm of penetration.

DCP logs indicate 5 blows per 100mm penetration, which is equivalent to an ultimate bearing capacity of 300kPa, was consistently encountered from a shallow depth.

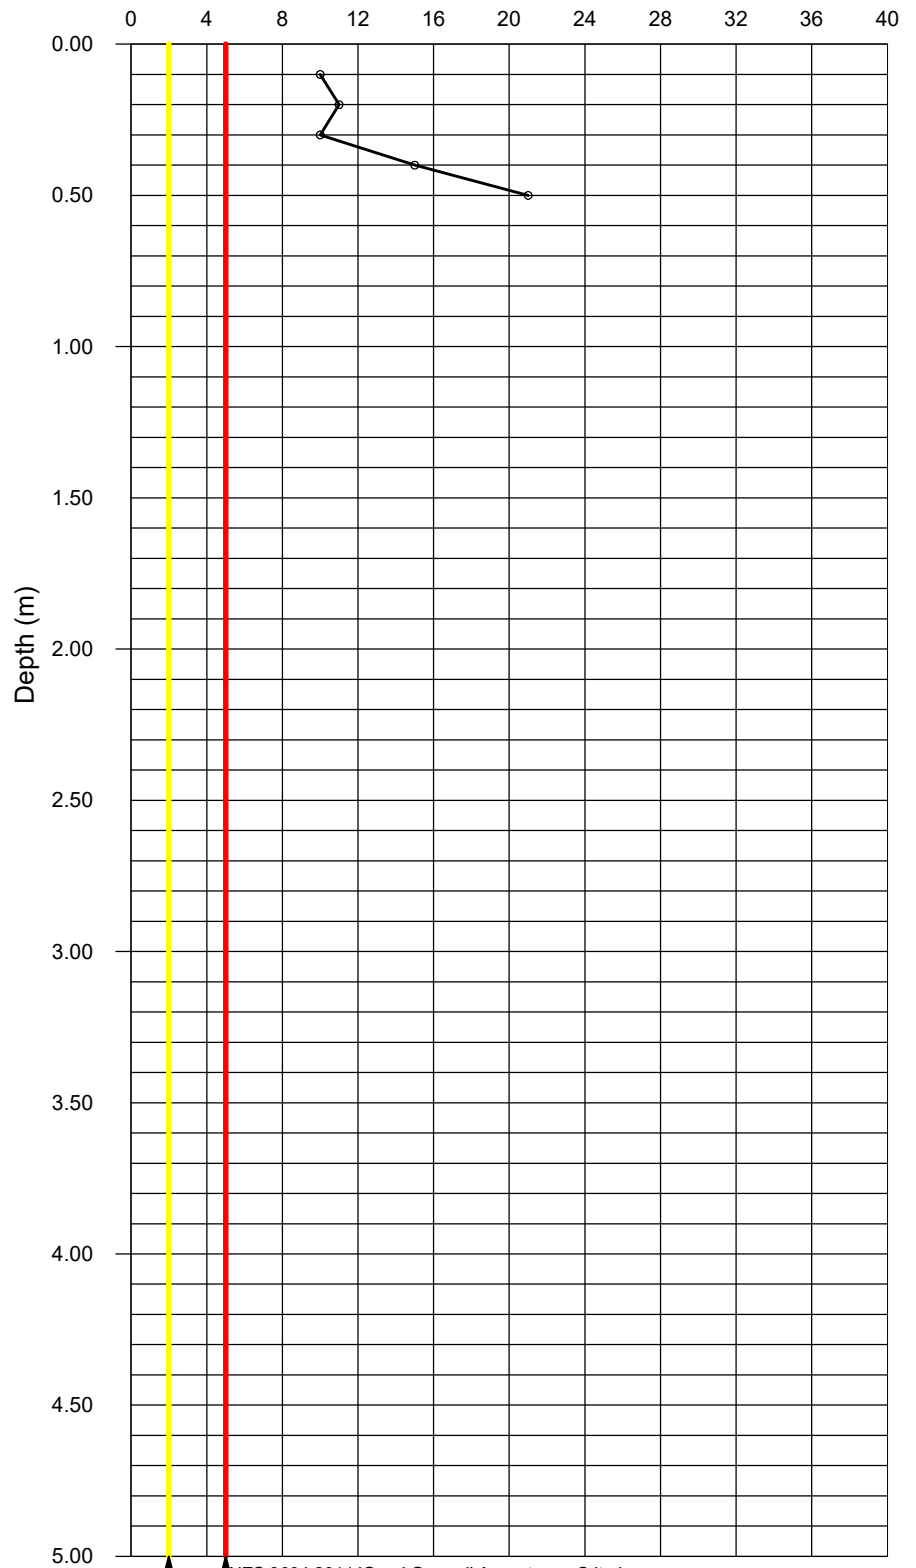
Number of blows per 100mm

21 blows for 100mm in the last increment.
Co-ordinates and elevation data from site survey.
Elevation based on Lyttelton Vertical Datum.
Effective refusal, 20+ blows per 100mm of penetration.

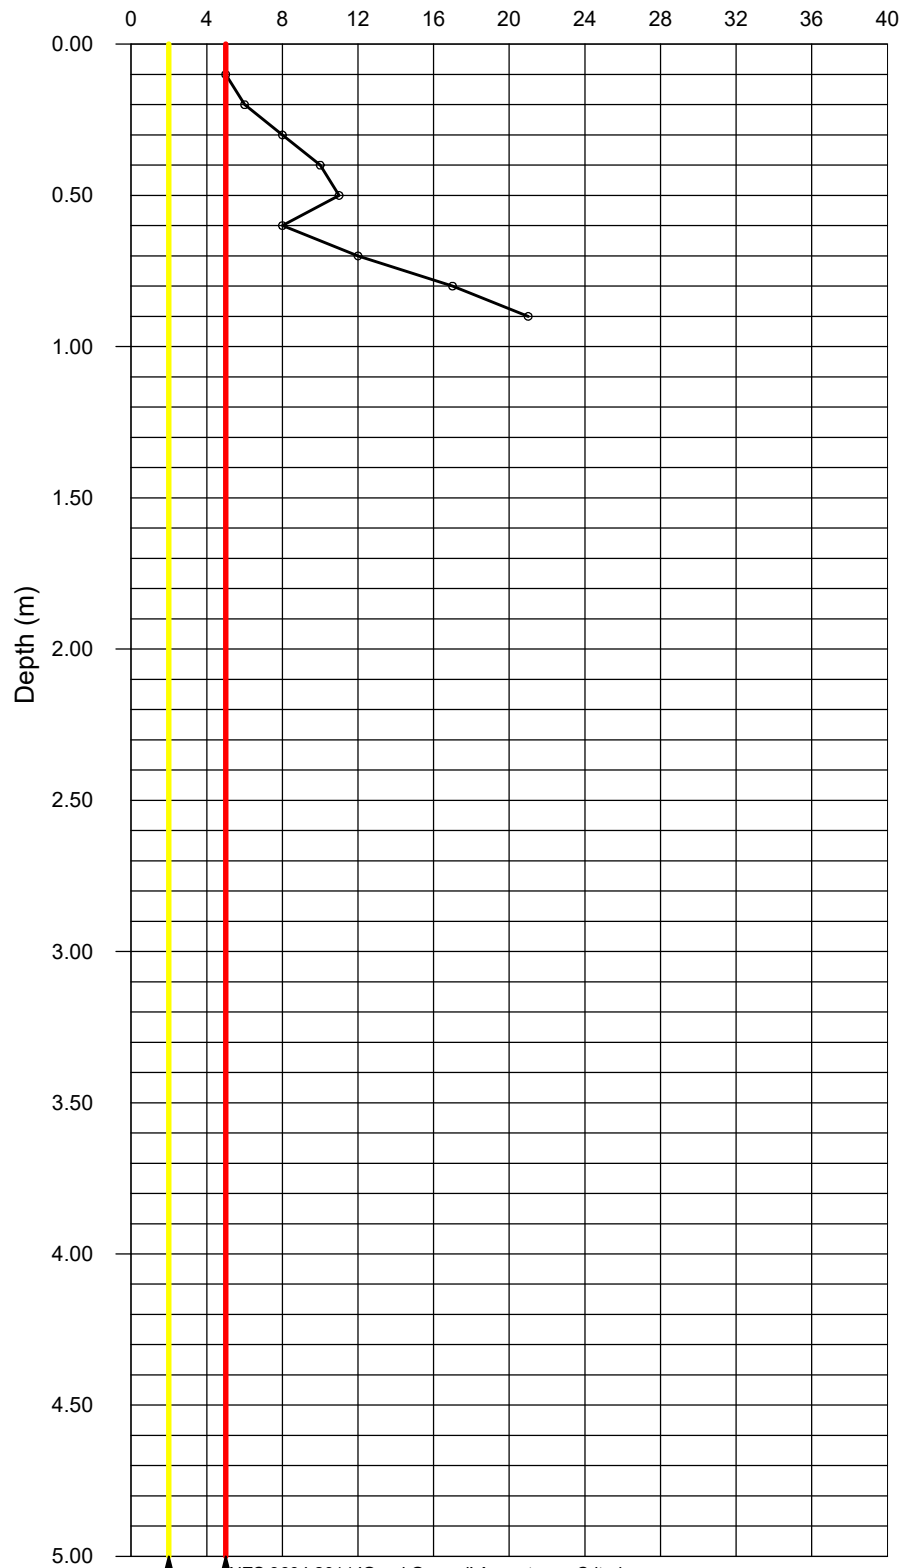
Number of blows per 100mm

21 blows for 100mm in the last increment.
Co-ordinates and elevation data from site survey.
Elevation based on Lyttelton Vertical Datum.
Effective refusal, 20+ blows per 100mm of penetration.

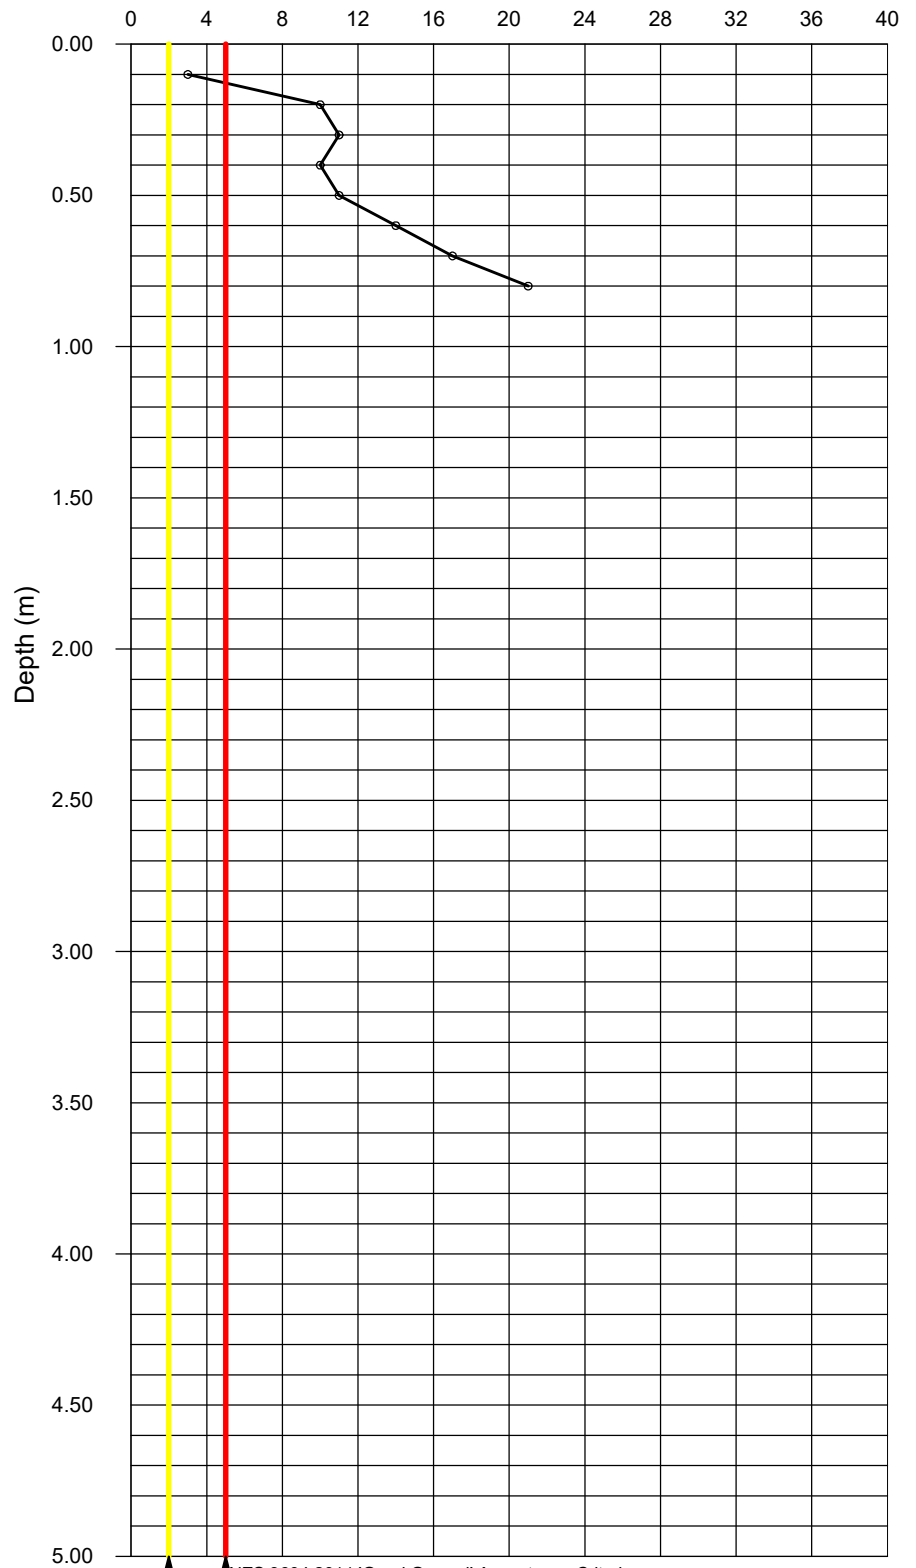
Number of blows per 100mm

21 blows for 100mm in the last increment.
Co-ordinates and elevation data from site survey.
Elevation based on Lyttelton Vertical Datum.
Effective refusal, 20+ blows per 100mm of penetration.

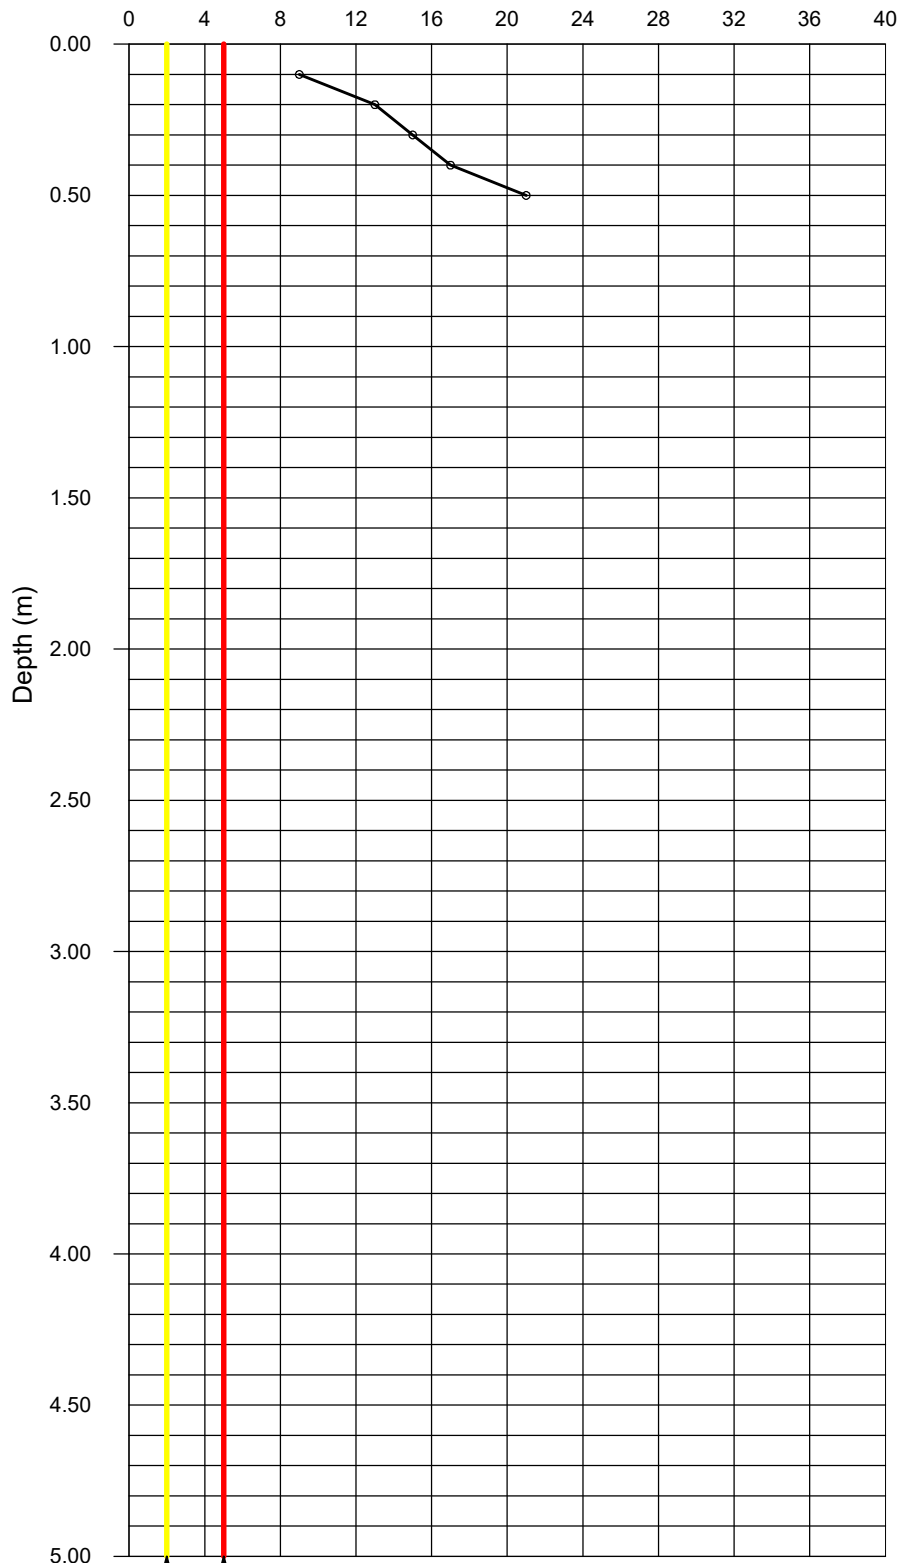
Number of blows per 100mm

21 blows for 100mm in the last increment.
Co-ordinates and elevation data from site survey.
Elevation based on Lyttelton Vertical Datum.
Effective refusal, 20+ blows per 100mm of penetration.

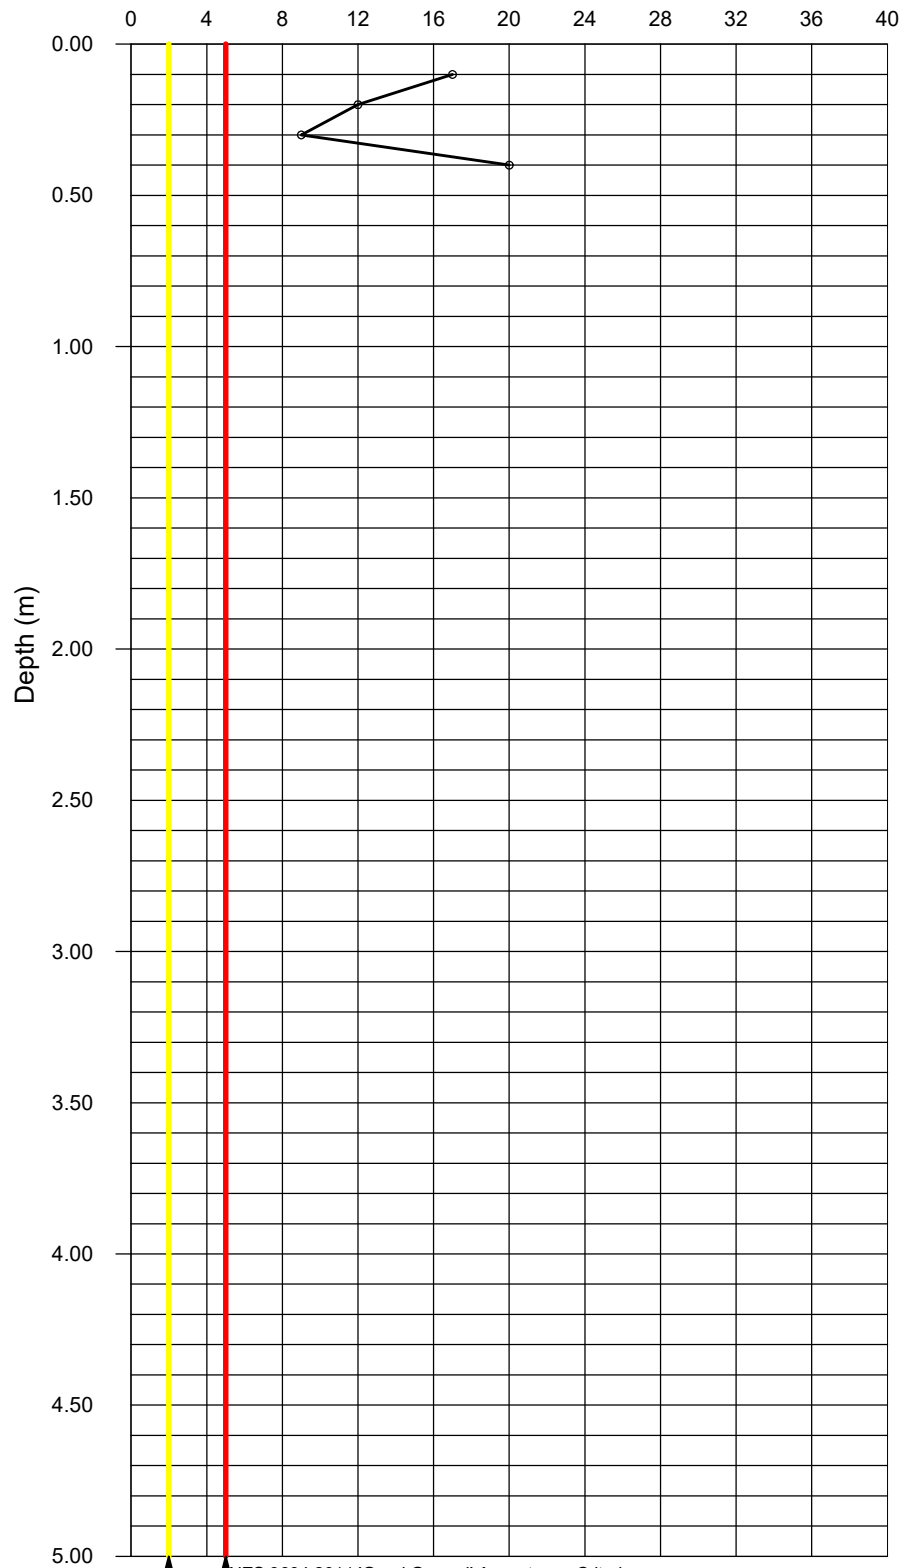
Number of blows per 100mm

20 blows for 100mm in the last increment.
Co-ordinates and elevation data from site survey.
Elevation based on Lyttelton Vertical Datum.
Effective refusal, 20+ blows per 100mm of penetration.
