Prestons Subdivision
GEOTECHNICAL REPORT FOR LOT 1067
CDL Land NZ Limited

13 September 2021
Revision: 1
Reference: 235361

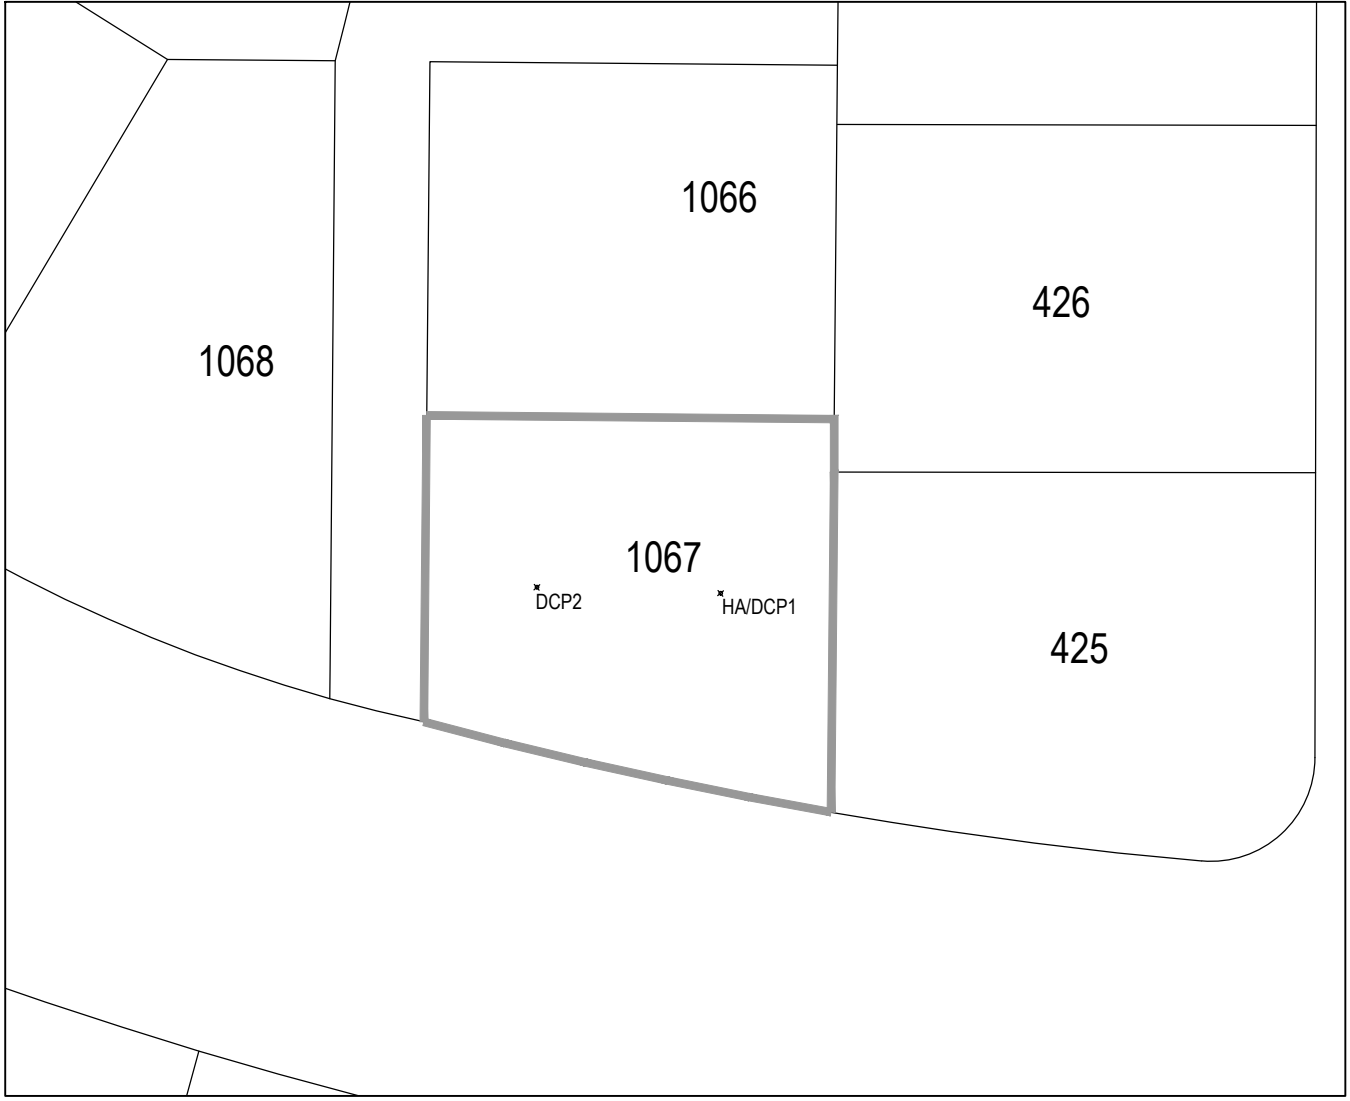
This building consent report is for Lot 1067 which is located in Stage 2 of the Prestons South Subdivision development (refer Figure 1 in Appendix A). The lot is bordered by residential lots to the north, south and west, with an access road to the east.

Two DCPs were carried out with the locations and results uploaded to the NZGD. The DCP test results are attached in Appendix B. One of the DCPs was located adjacent to the hand auger borehole, with the second DCP located on the opposite half of the lot.
