Prestons Park Subdivision
GEOTECHNICAL REPORT FOR LOT 977
CDL Land NZ Limited

5 August 2022
Revision: 1
Reference: 235361

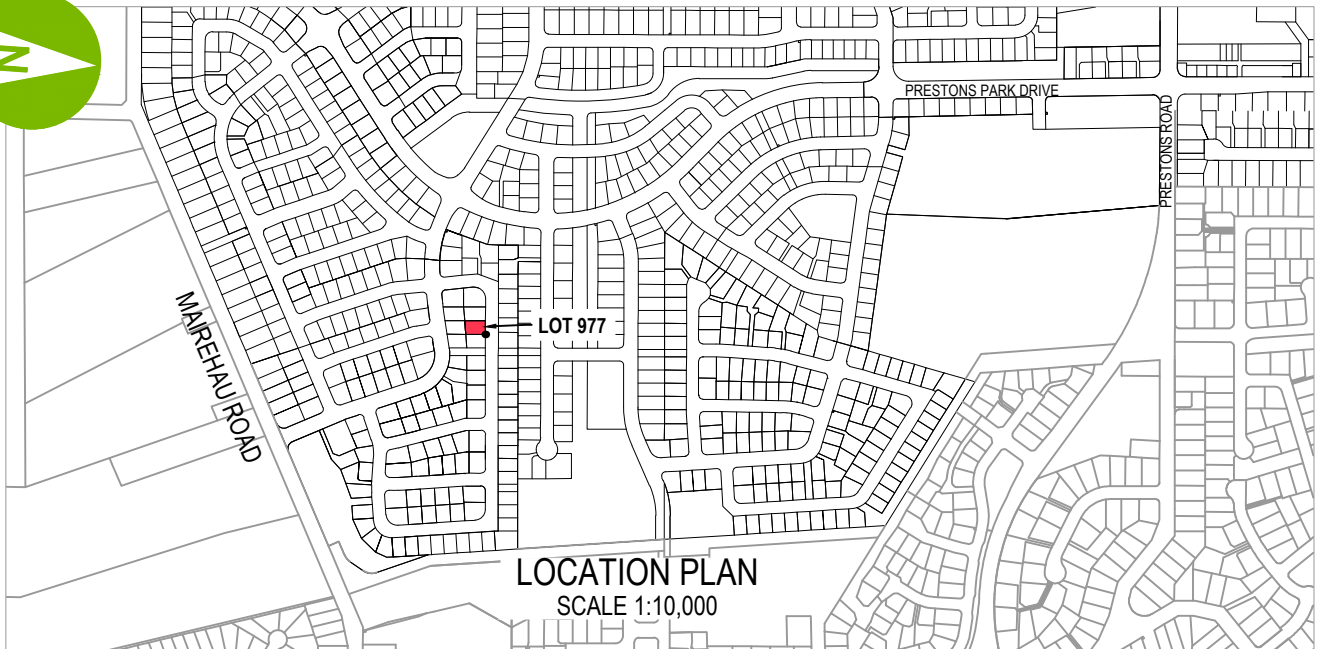
This building consent report is for Lot 977 which is located in Stage 5 of the Prestons Park Subdivision development (refer Figure 1 in Appendix A). The lot is bordered by residential lots to the south, west and east, with an access road to the north.
