Prestons Park Subdivision
GEOTECHNICAL REPORT FOR LOT 979
CDL Land NZ Limited

5 October 2022
Revision: 1
Reference: 235361

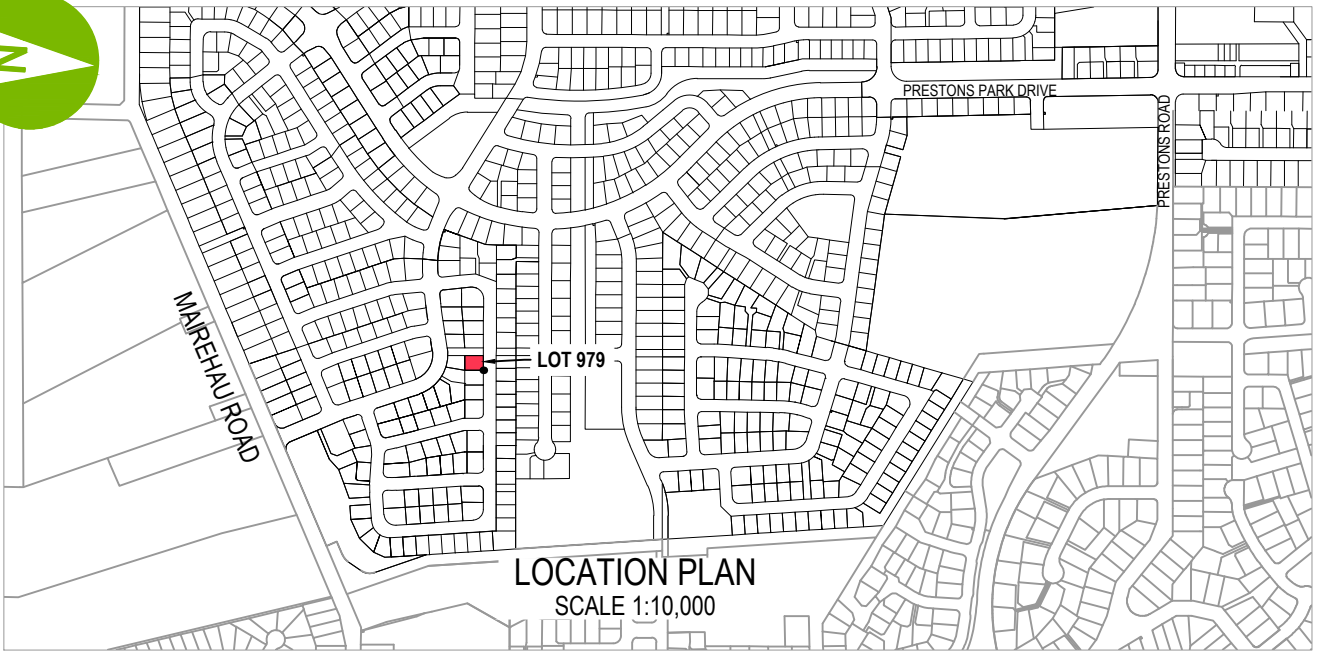
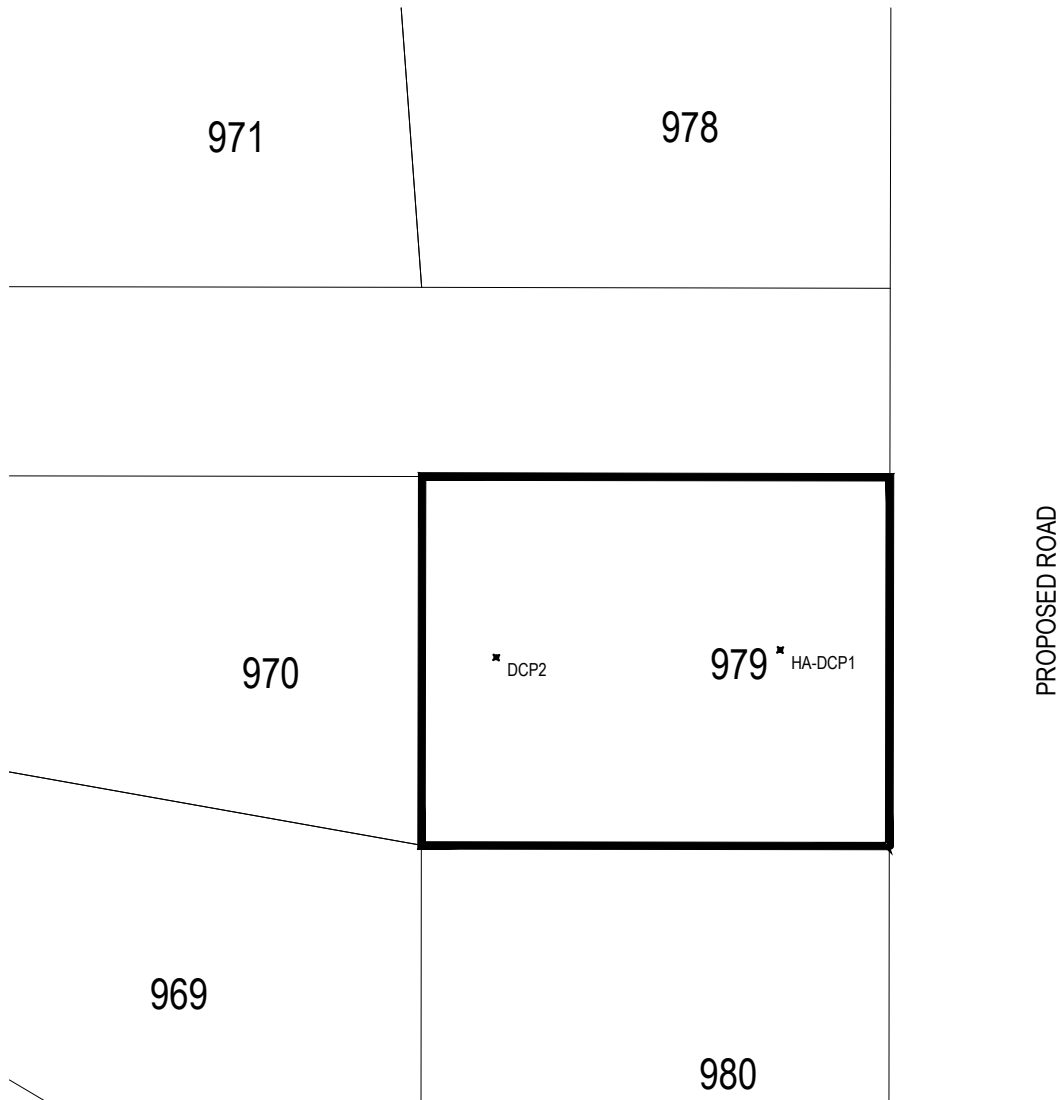
This building consent report is for Lot 979 which is located in Stage 5 of the Prestons Park Subdivision development (refer Figure 1 in Appendix A). The lot is bordered by residential lots to the south and east, an access road to the north and a reserve to the west.
