Prestons Park Subdivision
GEOTECHNICAL REPORT FOR LOT 980
CDL Land NZ Limited

9 November 2022
Revision: 1
Reference: 235361

| Document control | | | | | | aurecon |
|---|---|--|---|---|---|---|
| Report title | | GEOTECHNICAL REPORT FOR LOT 980 | | | | |

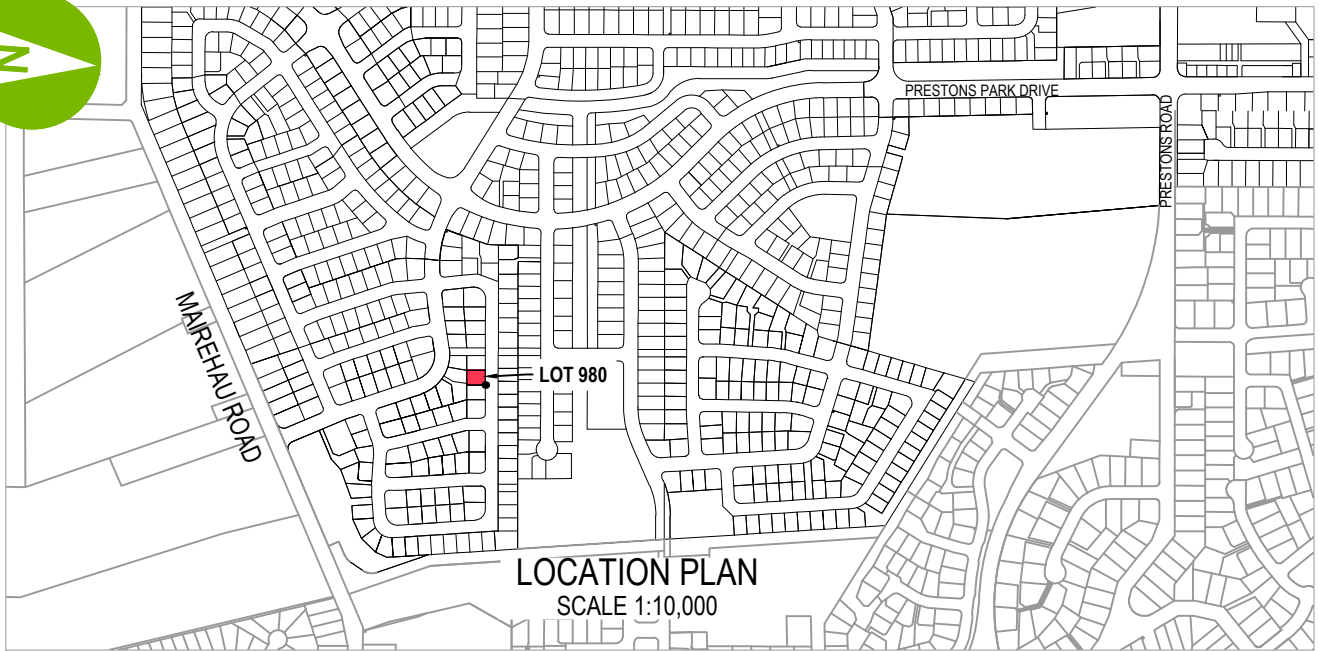
| CLIENT PRESTONS PARK | | | | | CHECKED | | TITLE LOT 980 SITE LOCATION PLAN FIGURE 1 | SCALE | SIZE |

This building consent report is for Lot 980 which is located in Stage 5 of the Prestons Park Subdivision development (refer Figure 1 in Appendix A). The lot is bordered by residential lots to the south, west and east, with an access road to the north.

One hand auger borehole was undertaken on the lot as part of the geotechnical investigation to assess the upper soil profile and the groundwater level. The test location and the borehole log have been uploaded to the New Zealand Geotechnical Database (NZGD). The borehole log is attached in Appendix B.

Two DCPs were carried out with the locations and results uploaded to the NZGD. The DCP test results are attached in Appendix B. One of the DCPs was located adjacent to the hand auger borehole, with the second DCP located on the opposite half of the lot.
