Prestons Park Subdivision
GEOTECHNICAL REPORT FOR LOT 993
CDL Land NZ Limited

9 November 2022
Revision: 1
Reference: 235361

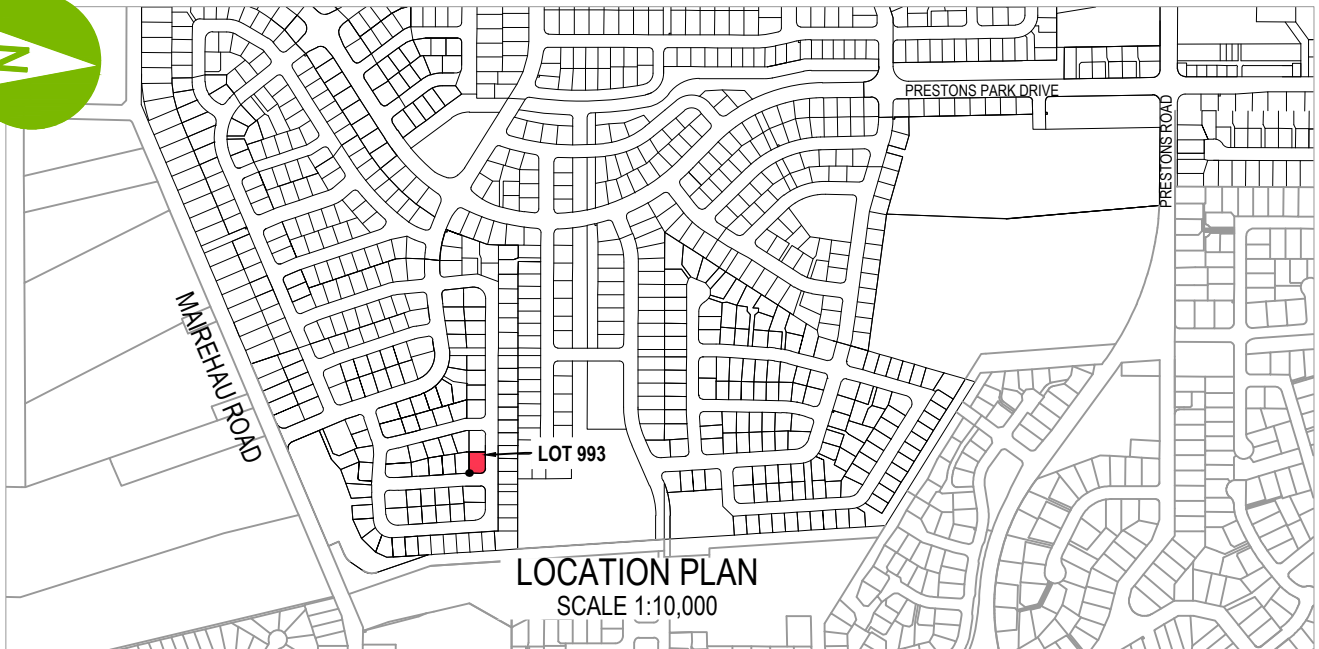
PROJECT
PRESTONS PARK
TITLE
LOT 993 SITE LOCATION PLAN FIGURE 1

This building consent report is for Lot 993 which is located in Stage 5-E3 of the Prestons Park Subdivision development (refer Figure 1 in Appendix A). The lot is bordered by residential lots to the west and south, with access roads to the north and east.

Two DCPs were carried out with the locations and results uploaded to the NZGD. The DCP test results are attached in Appendix B. One of the DCPs was located adjacent to the hand auger borehole, with the second DCP located on the opposite half of the lot.
