Prestons Park Subdivision
GEOTECHNICAL REPORT FOR LOT 1004
CDL Land NZ Limited

9 November 2022
Revision: 1
Reference: 235361

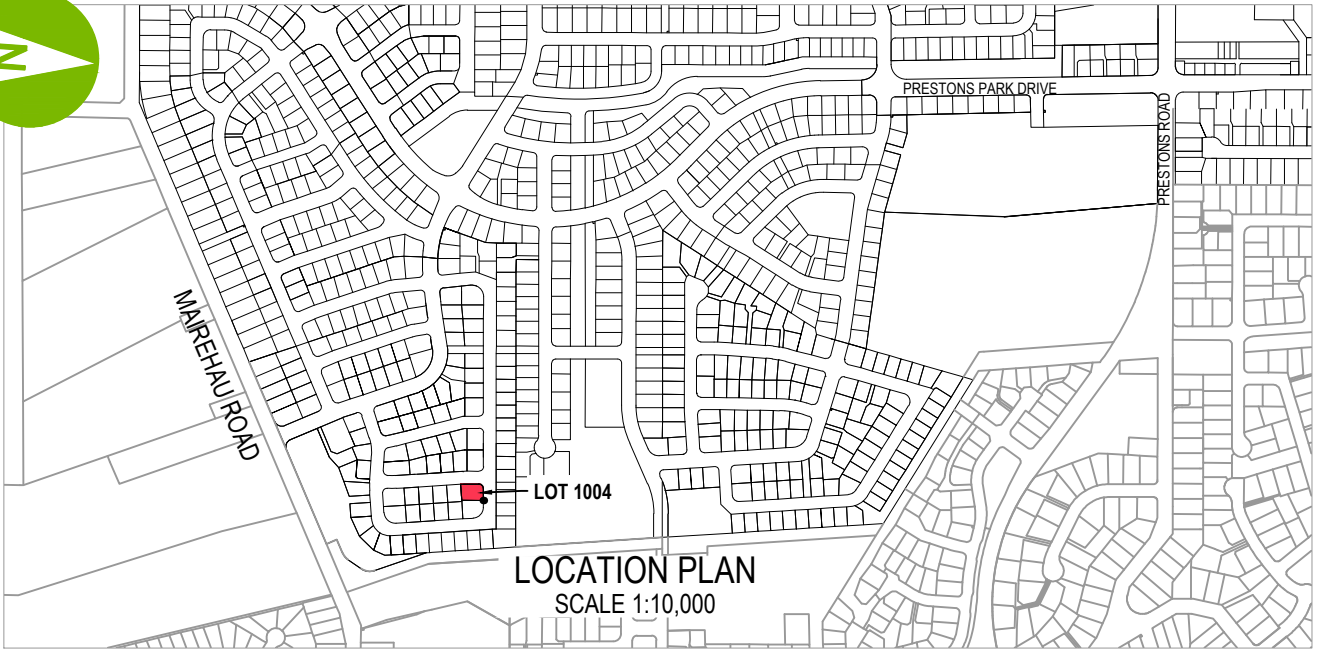
This building consent report is for Lot 1004 which is located in Stage 5-E3 of the Prestons Park Subdivision development (refer Figure 1 in Appendix A). The lot is bordered by residential lots to the east and south, with access roads to the west and north.

Two DCPs were carried out with the locations and results uploaded to the NZGD. The DCP test results are attached in Appendix B. One of the DCPs was located adjacent to the hand auger borehole, with the second DCP located on the opposite half of the lot.
