Prestons Park Subdivision
GEOTECHNICAL REPORT FOR LOT 1039
CDL Land NZ Limited

21 November 2022
Revision: 1
Reference: 235361

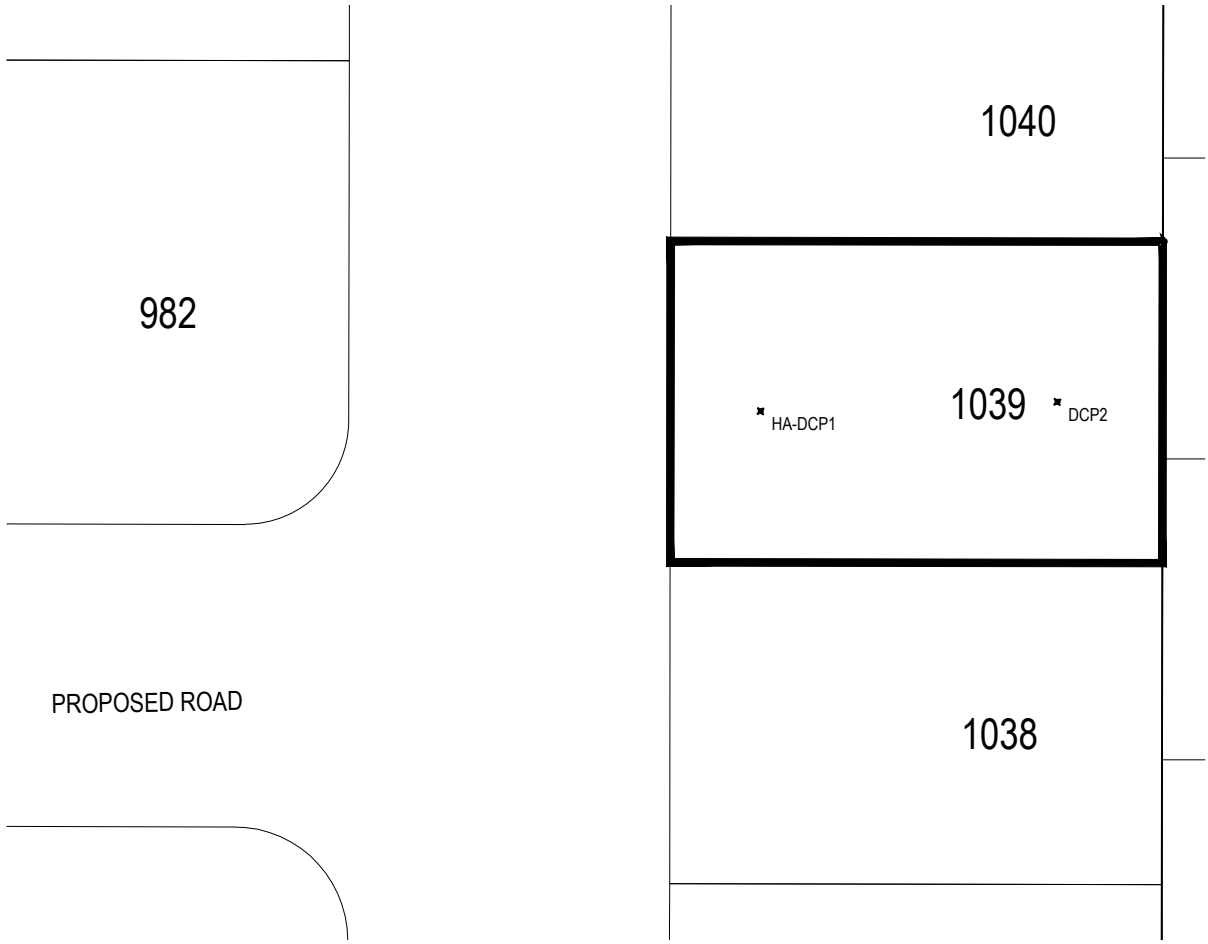
LOT 1039
SITE LOCATION PLAN
FIGURE 1

This building consent report is for Lot 1039 which is located in Stage 5 of the Prestons Park Subdivision development (refer Figure 1 in Appendix A). The lot is bordered by residential lots to the north, east and west, with an access road to the south.

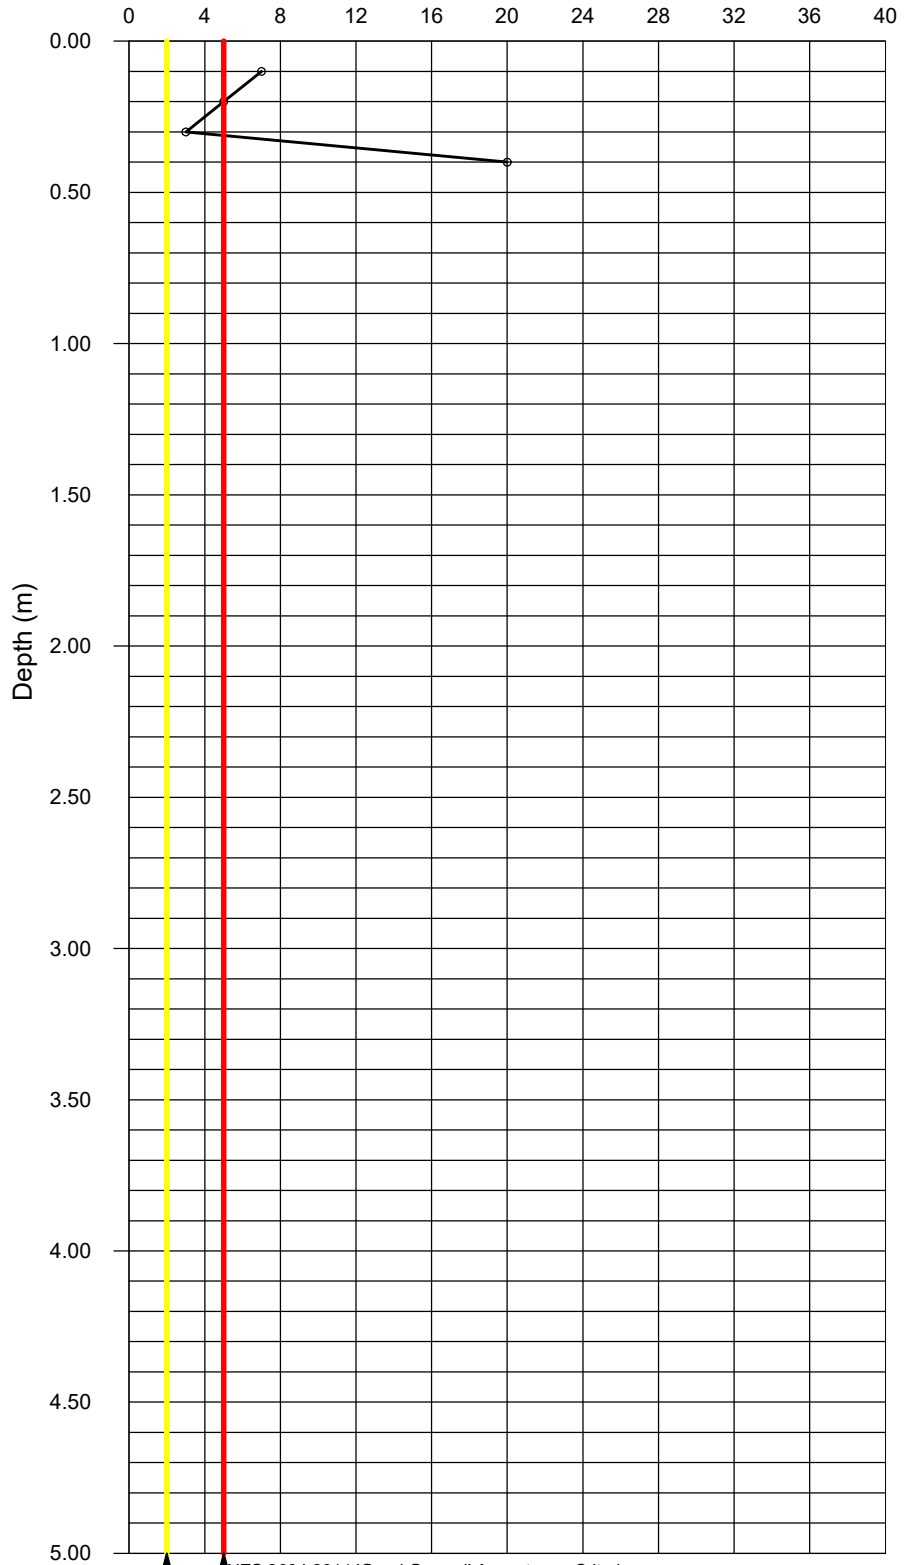
DCP logs indicate 5 blows per 100mm penetration, which is equivalent to an ultimate bearing capacity of 300kPa, was consistently encountered from a depth of 0.4m.

Depth (m)	Blows per 100 mm	Depth (m)	Blows per 100 mm
0.0	7	3.5	
0.1	5		
0.2	3		
0.3	20		
0.4		4.0	
0.5			
1.0		4.5	
1.5		5.0	
2.0			
2.5			
3.0			
3.5

20 blows for 100mm in the last increment.
Co-ordinates and elevation data from site survey.
Elevation based on Christchurch Drainage Datum.
Effective refusal, 20+ blows per 100mm

Based on our understanding of the site works and the investigation results, we recommend that NZS3604:2011 compliant foundations are embedded a minimum depth of 0.4m below current ground level.

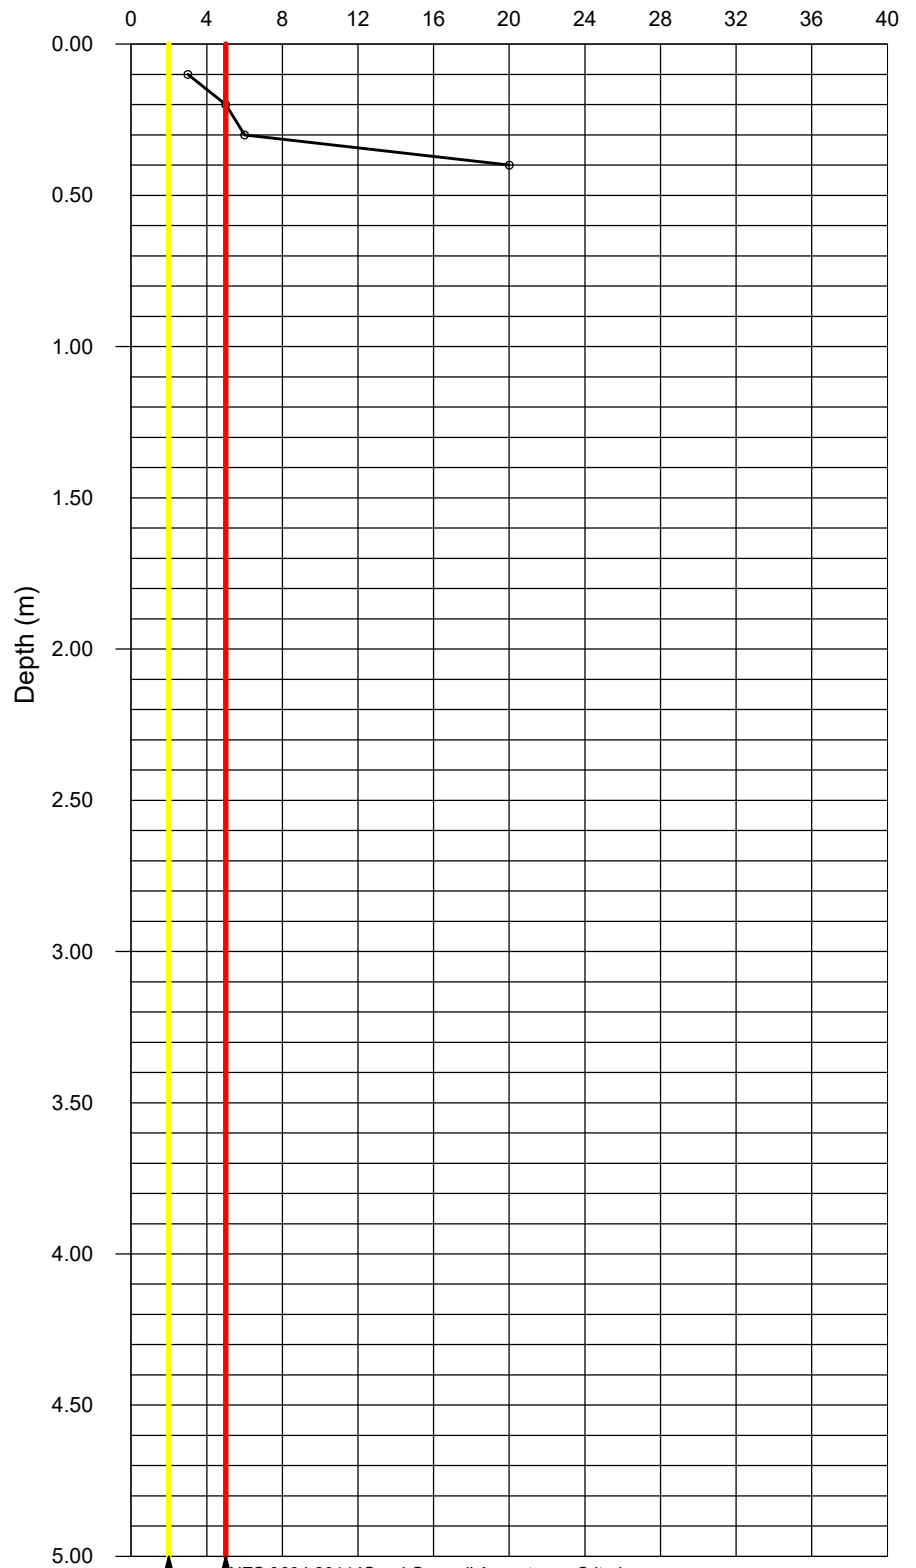
Depth (m)	Blows per 100 mm	Depth (m)	Blows per 100 mm
0.0	3	3.5	
0.1	5		
0.2	6		
0.3	20		
0.4		4.0	
0.5			
1.0		4.5	
1.5		5.0	
2.0			
2.5			
3.0			
3.5

20 blows for 100mm in the last increment.
Co-ordinates and elevation data from site survey.
Elevation based on Christchurch Drainage Datum.
Effective refusal, 20+ blows per 100mm
