Prestons Park Subdivision
GEOTECHNICAL REPORT FOR LOT 961
CDL Land NZ Limited

28 June 2023
Revision: 1
Reference: 235361

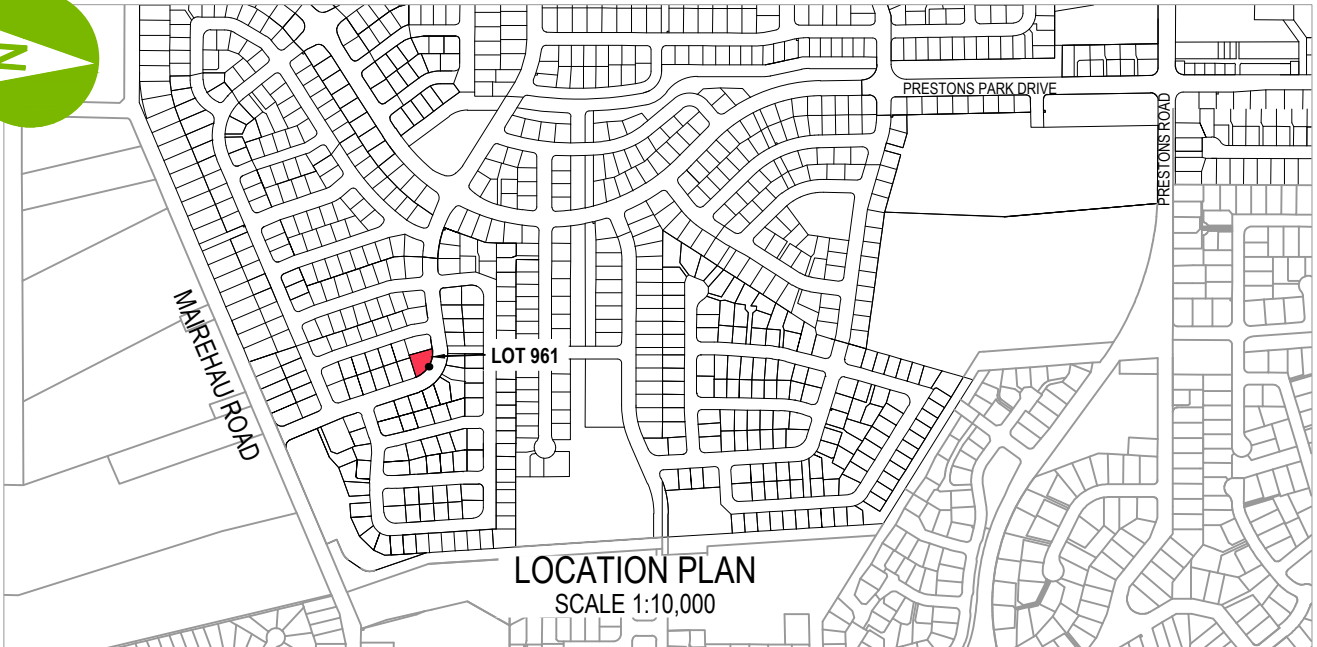
This building consent report is for Lot 961 which is located in Stage 5 of the Prestons Park Subdivision development (refer Figure 1 in Appendix A). The lot is bordered by residential lots to the west and south, with road access to the north and east.
