Prestons Park Subdivision
GEOTECHNICAL REPORT FOR LOT 938
CDL Land NZ Limited

26 June 2023
Revision: 1
Reference: 235361

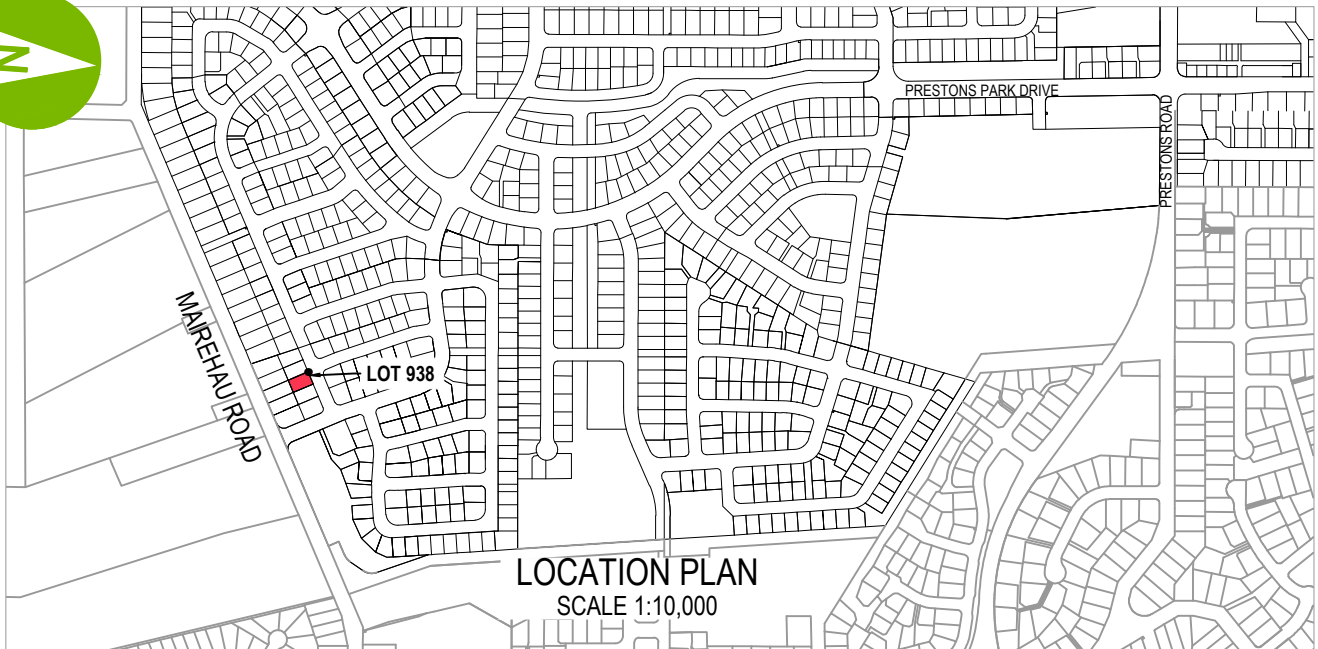
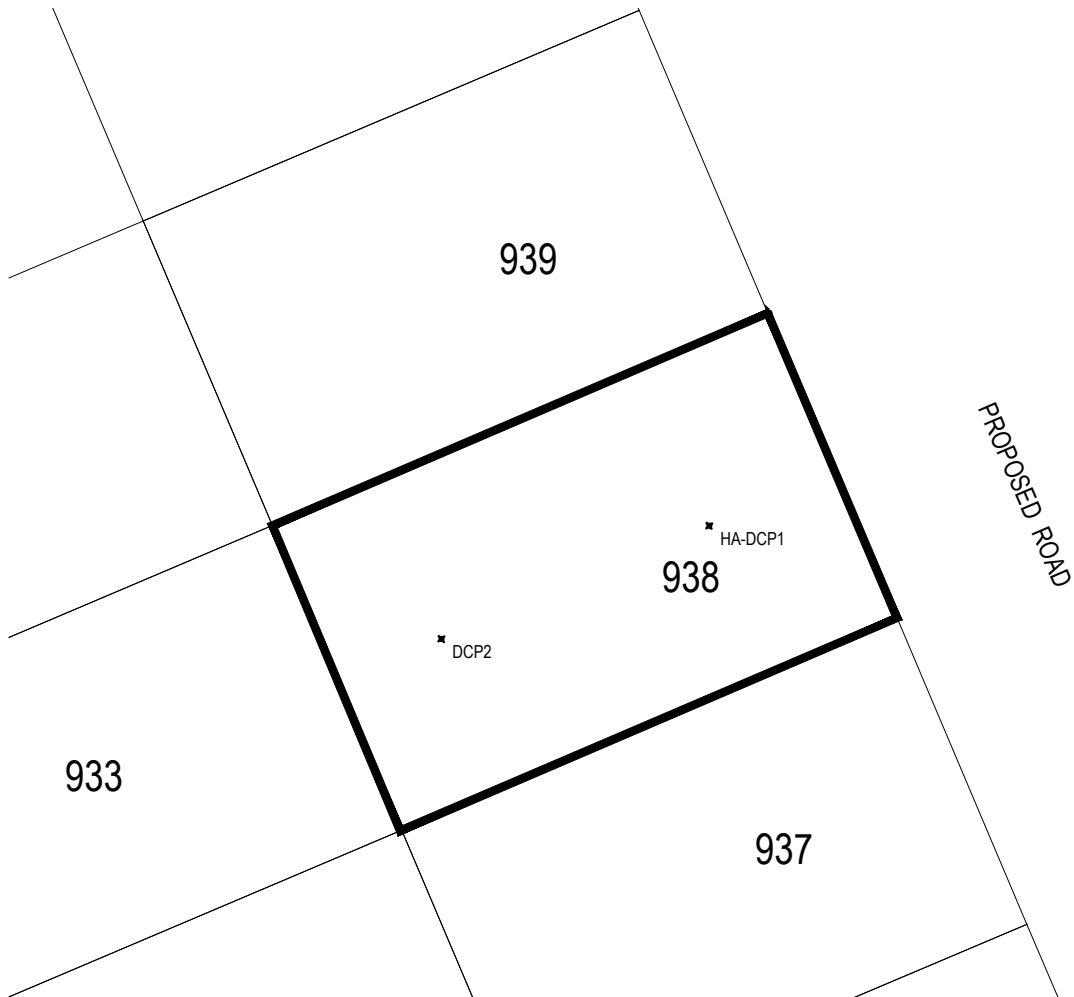
This building consent report is for Lot 938 which is located in Stage 5 of the Prestons Park Subdivision development (refer Figure 1 in Appendix A). The lot is boarded by residential lots east, west and south, with an access road to the north.

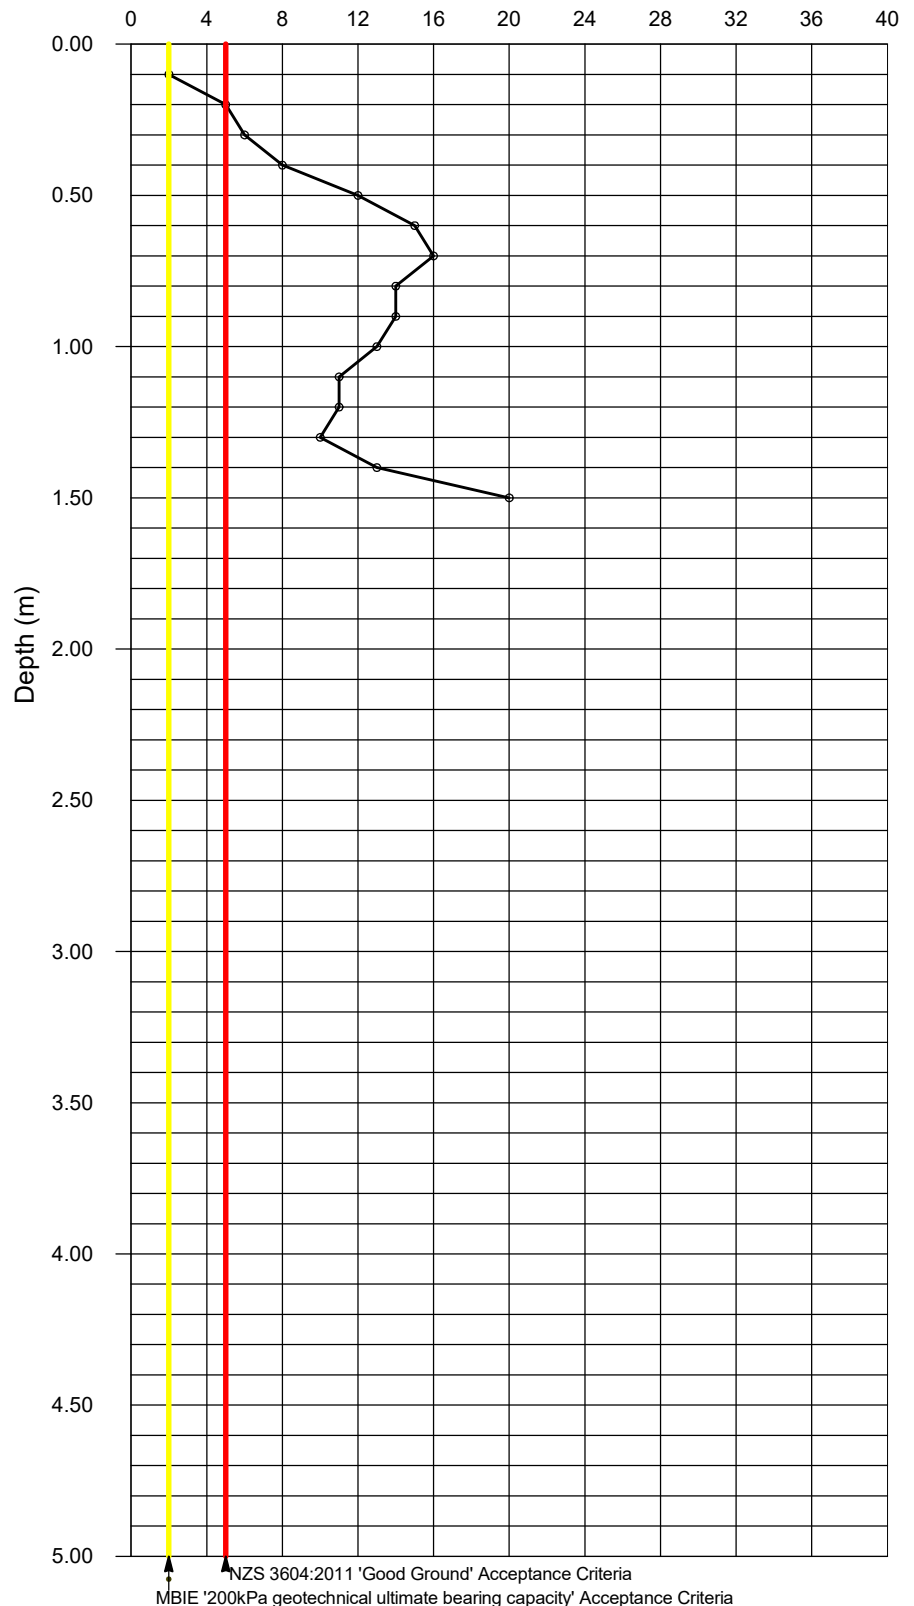
Depth (m)	Blows per 100 mm	Depth (m)	Blows per 100 mm
0.0	2	3.5	
	5		
	6		
	8		
0.5	12	4.0	
	15		
	16		
	14		
	14		
1.0	13	4.5	
	11		
	11		
	10		
	13		
1.5	20	5.0	
2.0			
2.5			
3.0			
3.5

20 blows for 100mm in the last increment.

Effective refusal, 20+ blows per 100mm

Number of blows per 100mm

Two DCPs were carried out with the locations and results uploaded to the NZGD. The DCP test results are attached in Appendix B. One of the DCPs was located adjacent to the hand auger borehole, with the second DCP located on the opposite half of the lot.

DCP logs indicate two blows per 100mm penetration, which is equivalent to an ultimate bearing capacity of 200kPa, was consistently encountered from a shallow depth.

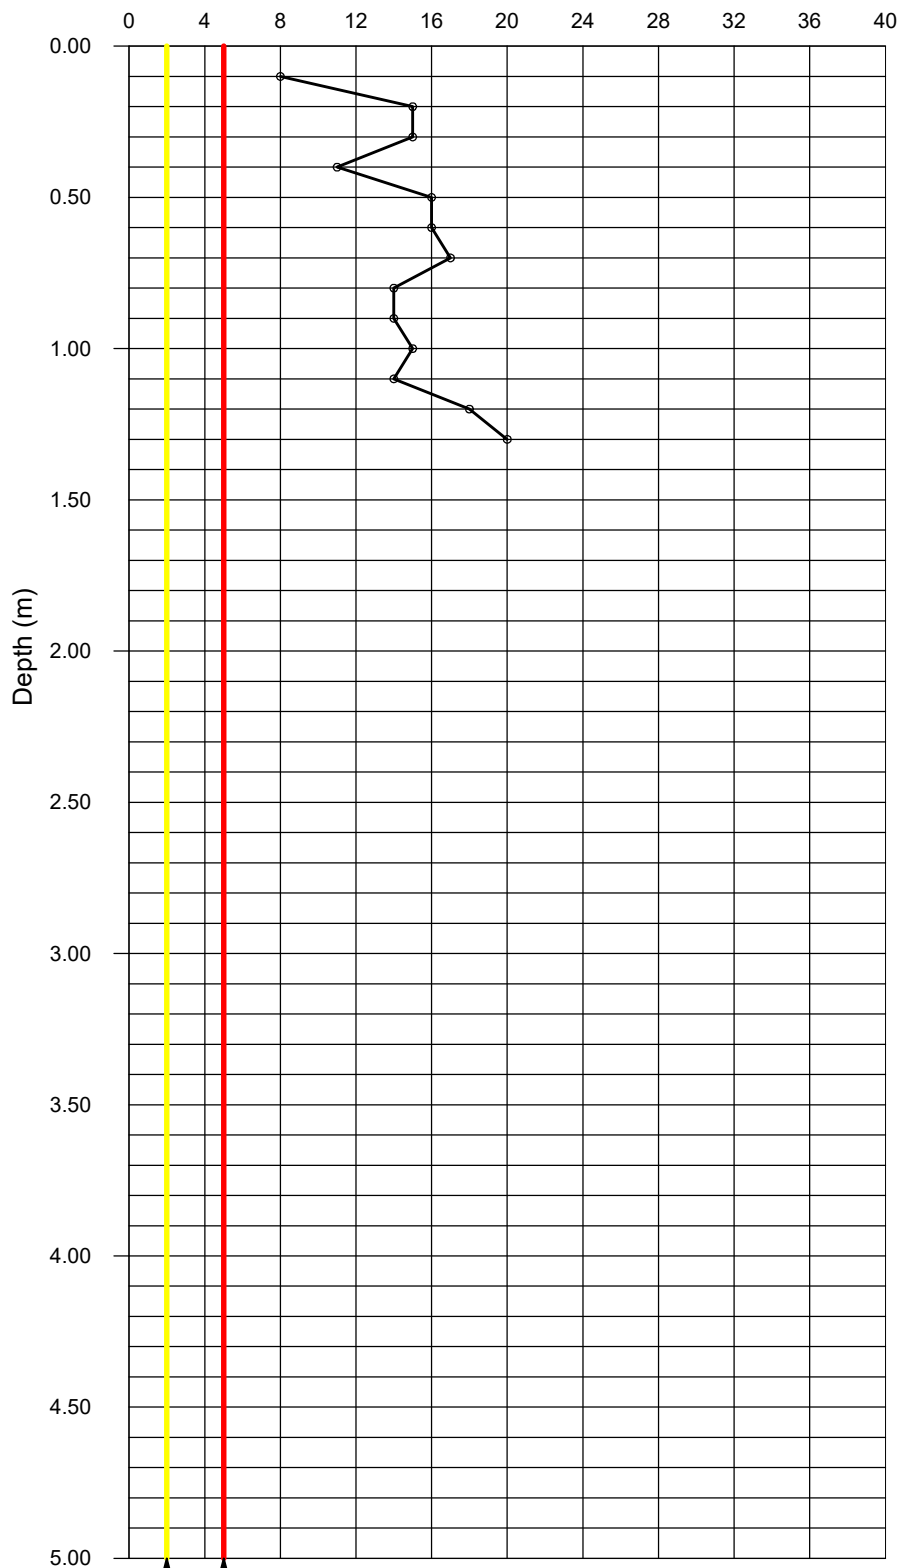
Depth (m)	Blows per 100 mm	Depth (m)	Blows per 100 mm
0.0	8	3.5	
	15		
	15		
	11		
0.5	16	4.0	
	16		
	17		
	14		
	14		
1.0	15	4.5	
	14		
	18		
	20		
1.5		5.0	
2.0			
2.5			
3.0			
3.5

Number of blows per 100mm

20 blows for 100mm in the last increment.
Co-ordinates and elevation data from site survey.
Elevation based on Christchurch Drainage Datum.
Effective refusal, 20+ blows per 100mm

NZS 3604:2011 'Good Ground' Acceptance Criteria
MBIE '200kPa geotechnical ultimate bearing capacity' Acceptance Criteria
