Prestons Park Subdivision
GEOTECHNICAL REPORT FOR LOT 940
CDL Land NZ Limited

26 June 2023
Revision: 1
Reference: 235361

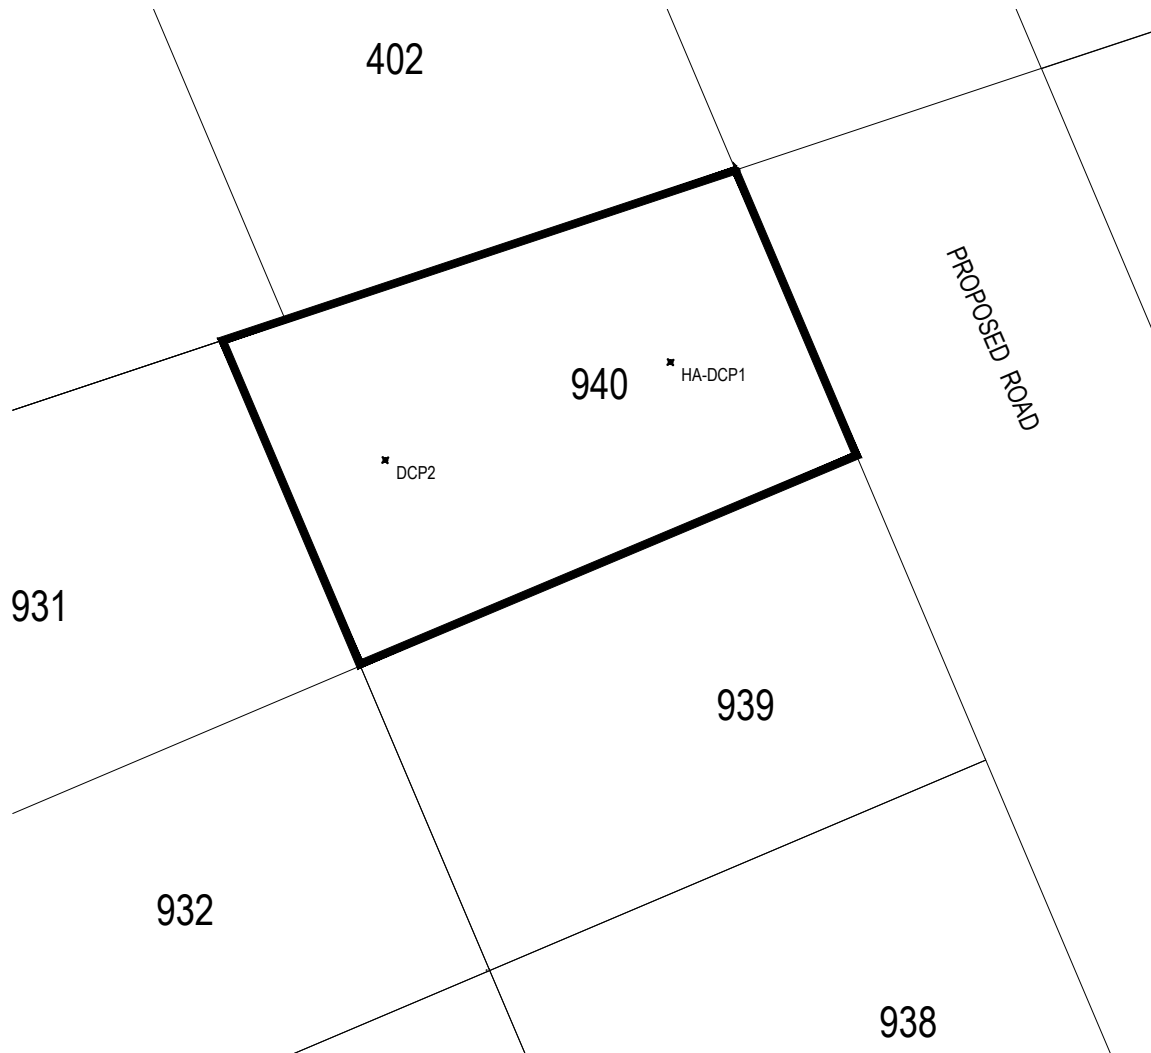
This building consent report is for Lot 940 which is located in Stage 5 of the Prestons Park Subdivision development (refer Figure 1 in Appendix A). The lot is boarded by residential lots to the east, west and south, with an access road to the north.

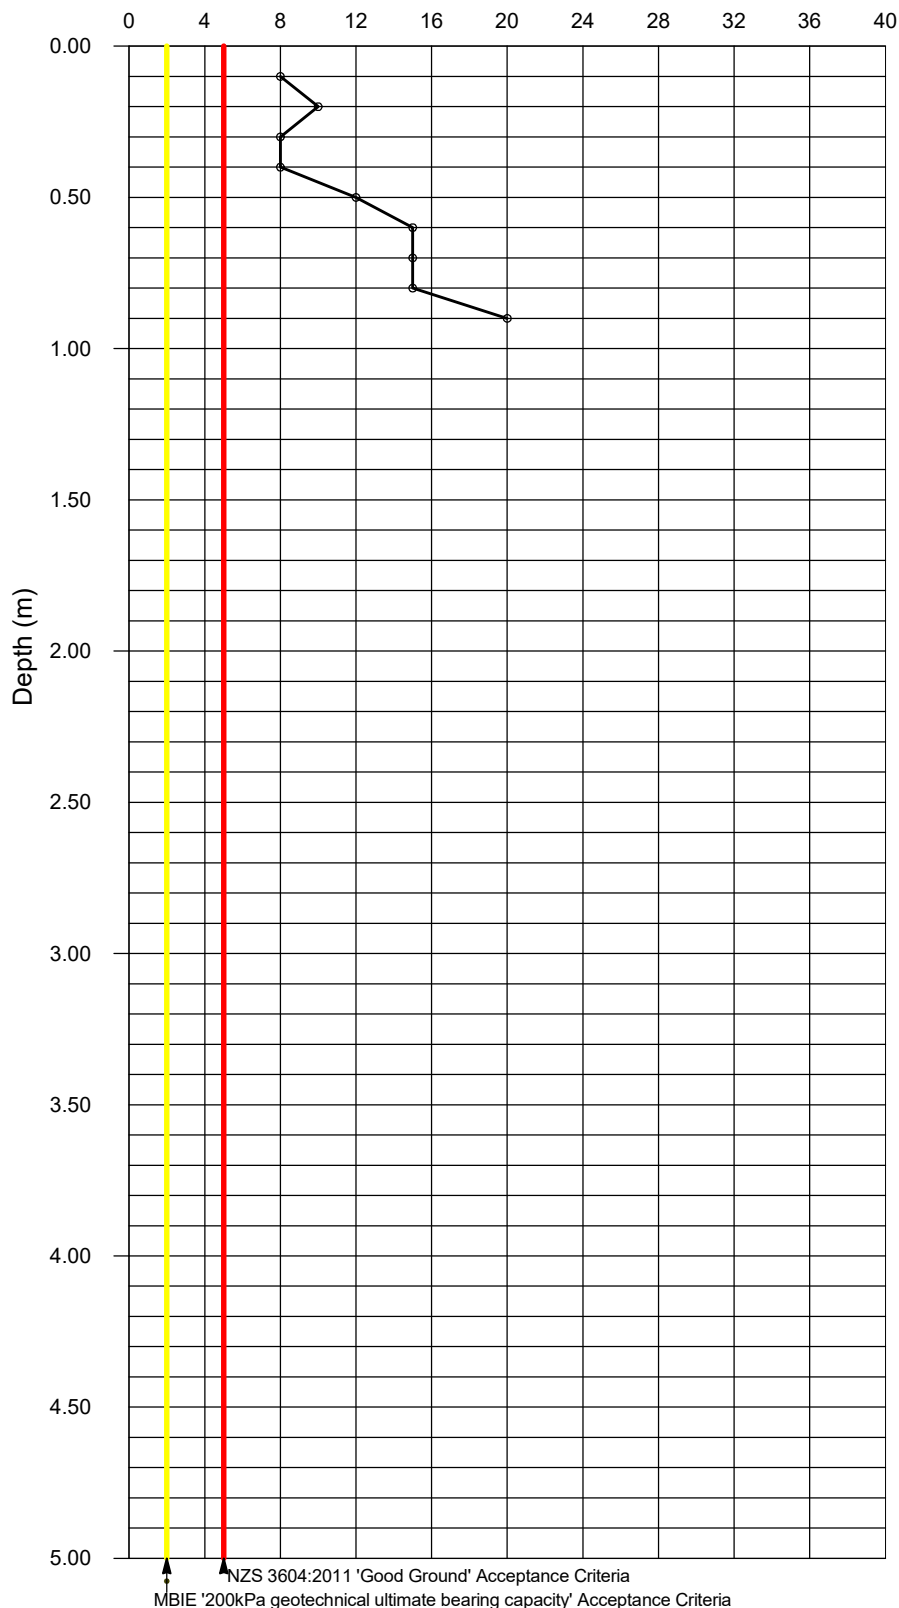
Depth (m)	Blows per 100 mm	Depth (m)	Blows per 100 mm
0.0	8	3.5	
	10		
	8		
	8		
0.5	12	4.0	
	15		
	15		
	15		
1.0	20	4.5	
1.5		5.0	
2.0			
2.5			
3.0			
3.5

20 blows for 100mm in the last increment.

Effective refusal, 20+ blows per 100mm

Two DCPs were carried out with the locations and results uploaded to the NZGD. The DCP test results are attached in Appendix B. One of the DCPs was located adjacent to the hand auger borehole, with the second DCP located on the opposite half of the lot.

DCP logs indicate two blows per 100mm penetration, which is equivalent to an ultimate bearing capacity of 200kPa, was consistently encountered from a shallow depth.

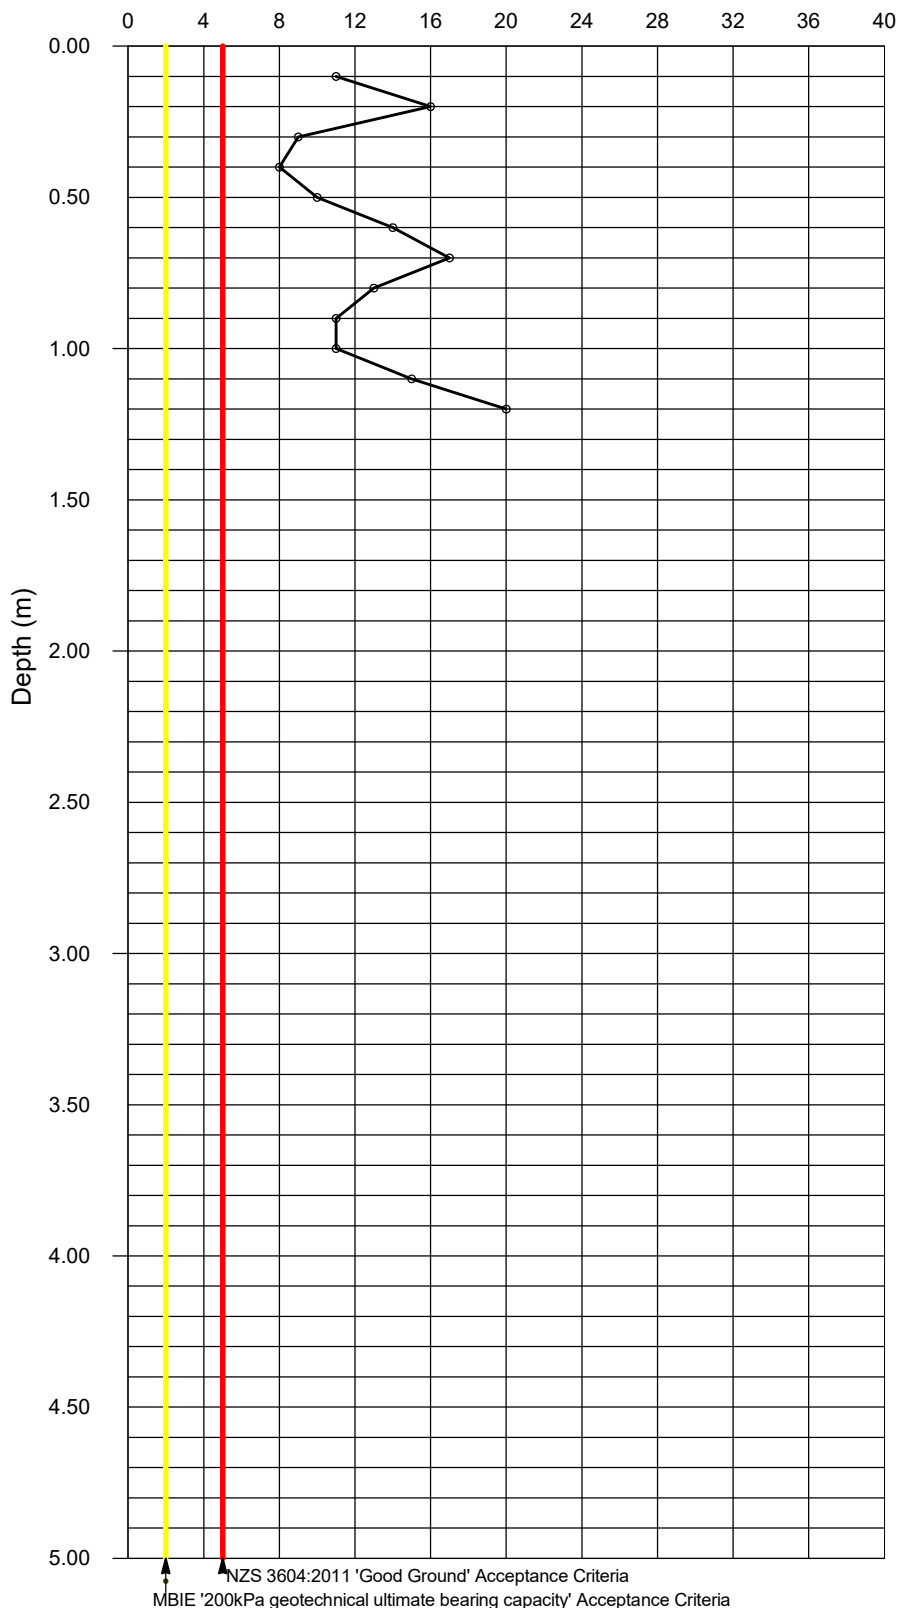
Depth (m)	Blows per 100 mm	Depth (m)	Blows per 100 mm
0.0	11	3.5	
	16		
	9		
	8		
0.5	10	4.0	
	14		
	17		
	13		
1.0	11	4.5	
	15		
	20		
1.5		5.0	
2.0			
2.5			
3.0			
3.5

20 blows for 100mm in the last increment.

Effective refusal, 20+ blows per 100mm
