Prestons Park Subdivision
GEOTECHNICAL REPORT FOR LOT 950
CDL Land NZ Limited

28 June 2023
Revision: 1
Reference: 235361

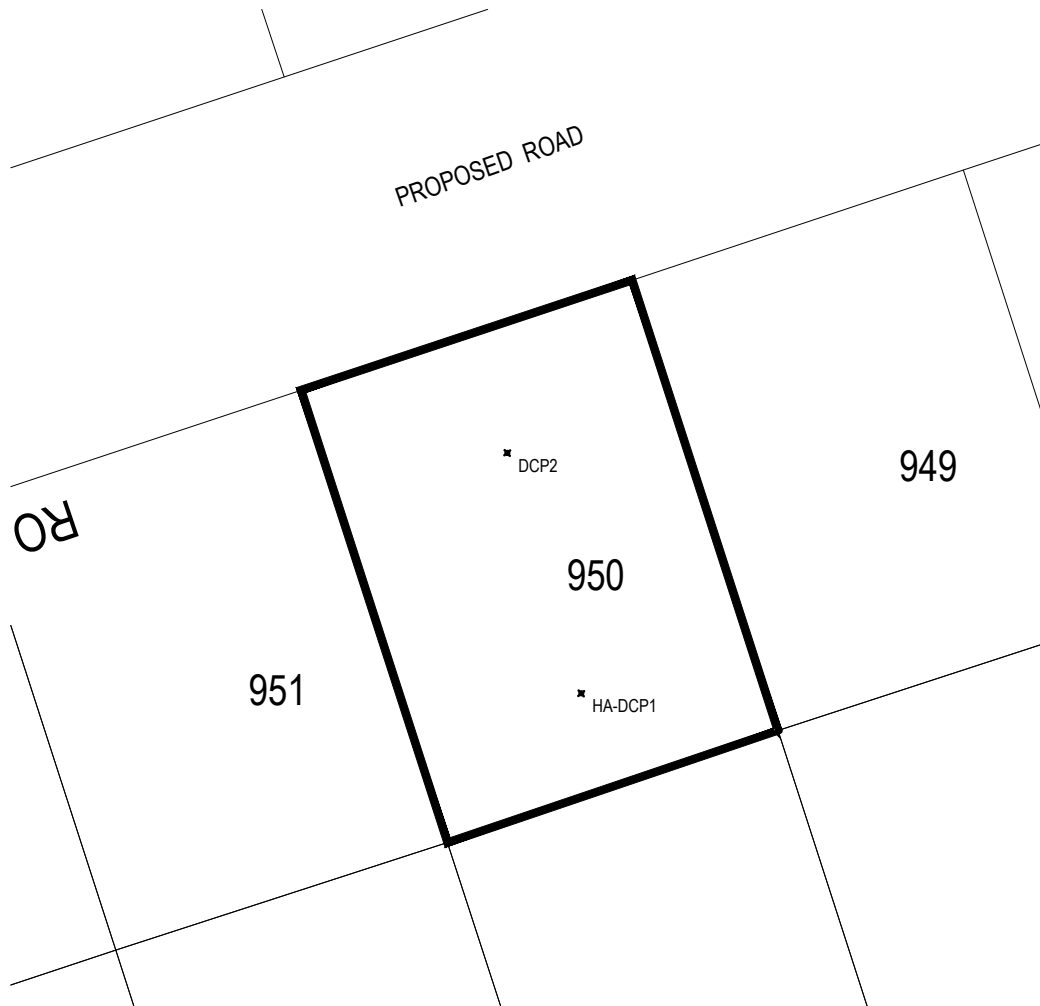
PROJECT
PRESTONS PARK
TITLE
LOT 950 SITE LOCATION PLAN FIGURE 1

This building consent report is for Lot 950 which is located in Stage 5 of the Prestons Park Subdivision development (refer Figure 1 in Appendix A). The lot is bordered by residential lots to the north, south and east, with access roads to the west.
