Prestons Park Subdivision
GEOTECHNICAL REPORT FOR LOT 952
CDL Land NZ Limited

28 June 2023
Revision: 1
Reference: 235361

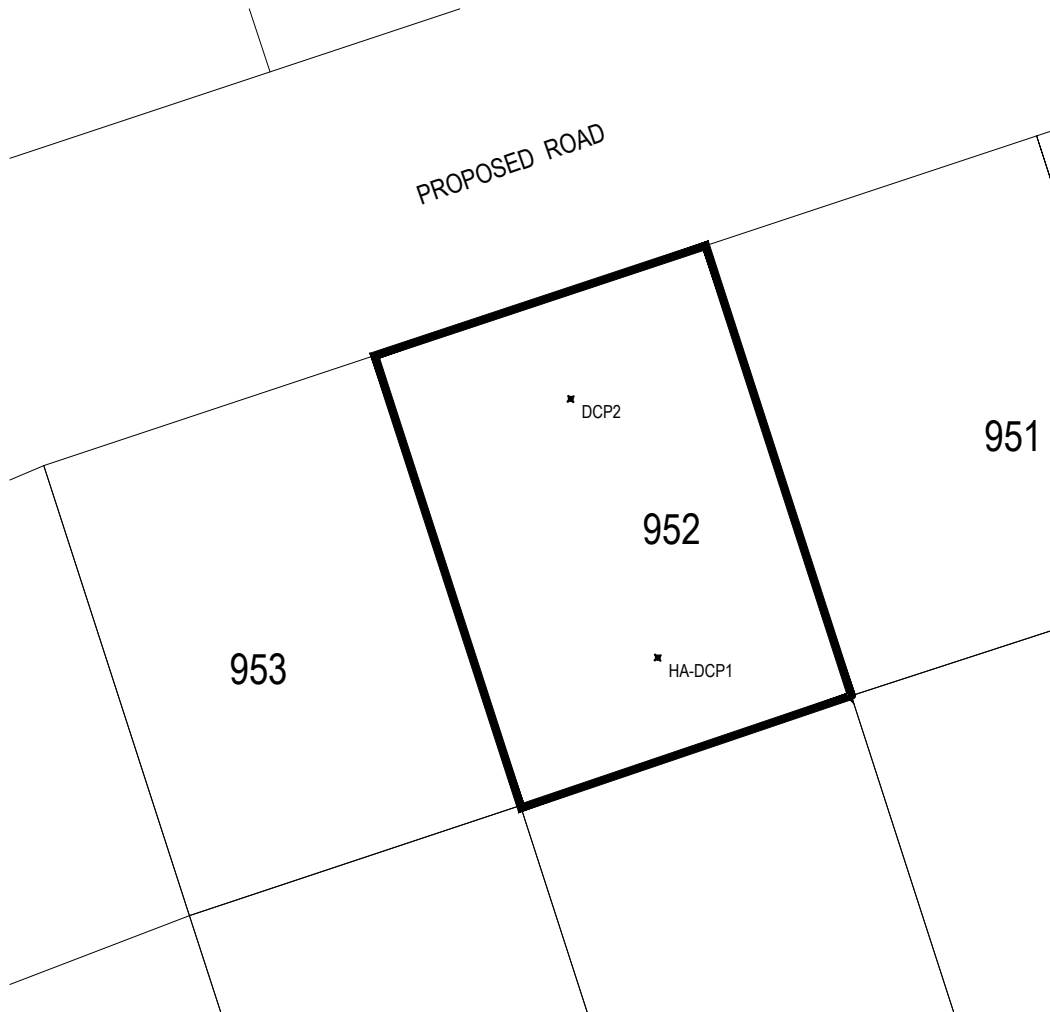
This building consent report is for Lot 952 which is located in Stage 5 of the Prestons Park Subdivision development (refer Figure 1 in Appendix A). The lot is bordered by residential lots to the north, south and east, with access roads to the west.

One hand auger borehole was undertaken on the lot as part of the geotechnical investigation to assess the upper soil profile and the groundwater level. The test location and the borehole log have been uploaded to the New Zealand Geotechnical Database (NZGD). The borehole log is attached in Appendix B.

Two DCPs were carried out with the locations and results uploaded to the NZGD. The DCP test results are attached in Appendix B. One of the DCPs was located adjacent to the hand auger borehole, with the second DCP located on the opposite half of the lot.
