Prestons Park Subdivision
GEOTECHNICAL REPORT FOR LOT 954
CDL Land NZ Limited

30 June 2023
Revision: 1
Reference: 235361

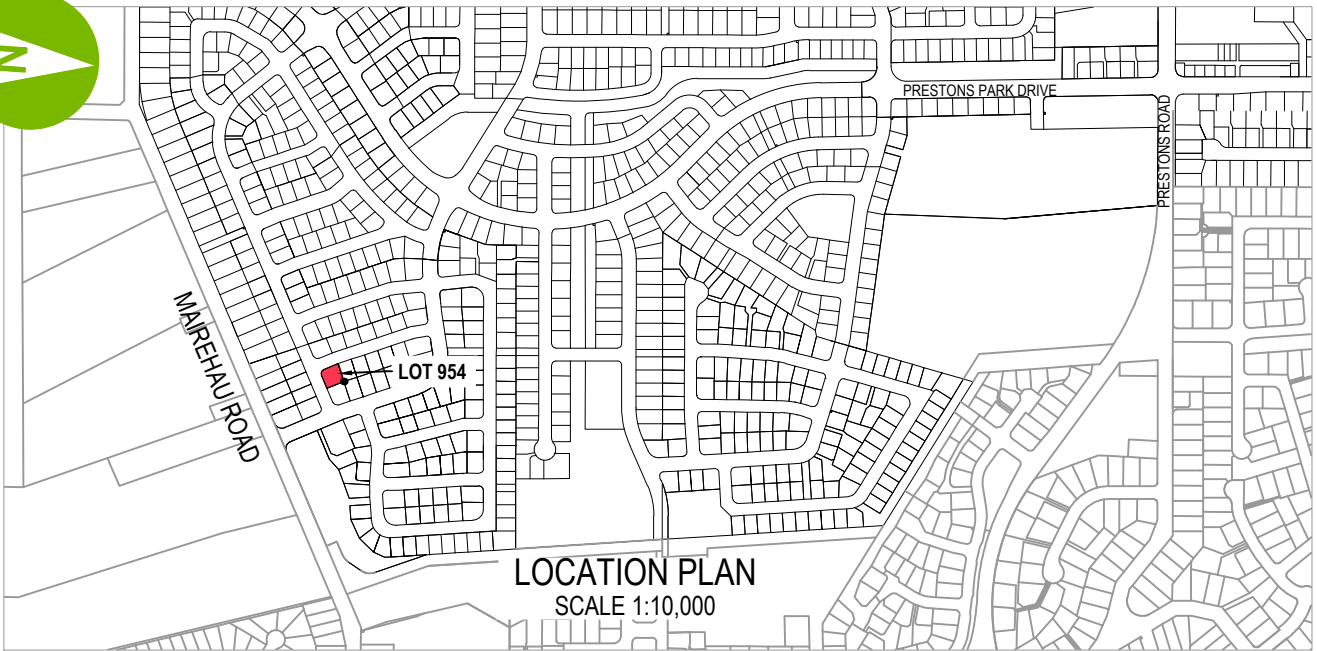
This building consent report is for Lot 954 which is located in Stage 5 of the Prestons Park Subdivision development (refer Figure 1 in Appendix A). The lot is bordered by residential lots to the north and east, with access roads to the west and south.
