Prestons Park Subdivision
GEOTECHNICAL REPORT FOR LOT 959
CDL Land NZ Limited

28 June 2023
Revision: 1
Reference: 235361

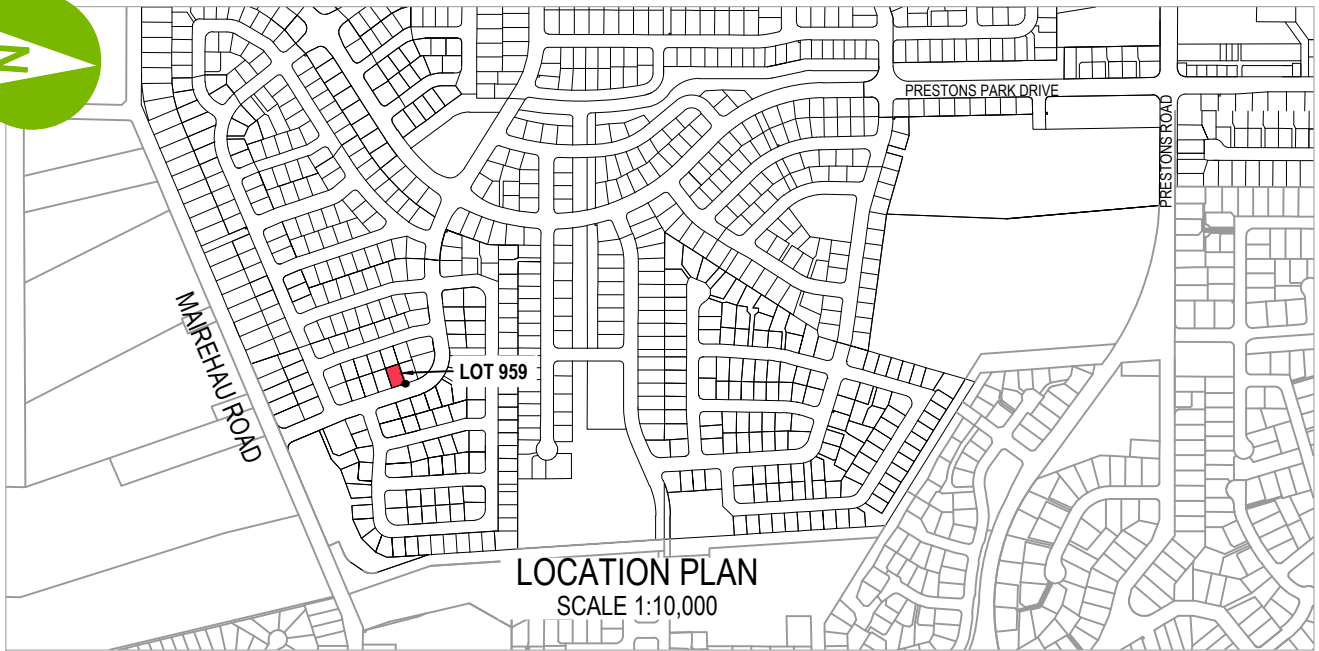
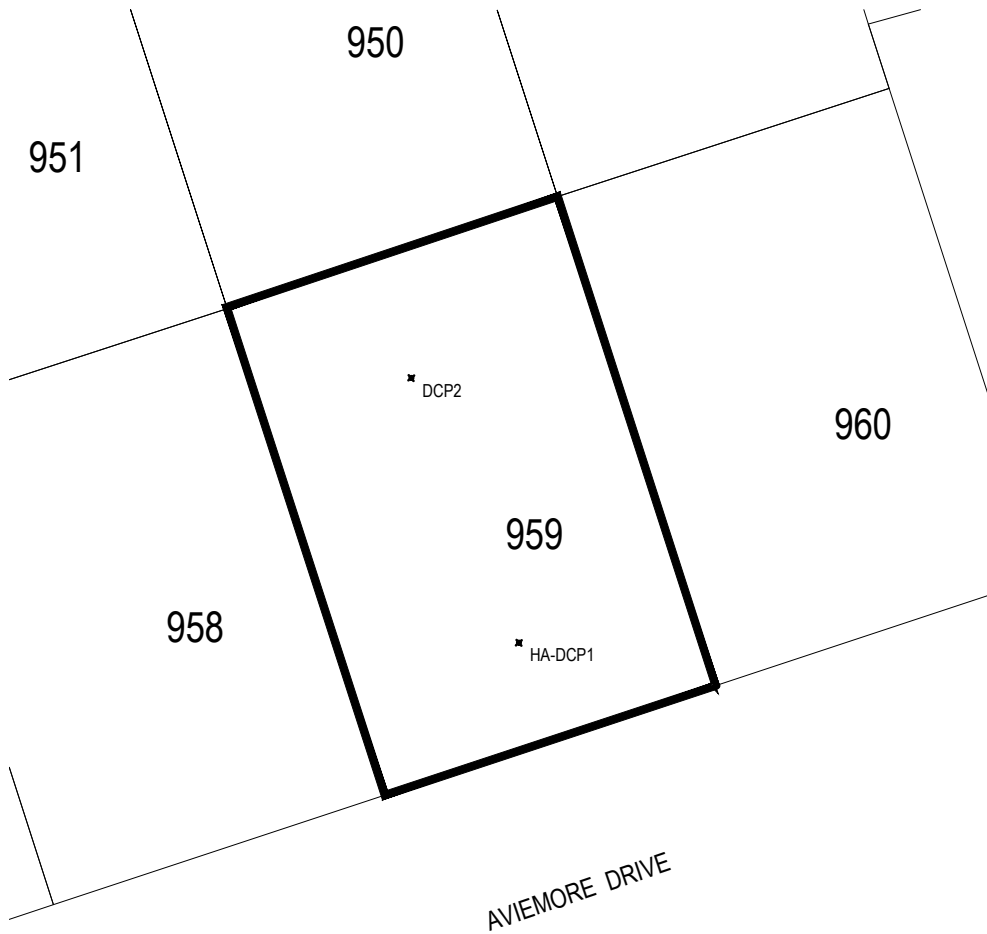
This building consent report is for Lot 959 which is located in Stage 5 of the Prestons Park Subdivision development (refer Figure 1 in Appendix A). The lot is bordered by residential lots to the west, north and south, with road access to the east.
