Prestons Park Subdivision
GEOTECHNICAL REPORT FOR LOT 960
CDL Land NZ Limited

28 June 2023
Revision: 1
Reference: 235361

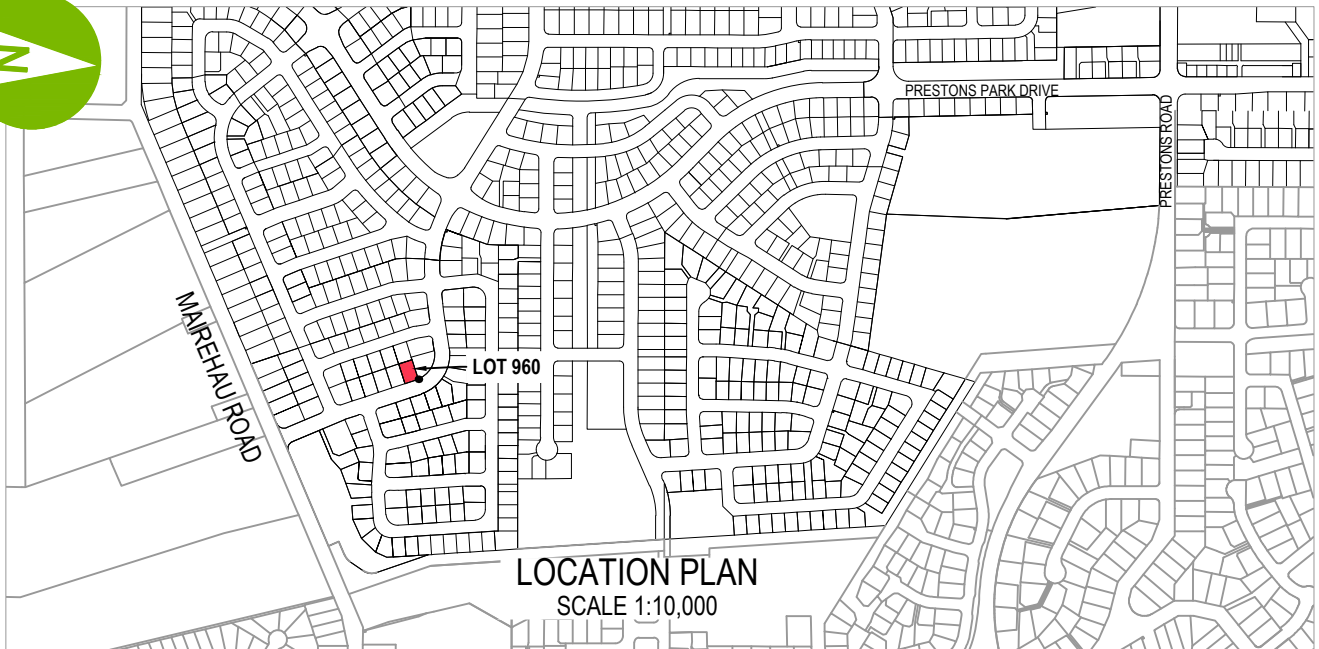
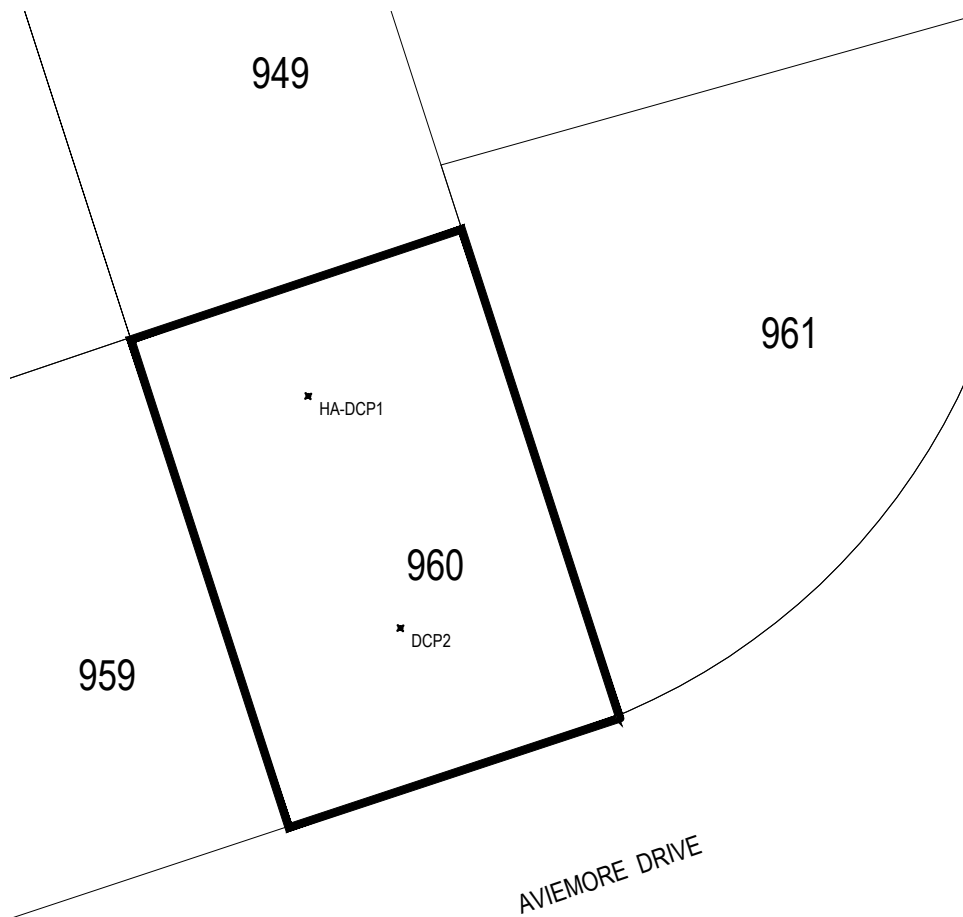
PROJECT	
PRESTONS PARK	
TITLE	
LOT 960	
SITE LOCATION PLAN	
FIGURE 1

This building consent report is for Lot 960 which is located in Stage 5 of the Prestons Park Subdivision development (refer Figure 1 in Appendix A). The lot is bordered by residential lots to the west, north and south, with road access to the east.
