Prestons Park Subdivision
GEOTECHNICAL REPORT FOR LOT 965
CDL Land NZ Limited

28 June 2023
Revision: 1
Reference: 235361

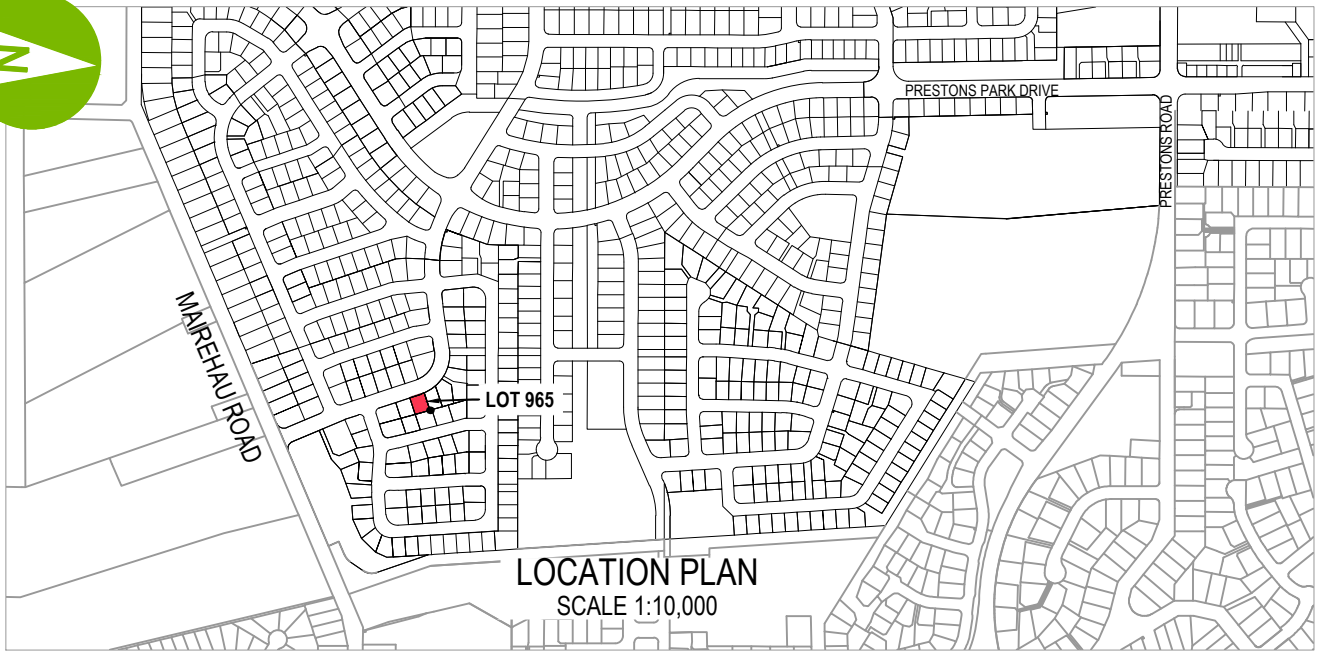
This building consent report is for Lot 965 which is located in Stage 5 of the Prestons Park Subdivision development (refer Figure 1 in Appendix A). The lot is bordered by residential lots to the north, south and east, with road access to the west.
