**Project:** Stonebrook Subdivision  
**Geotechnical Completion**  
**Report Stage 19**

**Reference:** 224926

**7 April 2015**

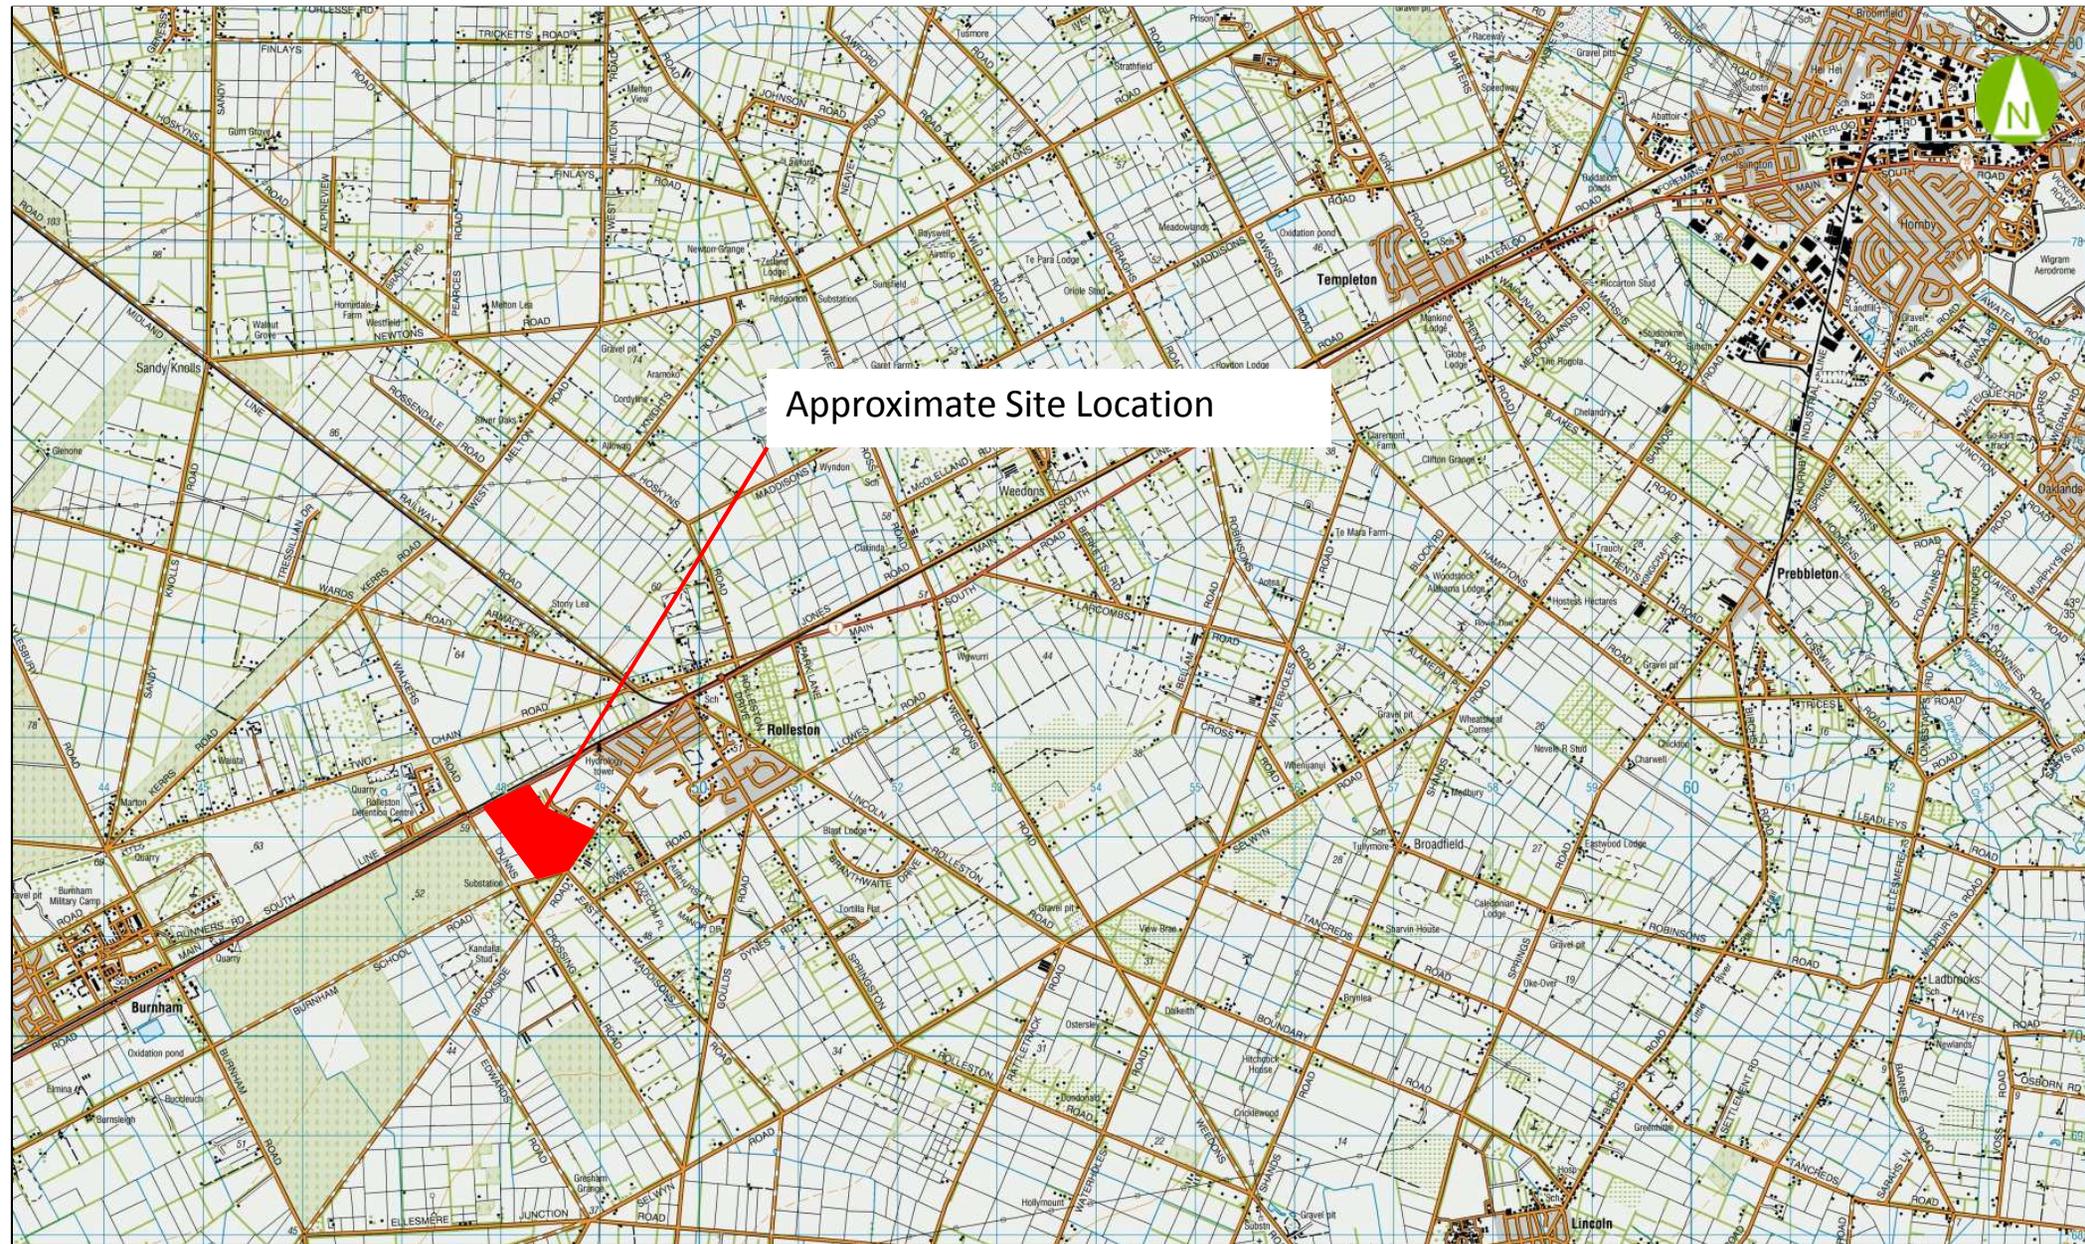
FIGURE 1

Approximate Site Location

REGIONAL SITE LOCATION PLAN

CDL Land New Zealand Limited is developing Stage 19 of the Stonebrook Subdivision, located on Burnham School Road, Rolleston (See Figure 1 in Appendix A). The site works on Stage 19 have included bulk earthworks. As part of the work, a geotechnical completion report is required to certify the site works have been carried out to the required standard and to provide recommendations for building development.

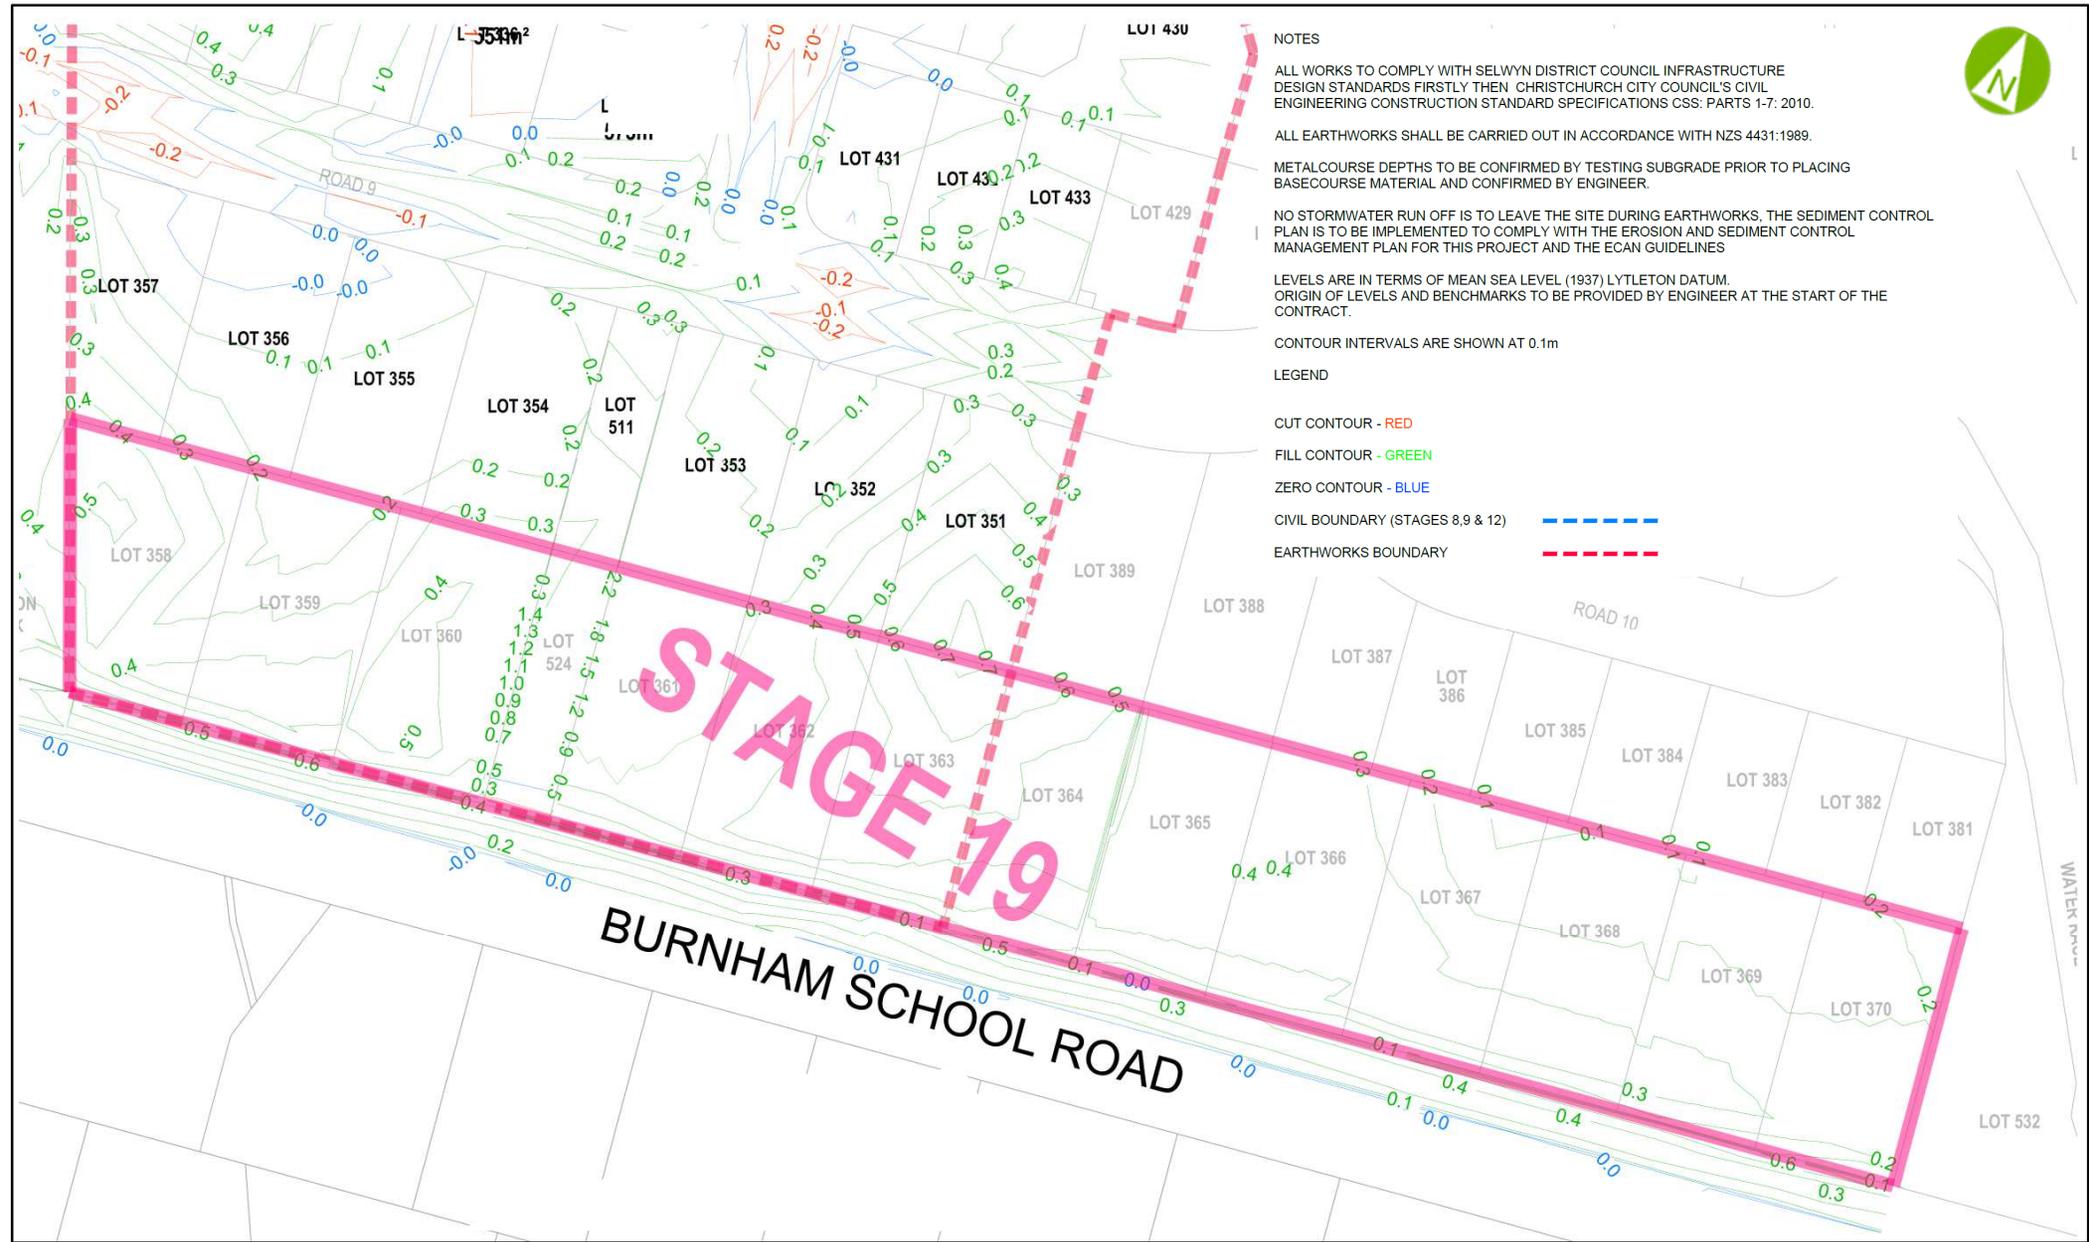
FIGURE 3

**EARTHWORKS STAGE 19 AND CUT/FILL CONTOURS**

We understand that the gravel fill placed across Stage 19 was sourced from a gravel stockpile in Stage 15 north west of Stage 19. The extent of filling is shown on Figure 3 in Appendix A.

The extent of earthfill on Lots within Stage 19 is shown on Figure 3 in Appendix A.

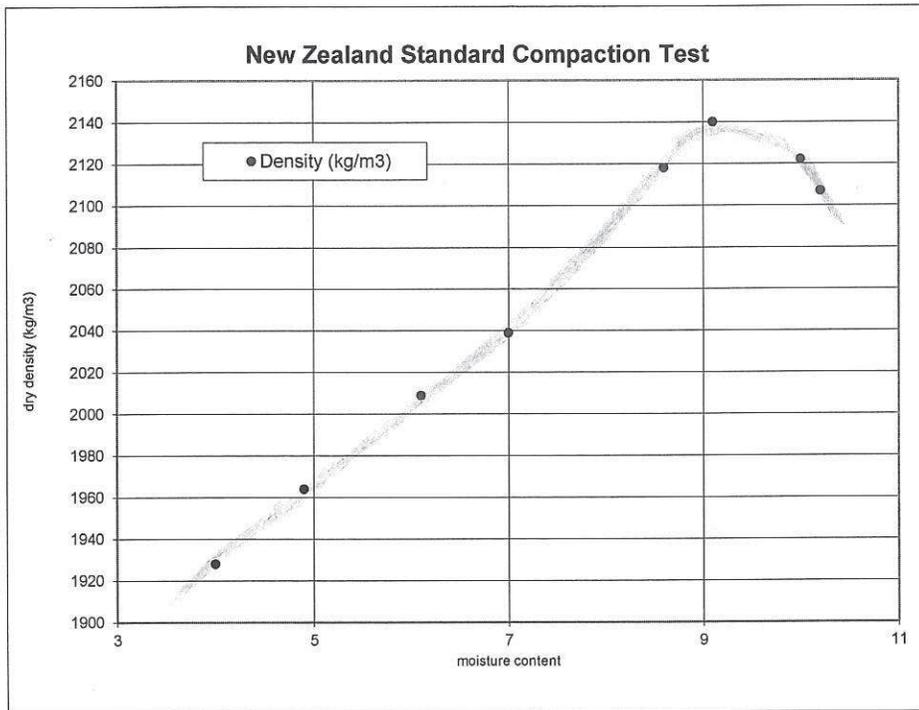
**DETERMINATION OF THE DRY DENSITY / WATER CONTENT RELATIONSHIP**  
**New Zealand Standard Compaction Test**

**e Type:** Sand and aggregate  
**e Source:** Rolleston CDL, Test Site E

City Care carried out forty four nuclear density tests on lots within Stage 19. The fill was generally placed in a single lift with exception to Lots 262 and 263 where fill was placed in three and two lifts, respectively, with NDM testing carried out following each lift. The compaction test results and the compaction curve for Test Site E is presented in Appendix B.

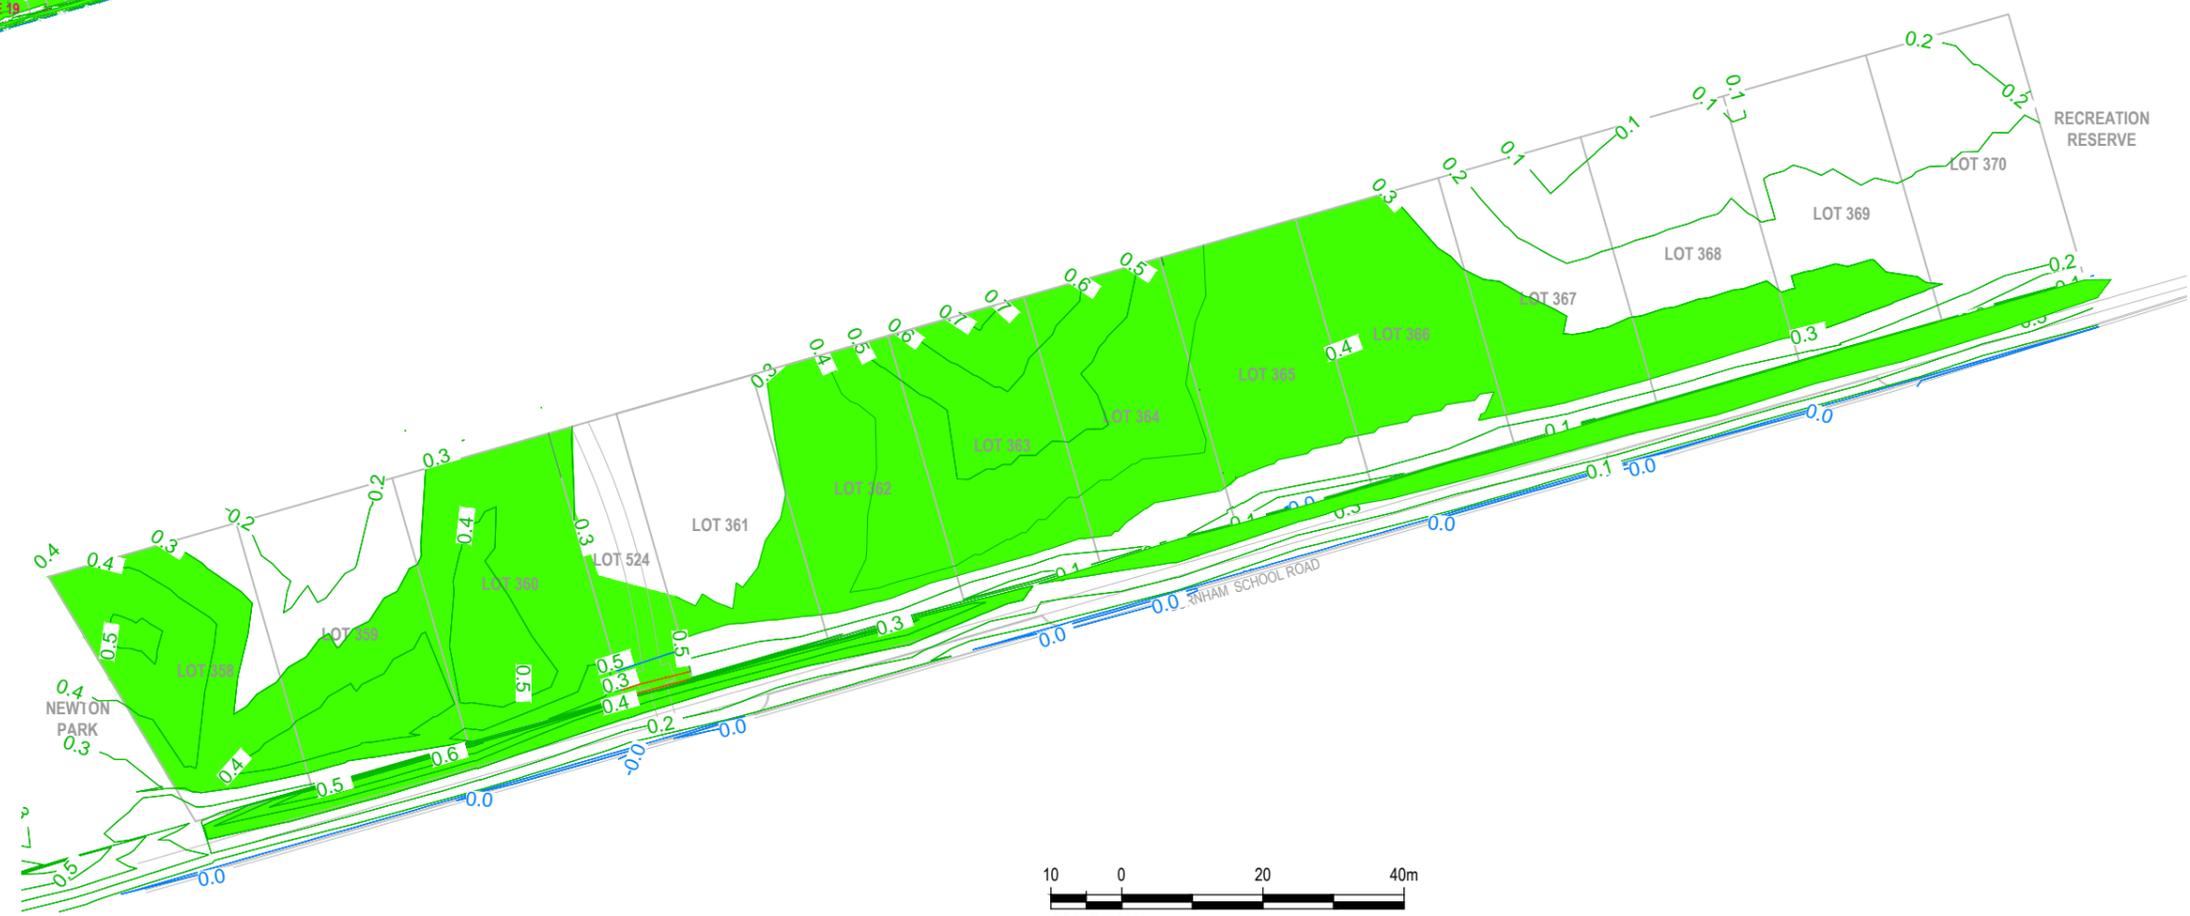
CLIENT		REV	DATE	REVISION DETAILS	APPROVED	DRAWN	DESIGNED	PROJECT		AS BUILT
						A.COLUMBUS	M.CROWE	STONEBROOK ROLLESTON		PROJECT No.
						CHECKED				224926
						D.WATSON		TITLE		SCALE
						APPROVED	DATE	STAGE 19		AS SHOWN
								FILL		SIZE
								AS BUILT		A3
										REV
						B.TOMS				DW-LD-S19-AB-CF-01
										A

The earth filling, with depths of fill are shown on the attached plan 224926-DW-LD-S19-AB-CF-01 [A], have been place in compliance with the terms of NZS 4431:1989.

The attached plan, 224926-DW-LD-S19-AB-CF-01 [A], shows those lots affected by filling and the extent of the fill as part of the development works.
