**Prestons Park Subdivision**  
**GEOTECHNICAL REPORT FOR LOT 995**  
**CDL Land NZ Limited**

**10 January 2024**  
**Revision: 1**  
**Reference: 235361**

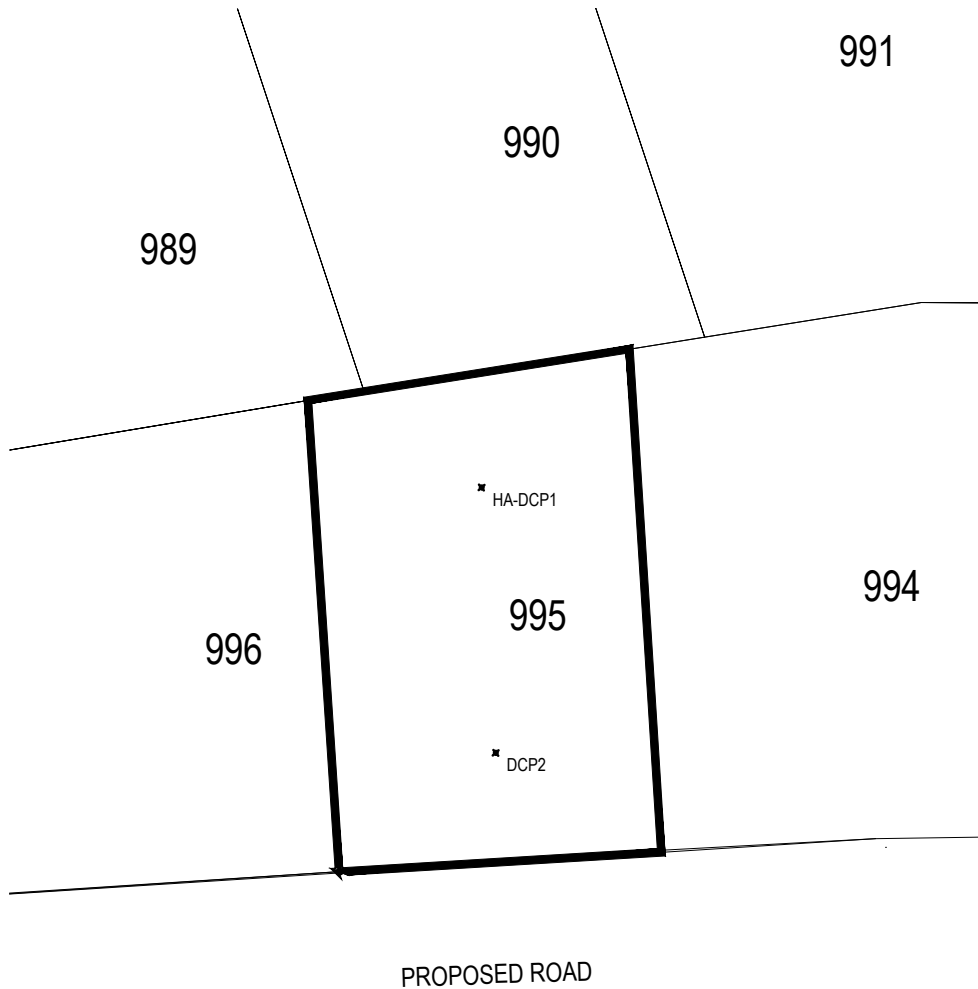
| CLIENT<br><b>PRESTONS PARK</b> | | | | | CHECKED | | TITLE<br>LOT 995<br>SITE LOCATION PLAN<br>FIGURE 1 | SCALE | SIZE |

This building consent report is for Lot 995 which is located in Stage 5 of the Prestons Park Subdivision development (refer Figure 1 in Appendix A). The lot is bordered by residential lots to the north, west and south and an access road to the east.

One hand auger borehole was undertaken on the lot as part of the geotechnical investigation to assess the upper soil profile and the groundwater level. The test location and the borehole log have been uploaded to the New Zealand Geotechnical Database (NZGD). The borehole log is attached in Appendix B.

Two DCPs were carried out with the locations and results uploaded to the NZGD. The DCP test results are attached in Appendix B. One of the DCPs was located adjacent to the hand auger borehole, with the second DCP located on the opposite half of the lot.

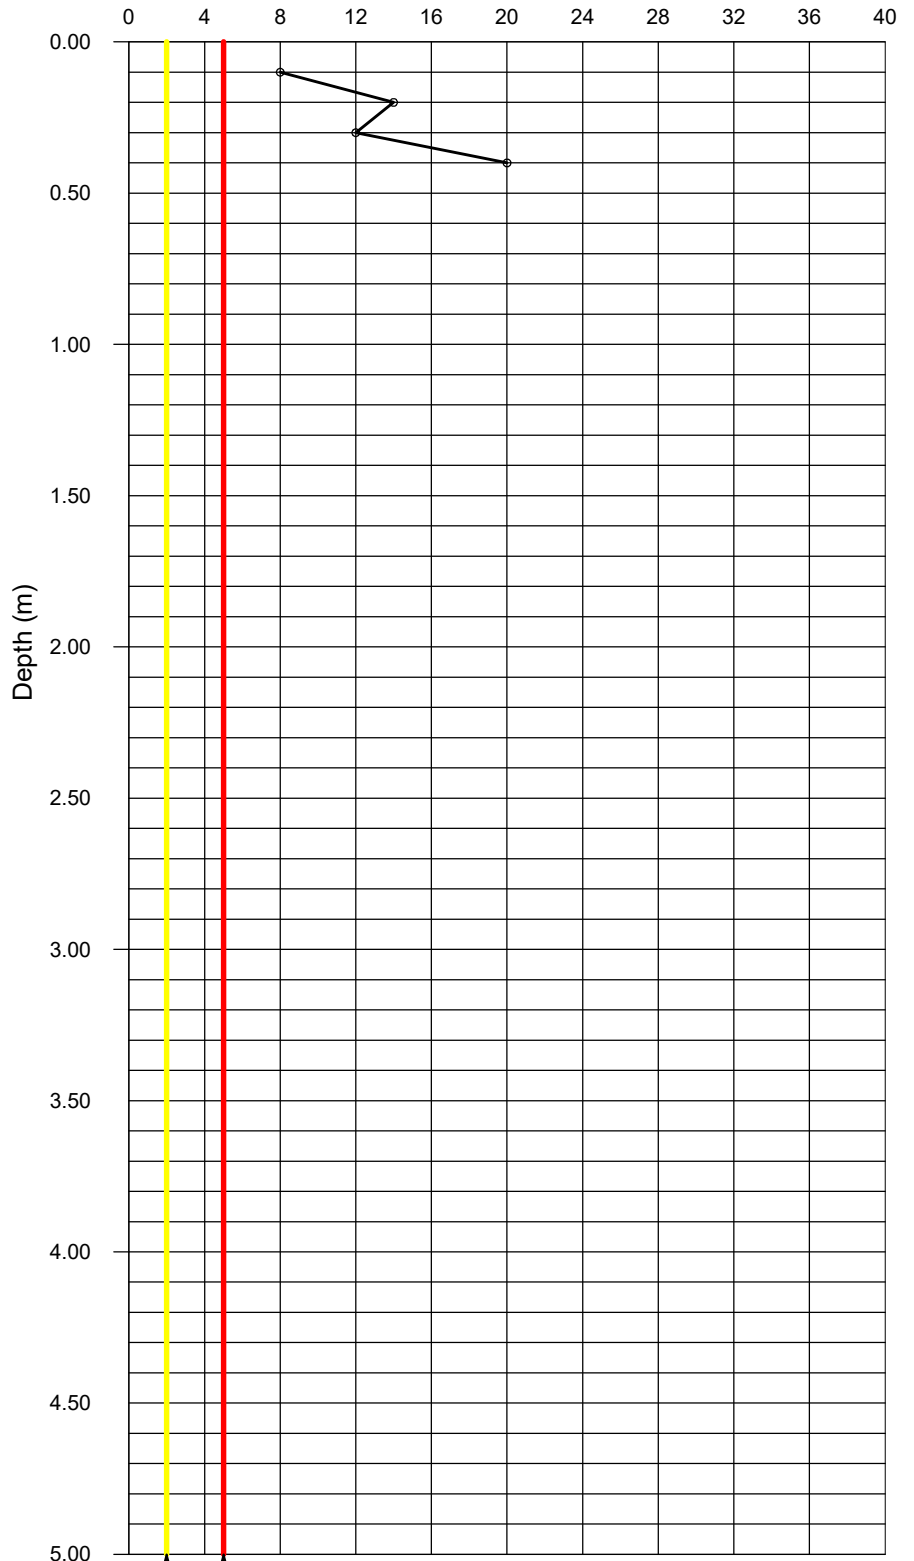
### Number of blows per 100mm

DCP logs indicate 5 blows per 100mm penetration, which is equivalent to an ultimate bearing capacity of 300kPa, was consistently encountered from shallow depths.

20 blows for 100mm in the last increment.  
Co-ordinates recorded in the field with a mobile device.  
RL from data survey based on design contours (+/- 10cm) (Christchurch Drainage Datum).  
Effective refusal, 20+ blows per 100mm

NZS 3604:2011 'Good Ground' Acceptance Criteria  
MBIE '200kPa geotechnical ultimate bearing capacity' Acceptance Criteria

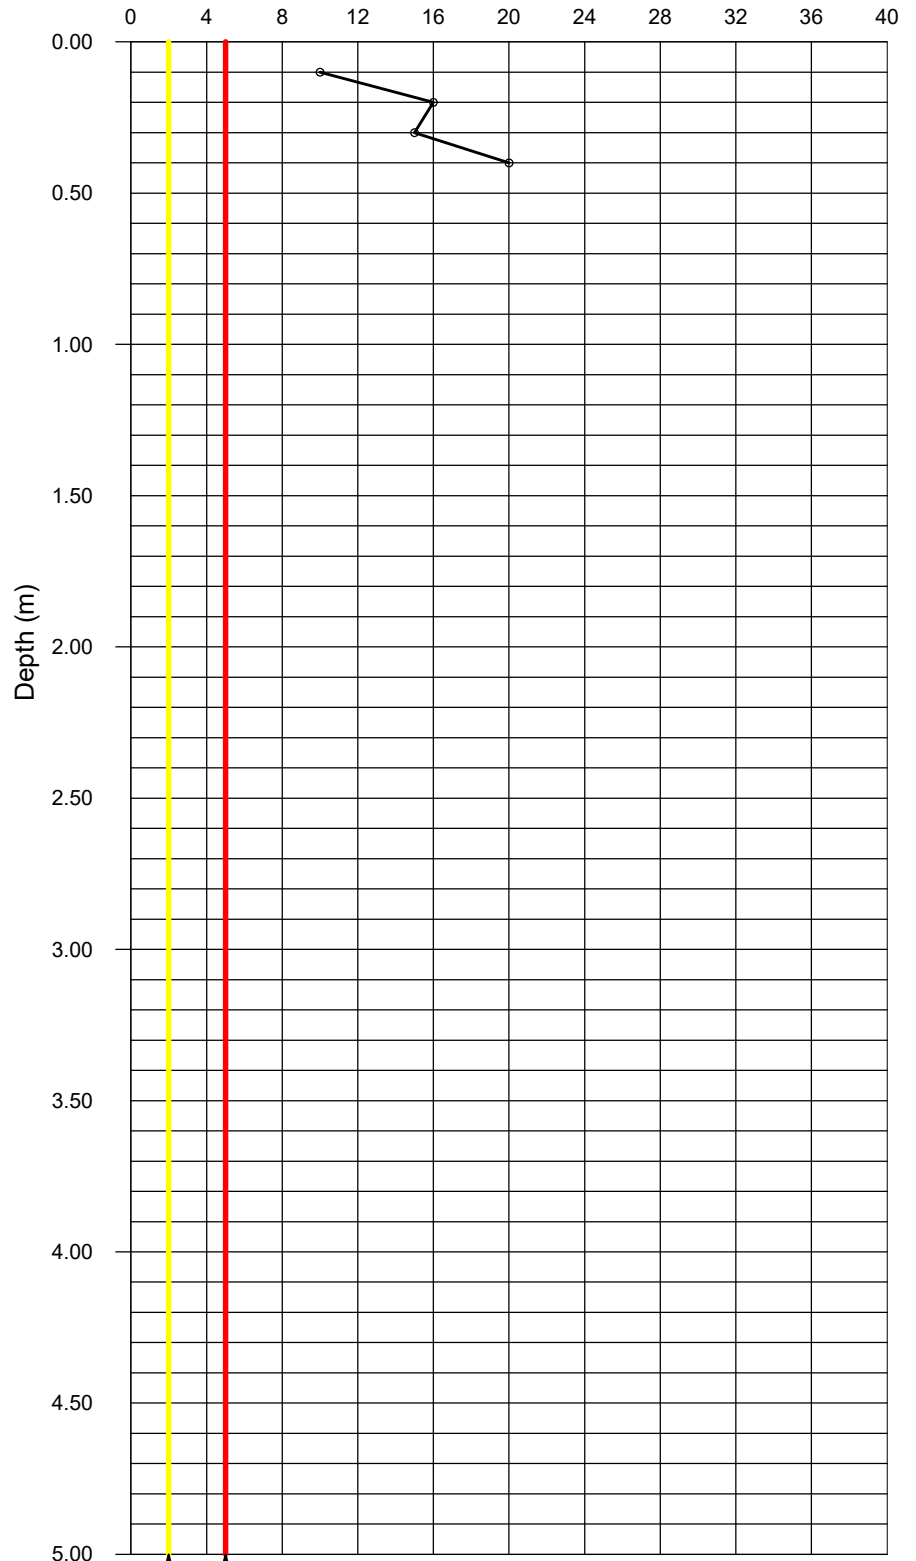
### Number of blows per 100mm

### Remarks:

20 blows for 100mm in the last increment.  
Co-ordinates recorded in the field with a mobile device.  
RL from data survey based on design contours (+/- 10cm) (Christchurch Drainage Datum).  
Effective refusal, 20+ blows per 100mm

NZS 3604:2011 'Good Ground' Acceptance Criteria  
MBIE '200kPa geotechnical ultimate bearing capacity' Acceptance Criteria
