**Prestons Park Subdivision**  
**GEOTECHNICAL REPORT FOR LOT 962**  
**CDL Land NZ Limited**

**30 January 2024**  
**Revision: 1**  
**Reference: 235361**

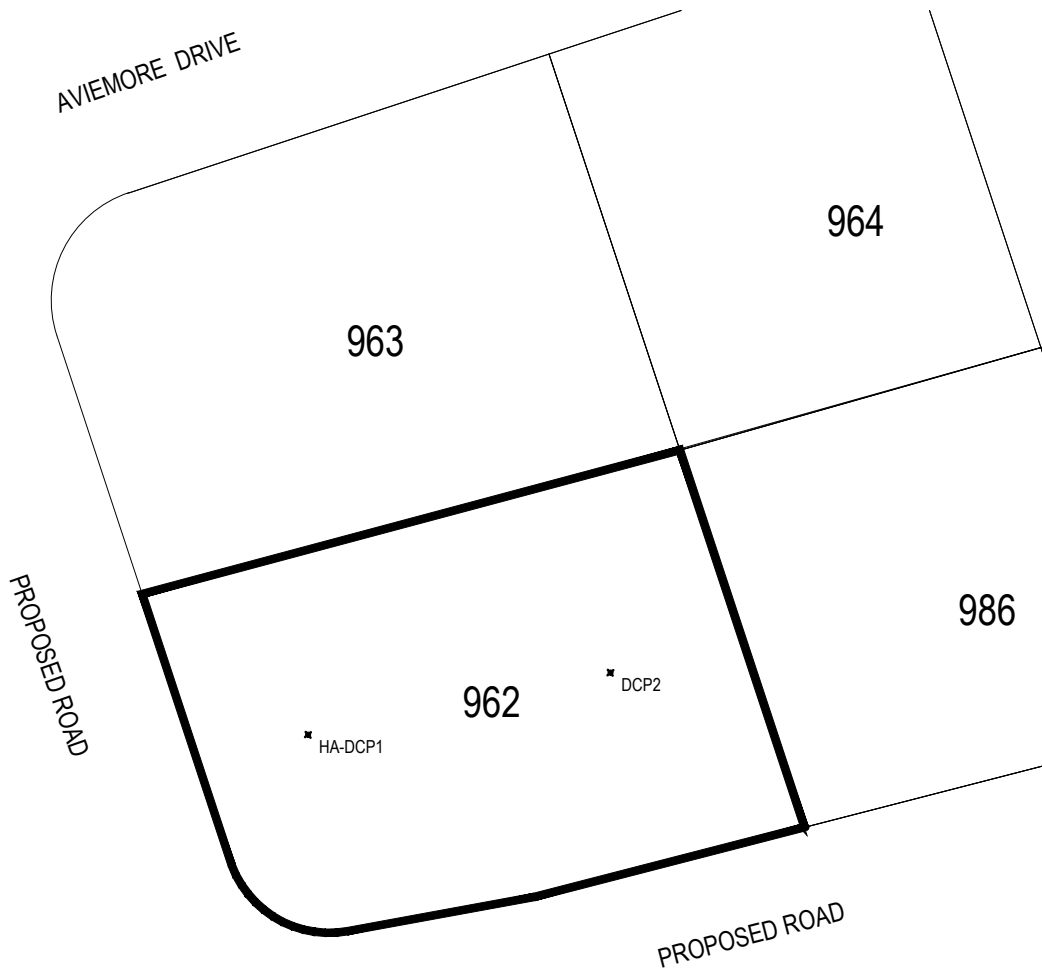
This building consent report is for Lot 962 which is located in Stage 5 of the Prestons Park Subdivision development (refer Figure 1 in Appendix A). The lot is bordered by residential lots to the north and west and an access road to the east and south.

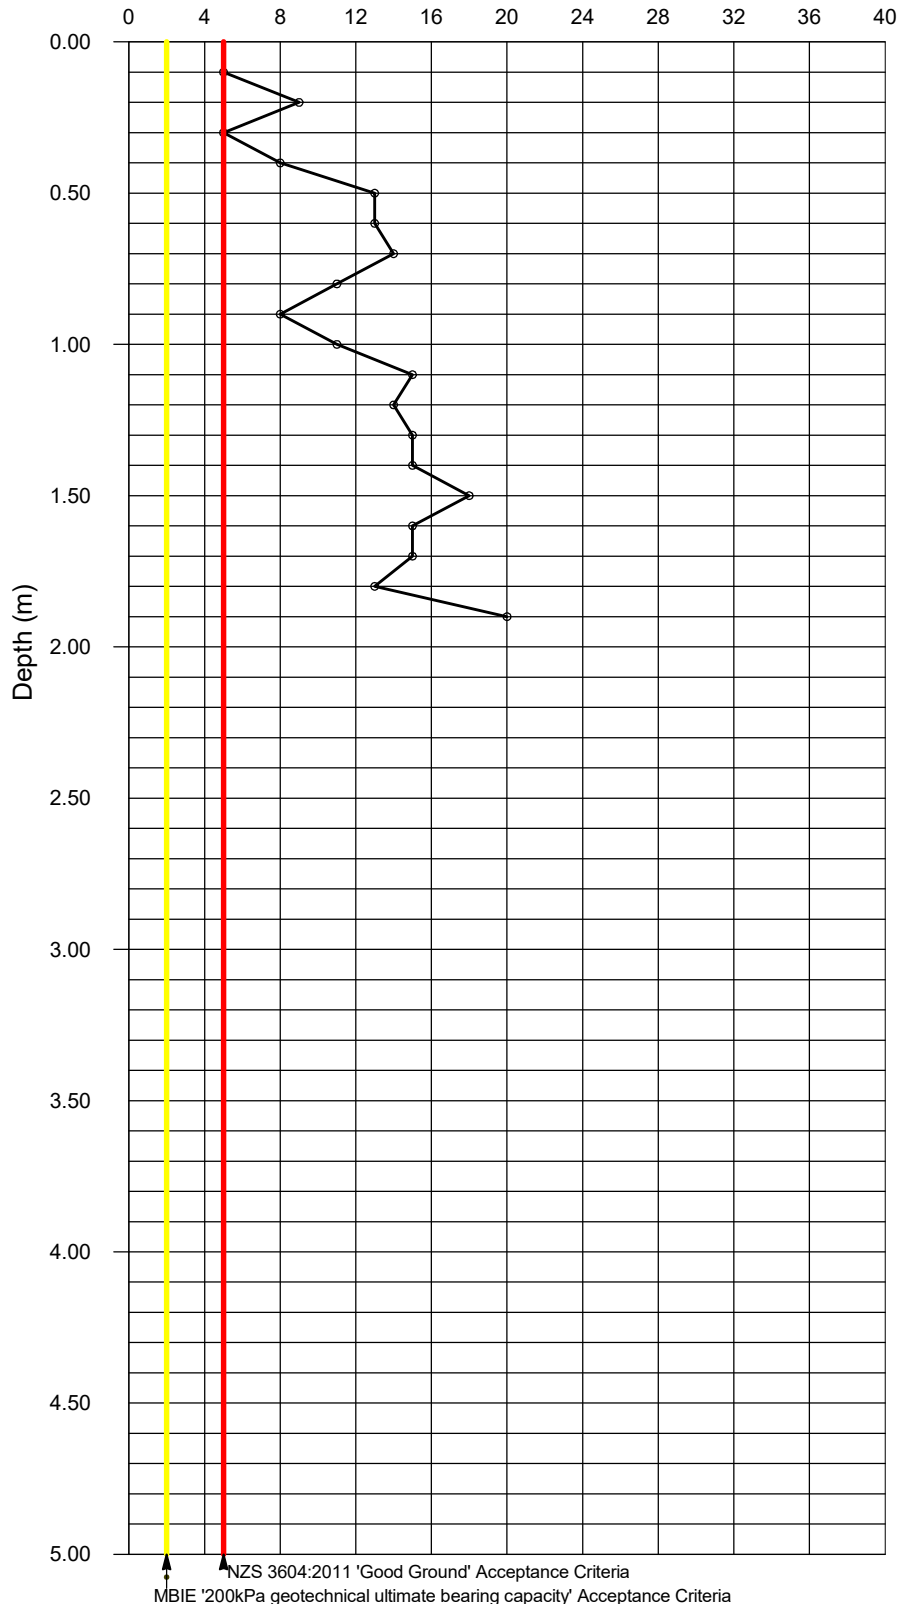
Depth (m)	Blows per 100 mm	Depth (m)	Blows per 100 mm
0.0	5	3.5	
0.1	9		
0.2	5		
0.3	8		
0.4	13	4.0	
0.5	13		
0.6	14		
0.7	11		
0.8	8		
0.9	11	4.5	
1.0	15		
1.1	14		
1.2	15		
1.3	15		
1.4	18	5.0	
1.5	15		
1.6	15		
1.7	13		
1.8	20		
1.9			
2.0			
2.1			
2.2			
2.3			
2.4			
2.5			
2.6			
2.7			
2.8			
2.9			
3.0			
3.1			
3.2			
3.3			
3.4			
3.5

### Number of blows per 100mm

Two DCPs were carried out with the locations and results uploaded to the NZGD. The DCP test results are attached in Appendix B. One of the DCPs was located adjacent to the hand auger borehole, with the second DCP located on the opposite half of the lot.

DCP logs indicate 5 blows per 100mm penetration, which is equivalent to an ultimate bearing capacity of 300kPa, was consistently encountered from shallow depths.

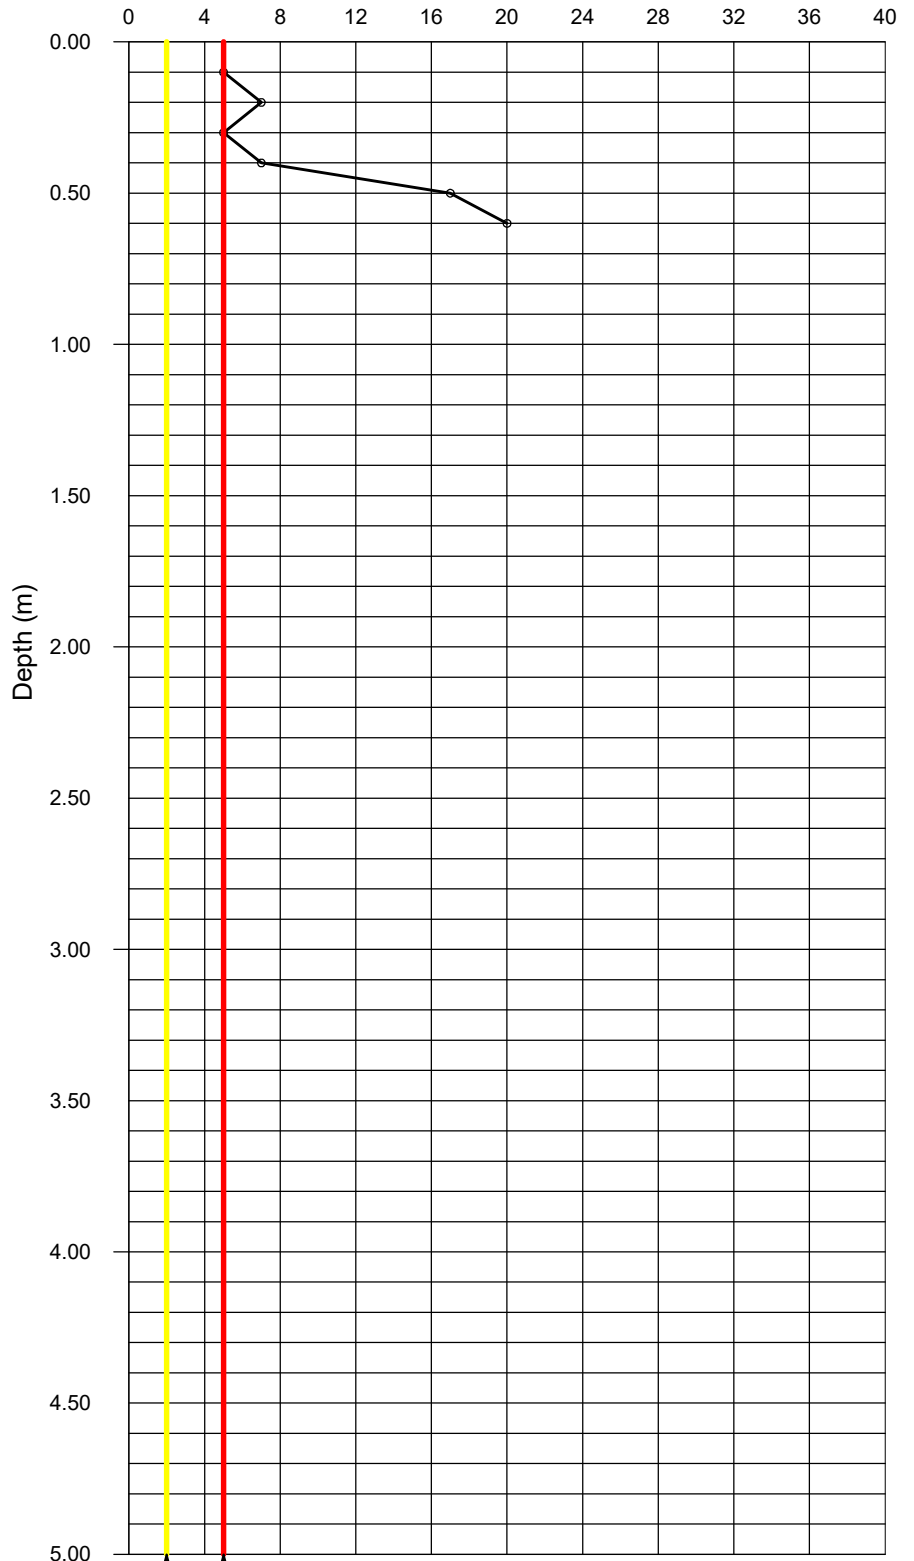
Depth (m)	Blows per 100 mm	Depth (m)	Blows per 100 mm
0.0	5	3.5	
	7		
	5		
	7		
0.5	17	4.0	
	20		
		4.5	
1.0			
		5.0	
1.5			
2.0			
2.5			
3.0			
3.5

### Number of blows per 100mm

20 blows for 100mm in the last increment.  
Co-ordinates recorded in the field with a mobile device.  
RL from data survey based on design contours (+/- 100mm) (Christchurch drainage datum).  
Effective refusal, 20+ blows per 100mm

NZS 3604:2011 'Good Ground' Acceptance Criteria  
MBIE '200kPa geotechnical ultimate bearing capacity' Acceptance Criteria
