Prestons Park Subdivision
GEOTECHNICAL REPORT FOR LOT 983
CDL Land NZ Limited

30 January 2024
Revision: 1
Reference: 235361

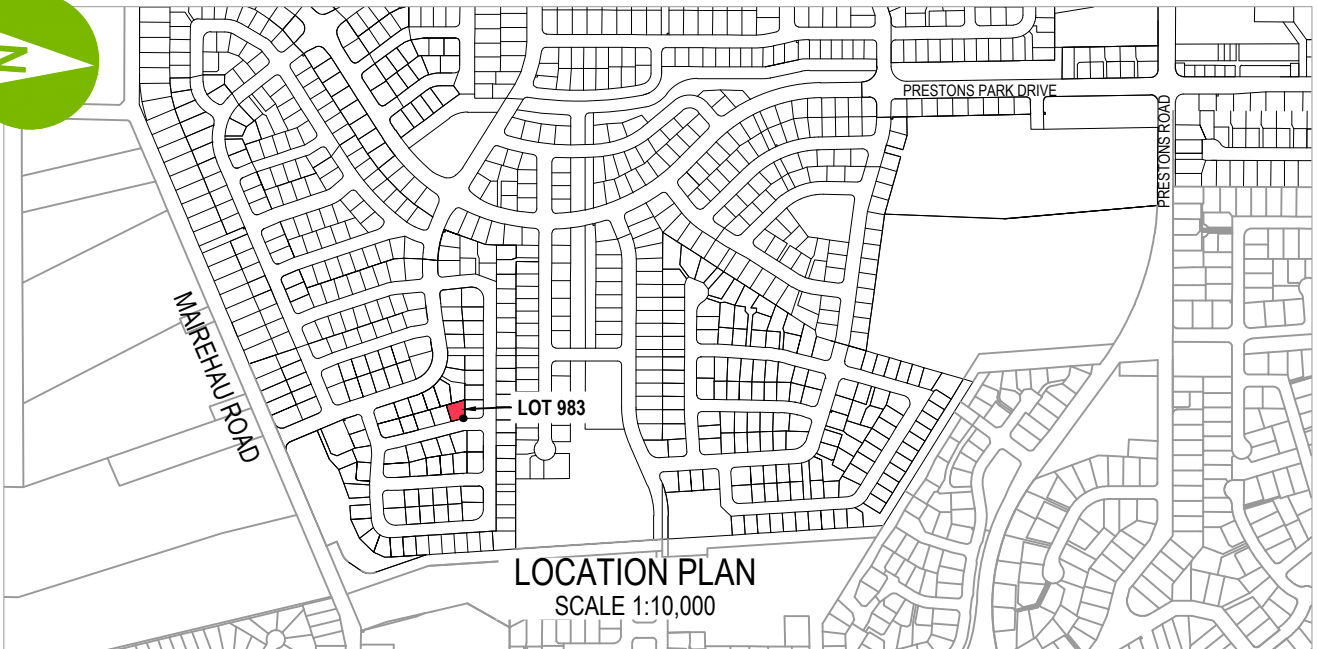
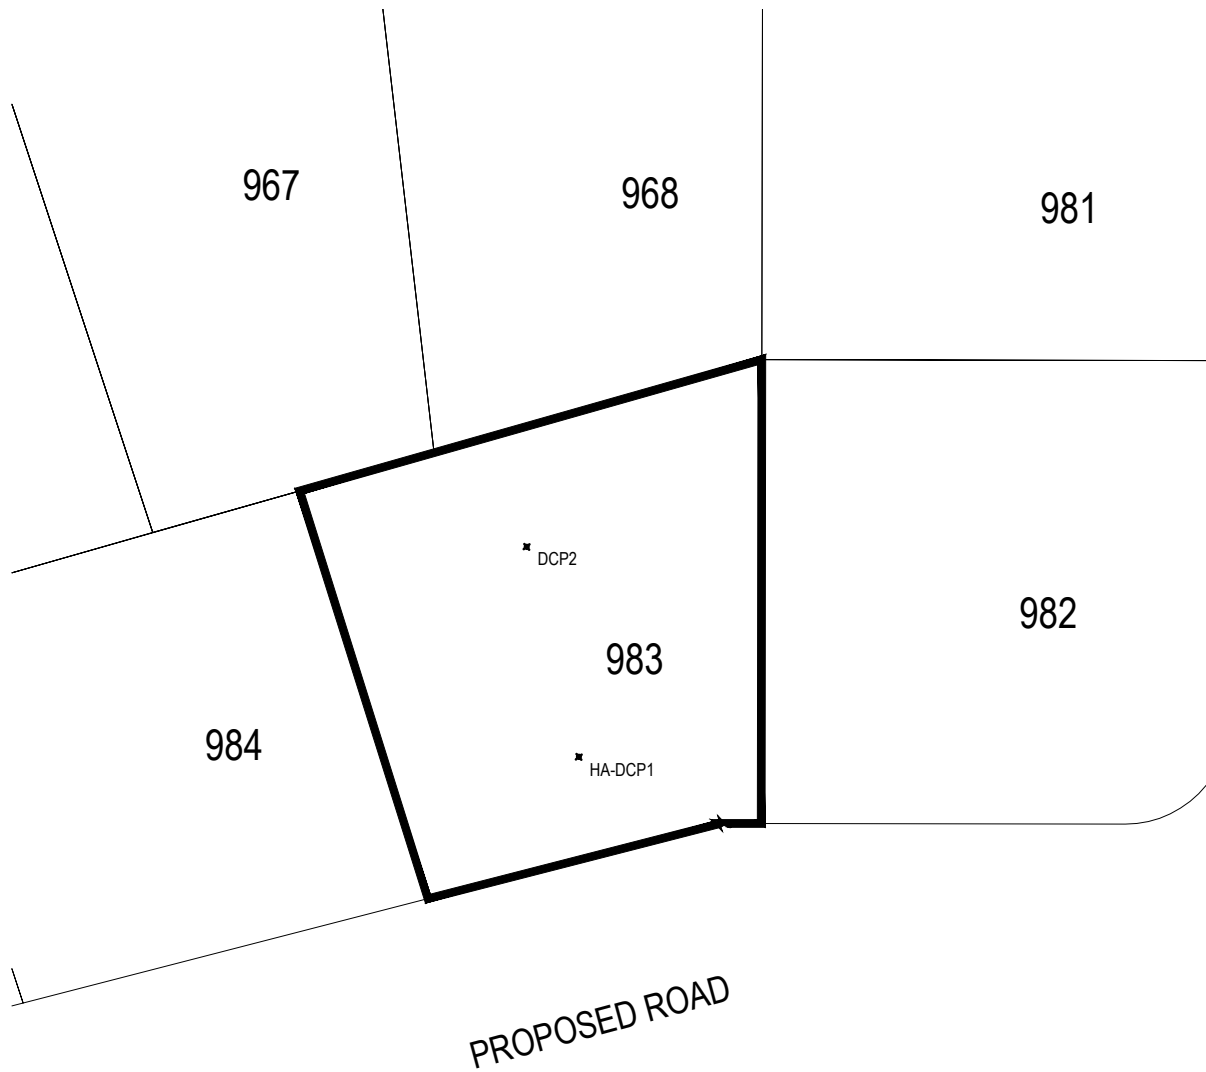
| CLIENT PRESTONS PARK | | | | | CHECKED | | TITLE LOT 983 SITE LOCATION PLAN FIGURE 1 | SCALE | SIZE |

This building consent report is for Lot 983 which is located in Stage 5 of the Prestons Park Subdivision development (refer Figure 1 in Appendix A). The lot is bordered by residential lots to the north, west and south and an access road to the east.
