**Prestons Park Subdivision**  
**GEOTECHNICAL REPORT FOR LOT 985**  
**CDL Land NZ Limited**

**30 January 2024**  
**Revision: 1**  
**Reference: 235361**

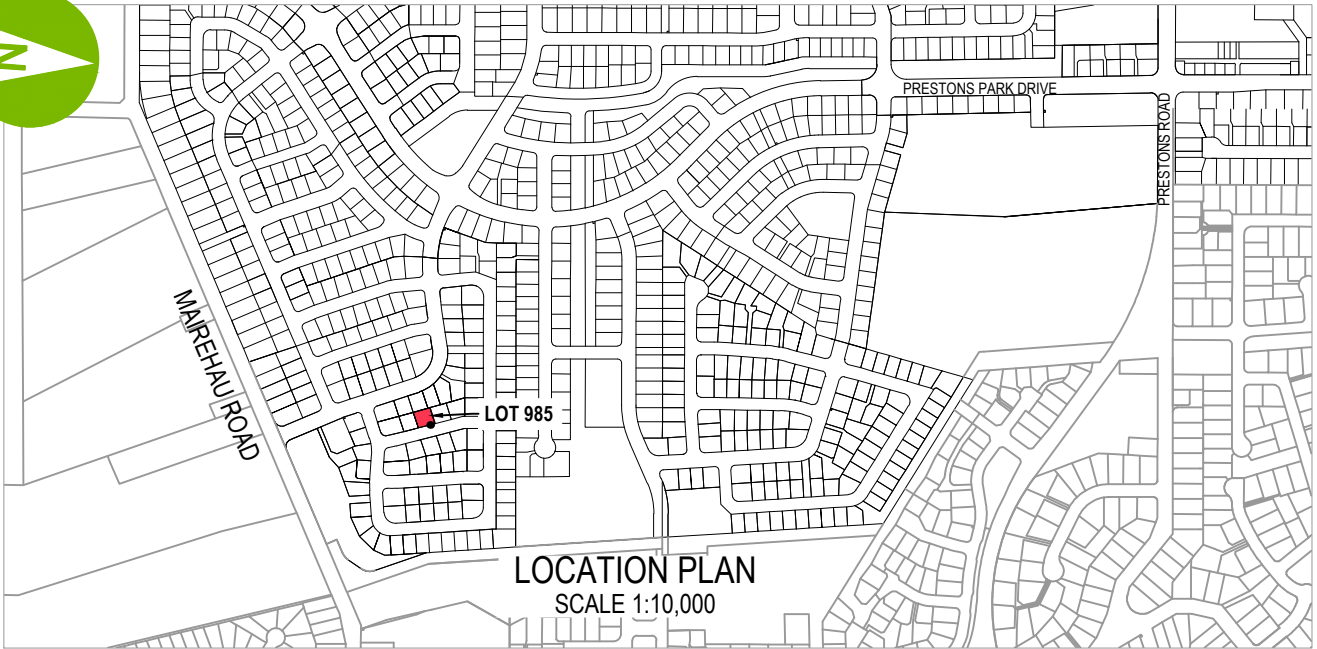
This building consent report is for Lot 985 which is located in Stage 5 of the Prestons Park Subdivision development (refer Figure 1 in Appendix A). The lot is bordered by residential lots to the north, west and south and an access road to the east.
