**Prestons Park Subdivision**  
**GEOTECHNICAL REPORT FOR LOT 986**  
**CDL Land NZ Limited**

**30 January 2024**  
**Revision: 1**  
**Reference: 235361**

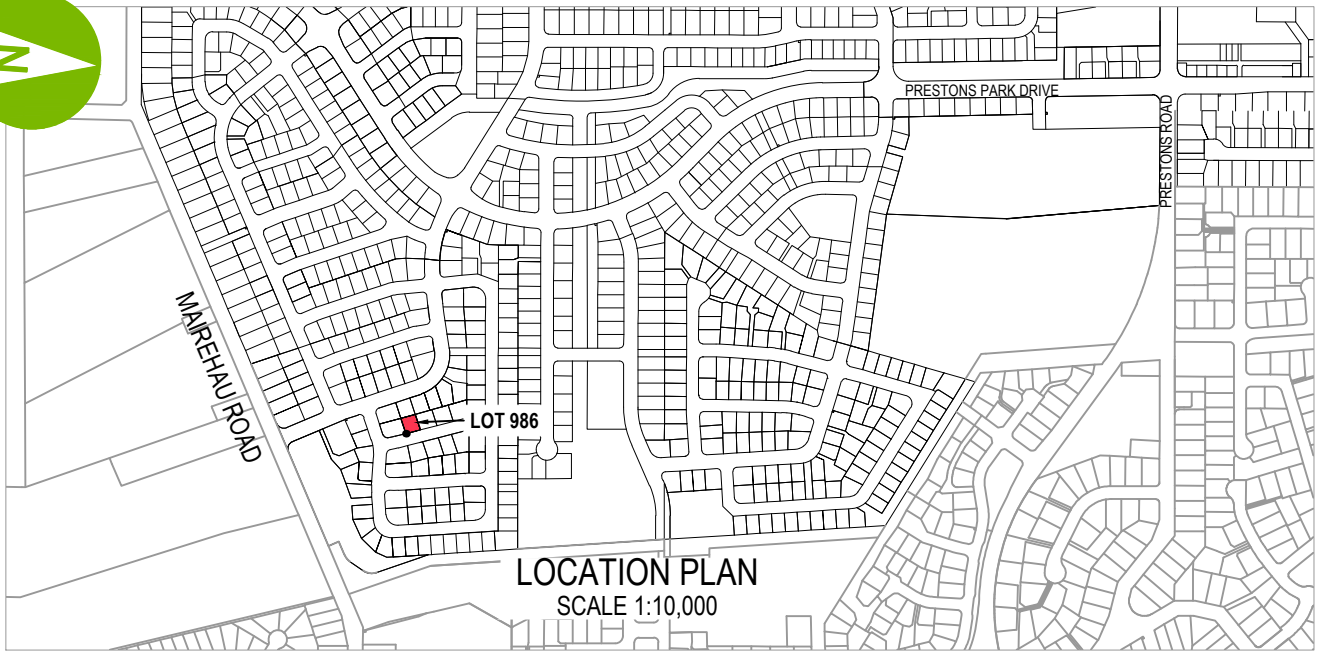
This building consent report is for Lot 986 which is located in Stage 5 of the Prestons Park Subdivision development (refer Figure 1 in Appendix A). The lot is bordered by residential lots to the north, west and south and an access road to the east.
