**Prestons Park Subdivision**  
**GEOTECHNICAL REPORT FOR LOT 987**  
**CDL Land NZ Limited**

**30 January 2024**  
**Revision: 1**  
**Reference: 235361**

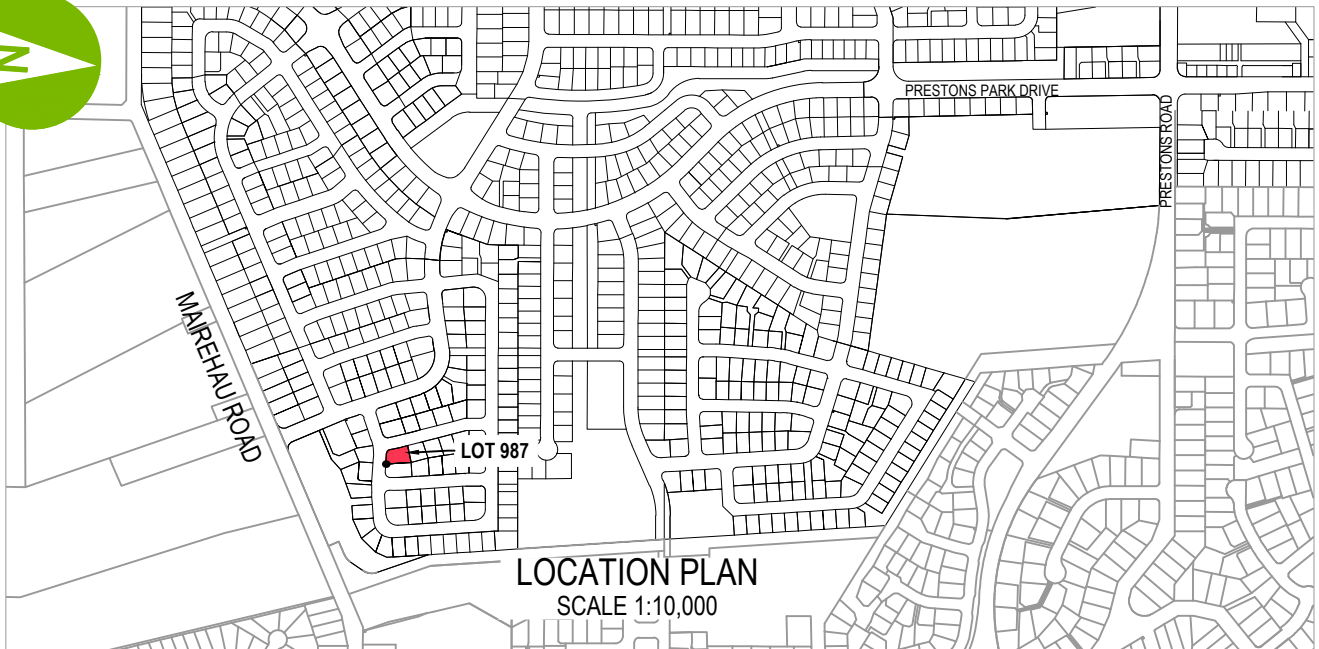
PROJECT
PRESTONS PARK
TITLE
LOT 987 SITE LOCATION PLAN FIGURE 1

This building consent report is for Lot 987 which is located in Stage 5 of the Prestons Park Subdivision development (refer Figure 1 in Appendix A). The lot is bordered by residential lots to the north and east and an access road to the south and west.
