**Prestons Park Subdivision**  
**GEOTECHNICAL REPORT FOR LOT 990**  
**CDL Land NZ Limited**

**30 January 2024**  
**Revision: 1**  
**Reference: 235361**

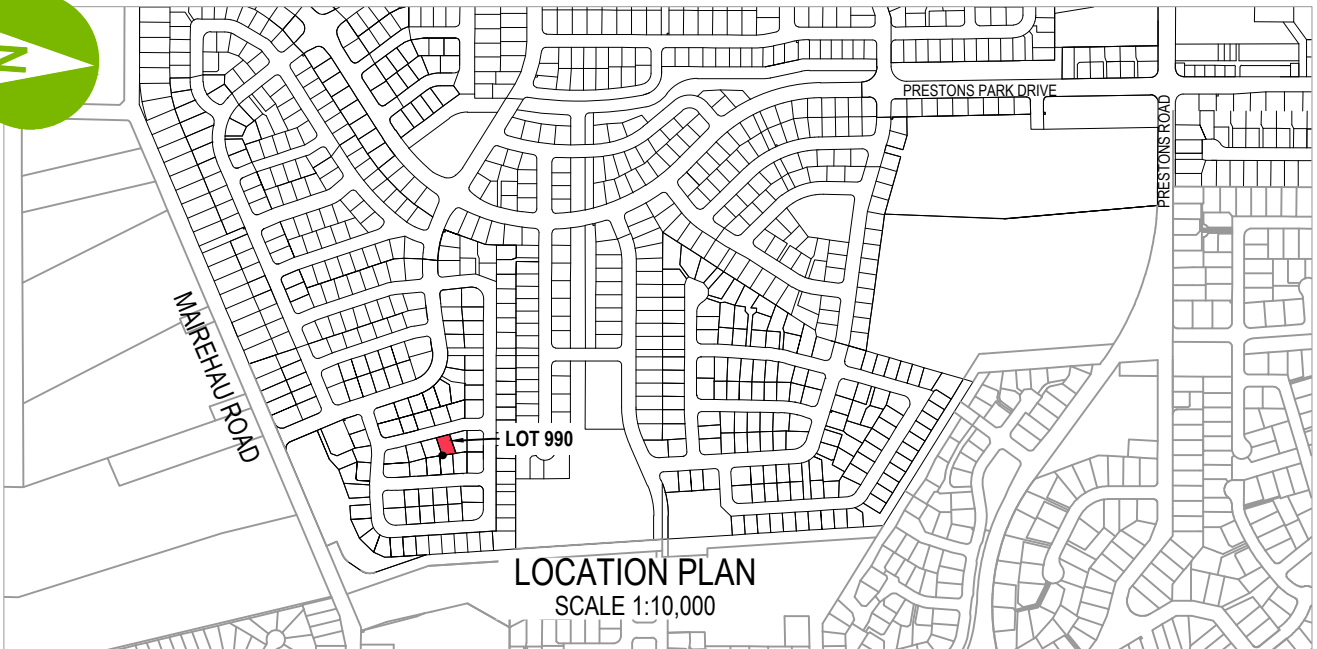
PROJECT
PRESTONS PARK
TITLE
LOT 990 SITE LOCATION PLAN FIGURE 1

This building consent report is for Lot 990 which is located in Stage 5 of the Prestons Park Subdivision development (refer Figure 1 in Appendix A). The lot is bordered by residential lots to the north, east and south and an access road to the west.
