Prestons Park Subdivision
GEOTECHNICAL REPORT FOR LOT 291
CDL Land NZ Limited

8 April 2024
Revision: 0
Reference: 235361

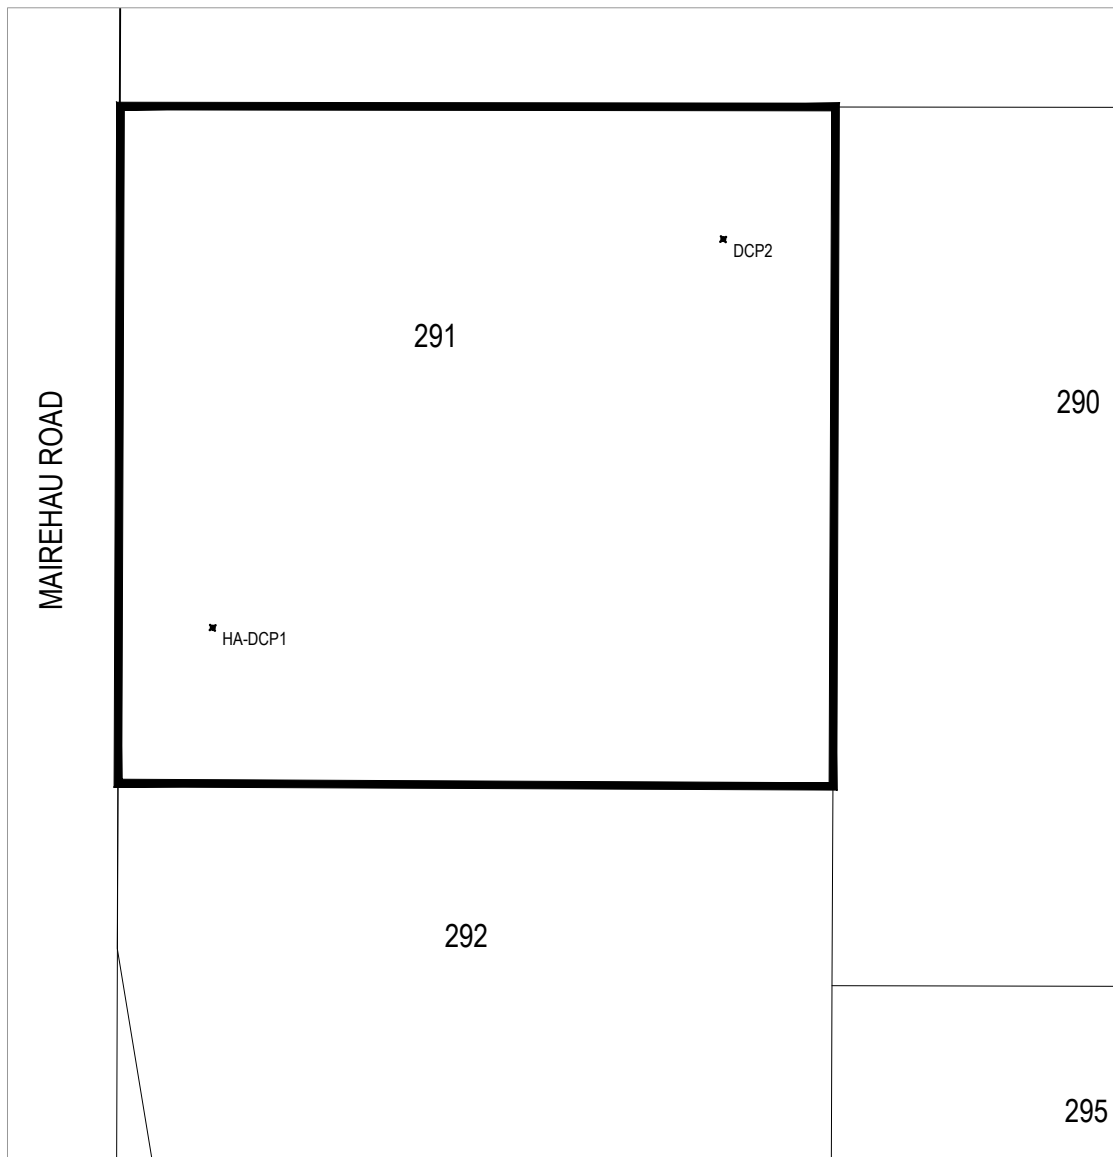
This building consent report is for Lot 291 which is located in Stage 2 of the Prestons Park Subdivision development (refer Figure 1 in Appendix A). The lot is bordered by residential lots to the north and east, Mairehau Road to the south, and agricultural land to the west.
