Prestons Park Subdivision
GEOTECHNICAL REPORT FOR LOT 292
CDL Land NZ Limited

8 April 2024
Revision: 0
Reference: 235361

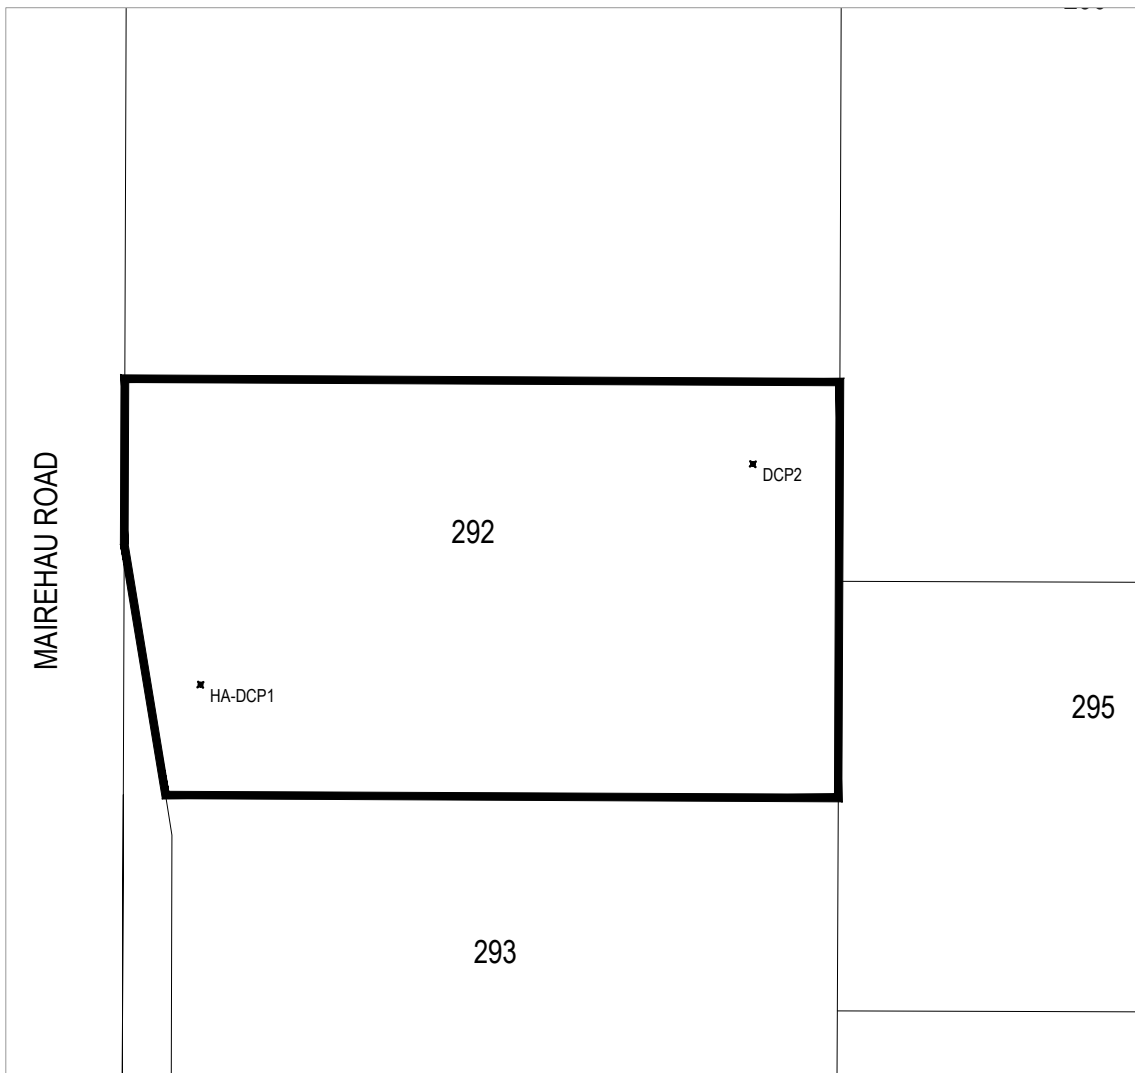
This building consent report is for Lot 292 which is located in Stage 2 of the Prestons Park Subdivision development (refer Figure 1 in Appendix A). The lot is bordered by residential lots to the north, east and west and Mairehau Road to the south.
