Prestons Park Subdivision  
GEOTECHNICAL REPORT FOR LOT 312  
CDL Land NZ Limited

26 July 2024  
Revision: 0  
Reference: 235361

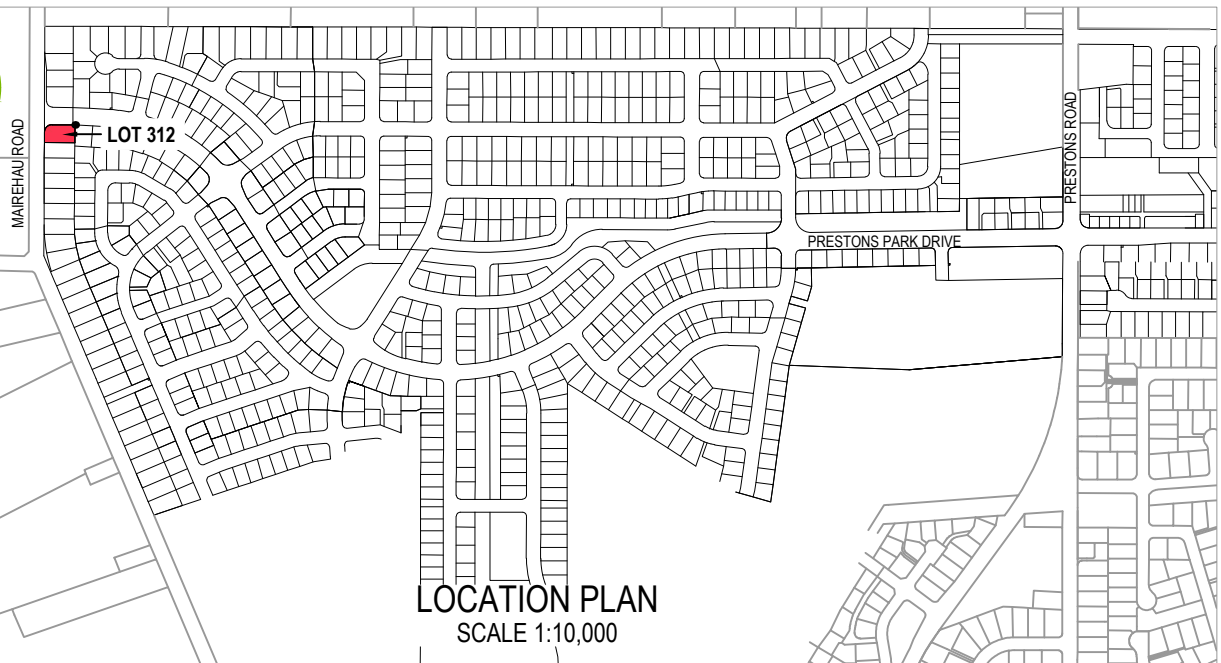
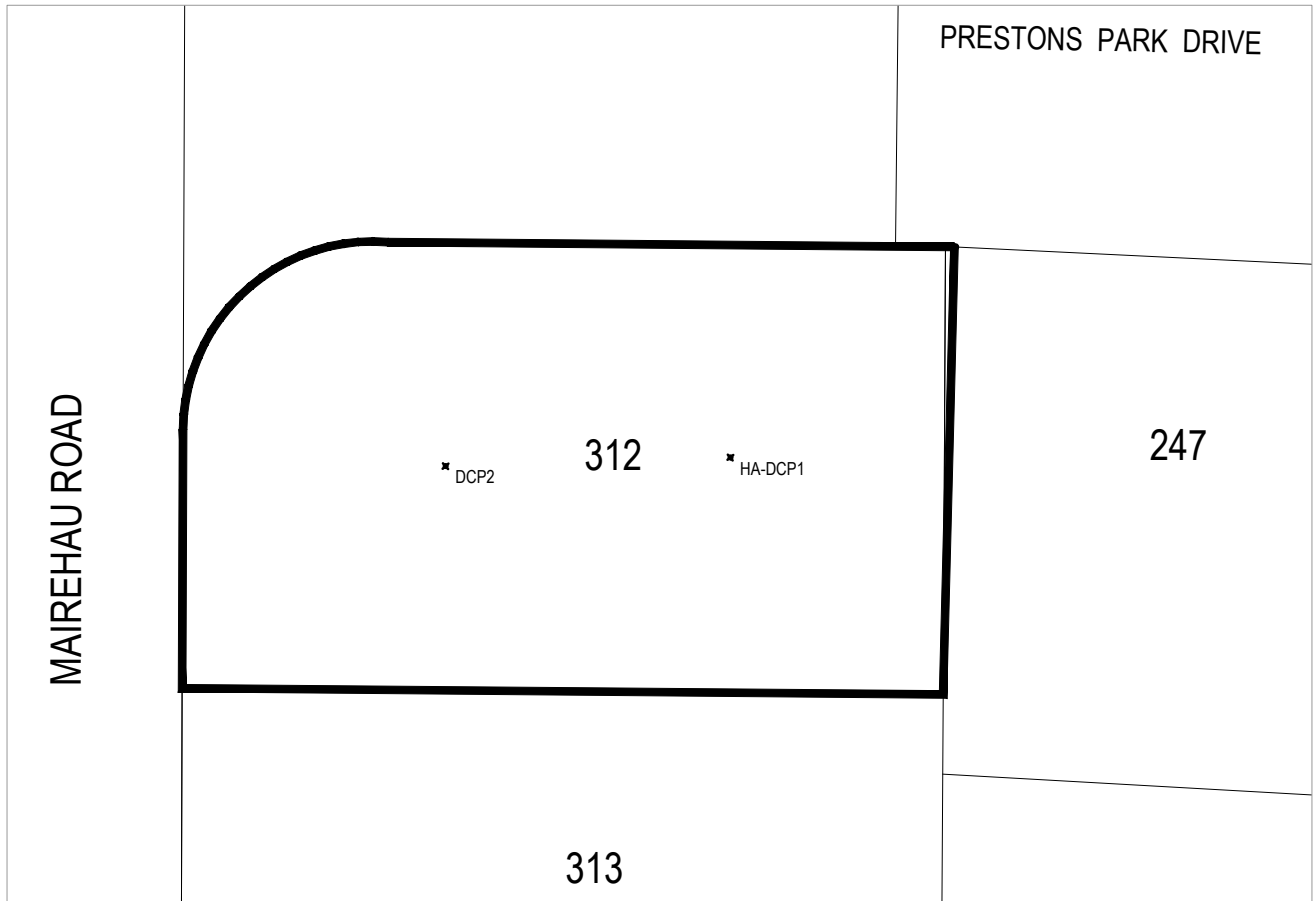
PROJECT
PRESTONS PARK
TITLE
LOT 312
SITE LOCATION PLAN
FIGURE 1

This building consent report is for Lot 312 which is located in Stage 2 of the Prestons Park Subdivision development (refer Figure 1 in Appendix A). The lot is bordered by residential lots to the north, west and east and Mairehau Road to the south.

Two DCPs were carried out with the locations and results uploaded to the NZGD. The DCP test results are attached in Appendix B. One of the DCPs was located adjacent to the hand auger borehole, with the second DCP located on the opposite half of the lot.

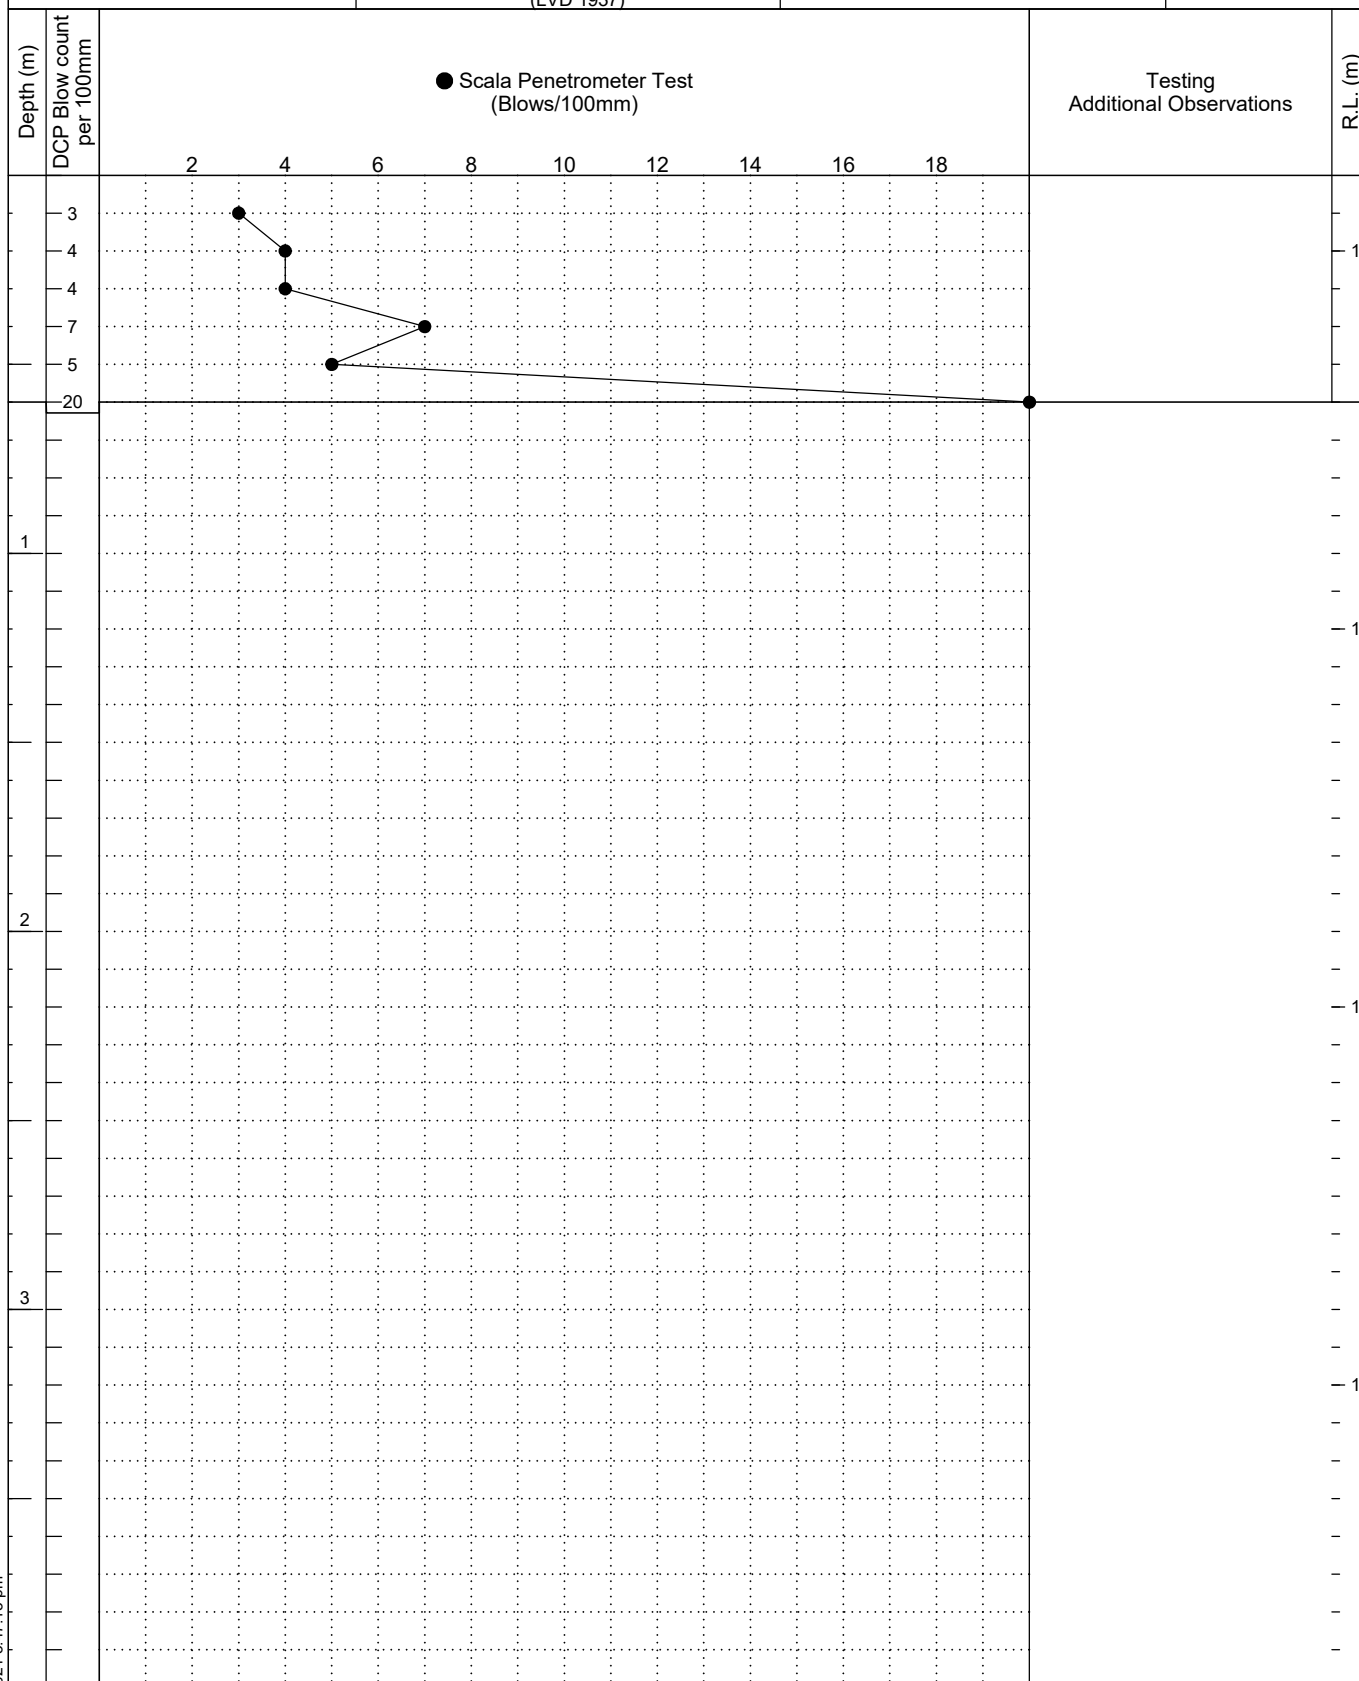
<b>DRILLING INFORMATION</b>	<b>CO-ORDINATES: NZTM</b>	Date started: 9/07/2024	Logged by: JN
Method: Scala Penetrometer	Easting: 1573211m	Date completed: 9/07/2024	Input by: AP
Equipment: Scala Penetrometer	Northing: 5185189m	Inclination: 90°	Checked by: RL
Contractor: N/A	Ground level: 14.2m (1 VD 1937)	Orientation: N/A	Verified by: KF

**Water Level Readings:**  
**Date Time | Hole Depth | Water Level**  
 Groundwater level not encountered

DCP logs indicate 5 blows per 100mm penetration, which is equivalent to an ultimate bearing capacity of 300kPa, was consistently encountered from a depth of 0.4m.
