Prestons Park Subdivision
GEOTECHNICAL REPORT FOR LOT 316
CDL Land NZ Limited

26 July 2024
Revision: 0
Reference: 235361

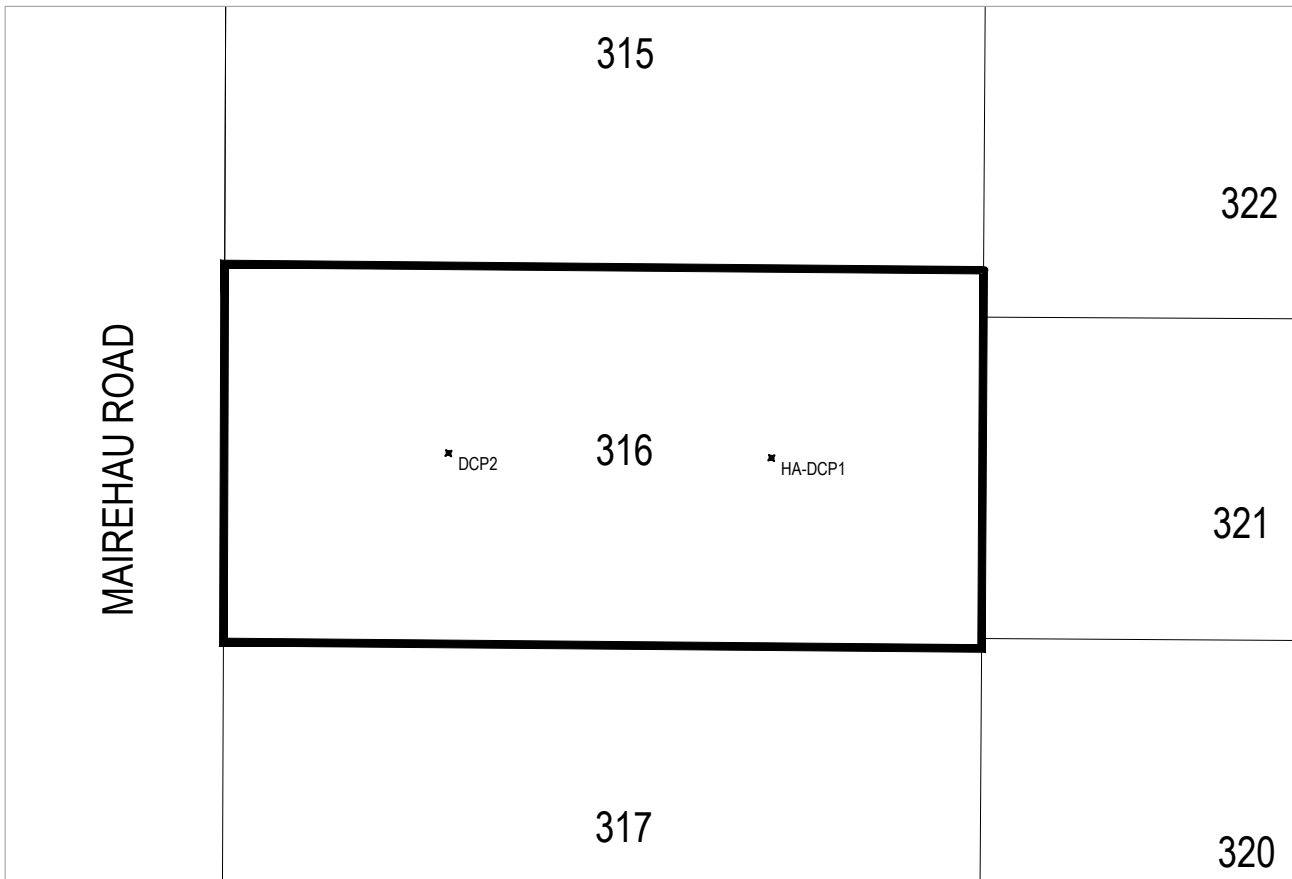
PROJECT	TITLE
PRESTONS PARK	LOT 316
	SITE LOCATION PLAN
	FIGURE 1

This building consent report is for Lot 316 which is located in Stage 2 of the Prestons Park Subdivision development (refer Figure 1 in Appendix A). The lot is bordered by residential lots to the north, west and east and Mairehau Road to the south.

Two DCPs were carried out with the locations and results uploaded to the NZGD. The DCP test results are attached in Appendix B. One of the DCPs was located adjacent to the hand auger borehole, with the second DCP located on the opposite half of the lot.

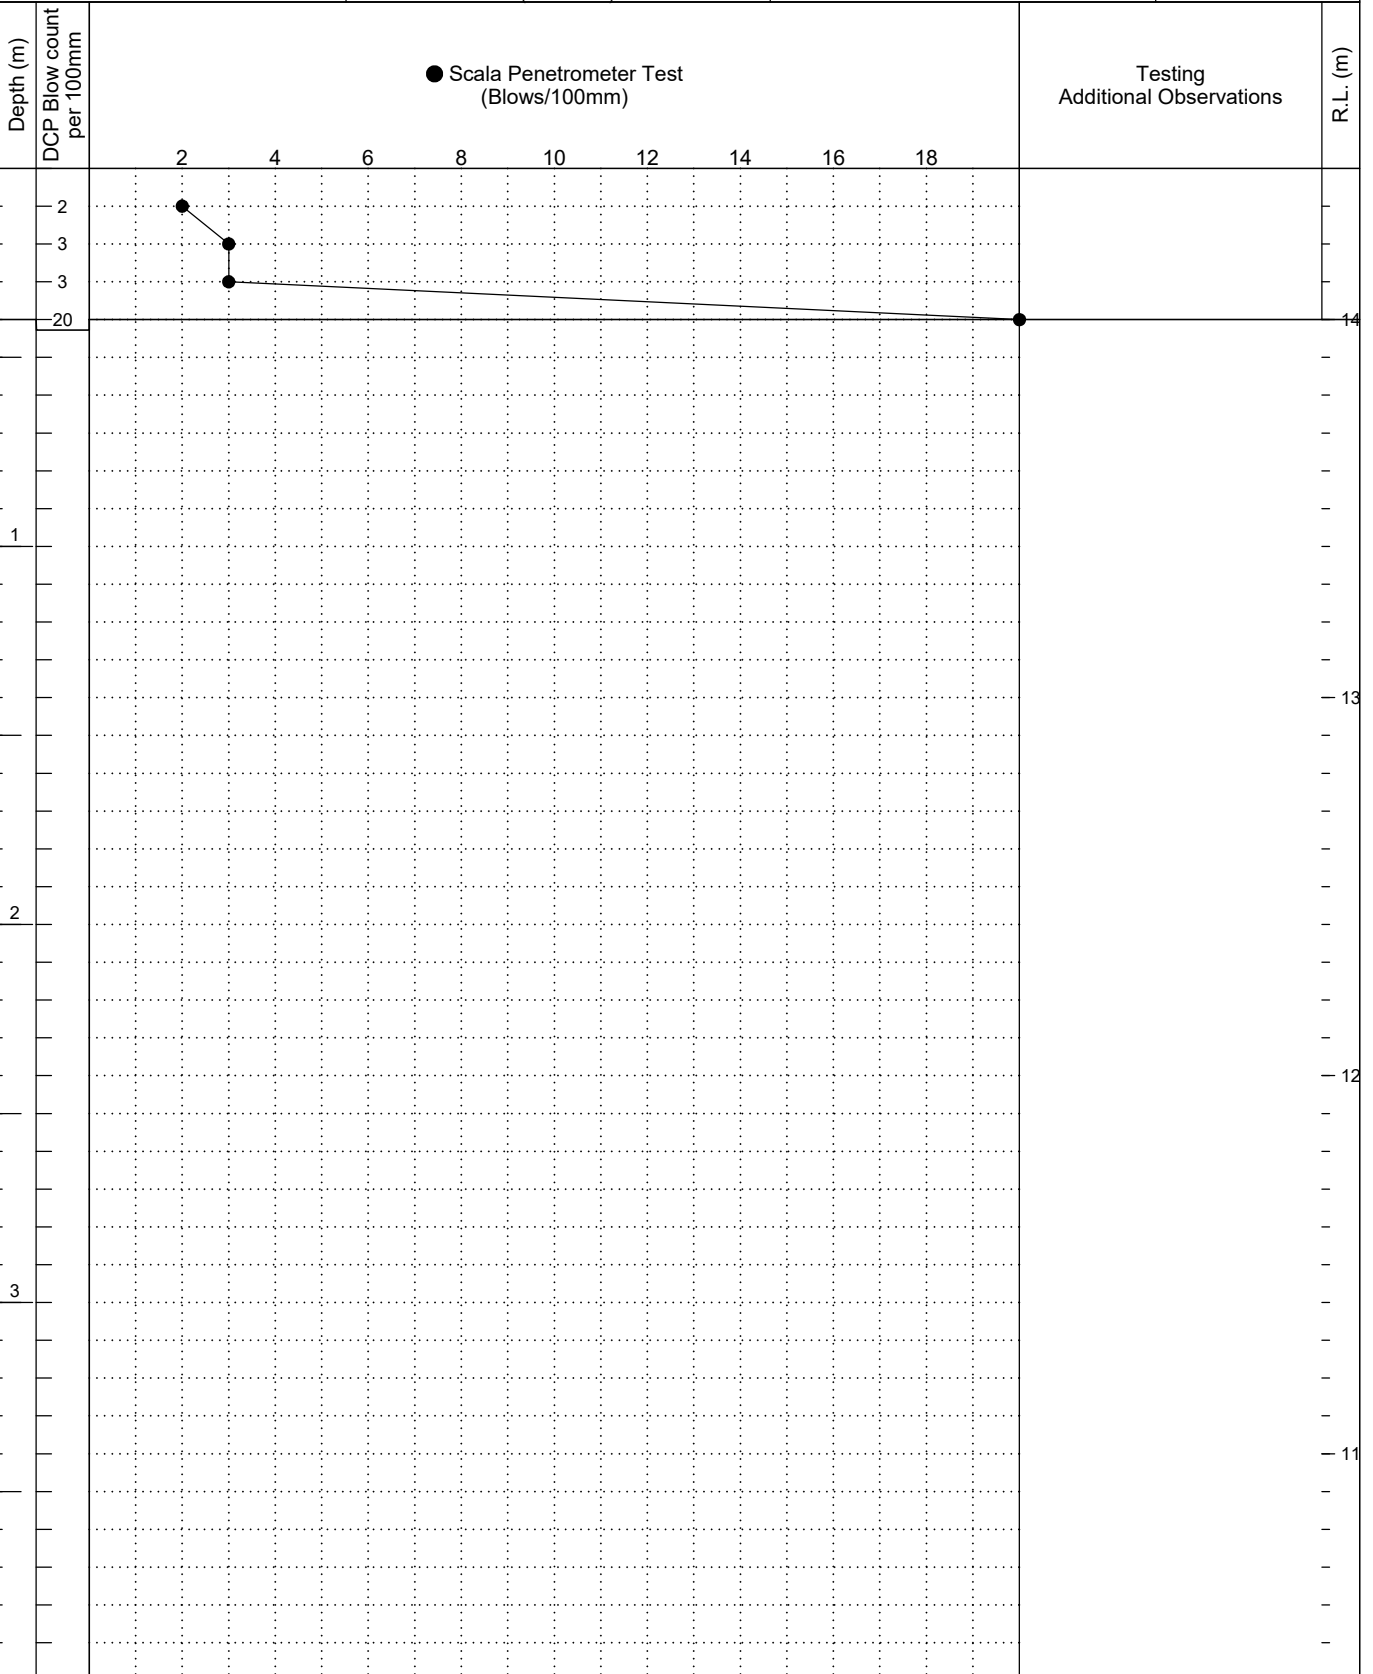
DCP logs indicate 5 blows per 100mm penetration, which is equivalent to an ultimate bearing capacity of 300kPa, was consistently encountered from a depth of 0.35m.

Based on our understanding of the site works and the investigation results, we recommend that NZS3604:2011 compliant foundations are embedded a minimum depth of 0.35m below current ground level.
