Prestons Park Subdivision  
GEOTECHNICAL REPORT FOR LOT 784  
CDL Land NZ Limited

26 August 2024  
Revision: 0  
Reference: 235361

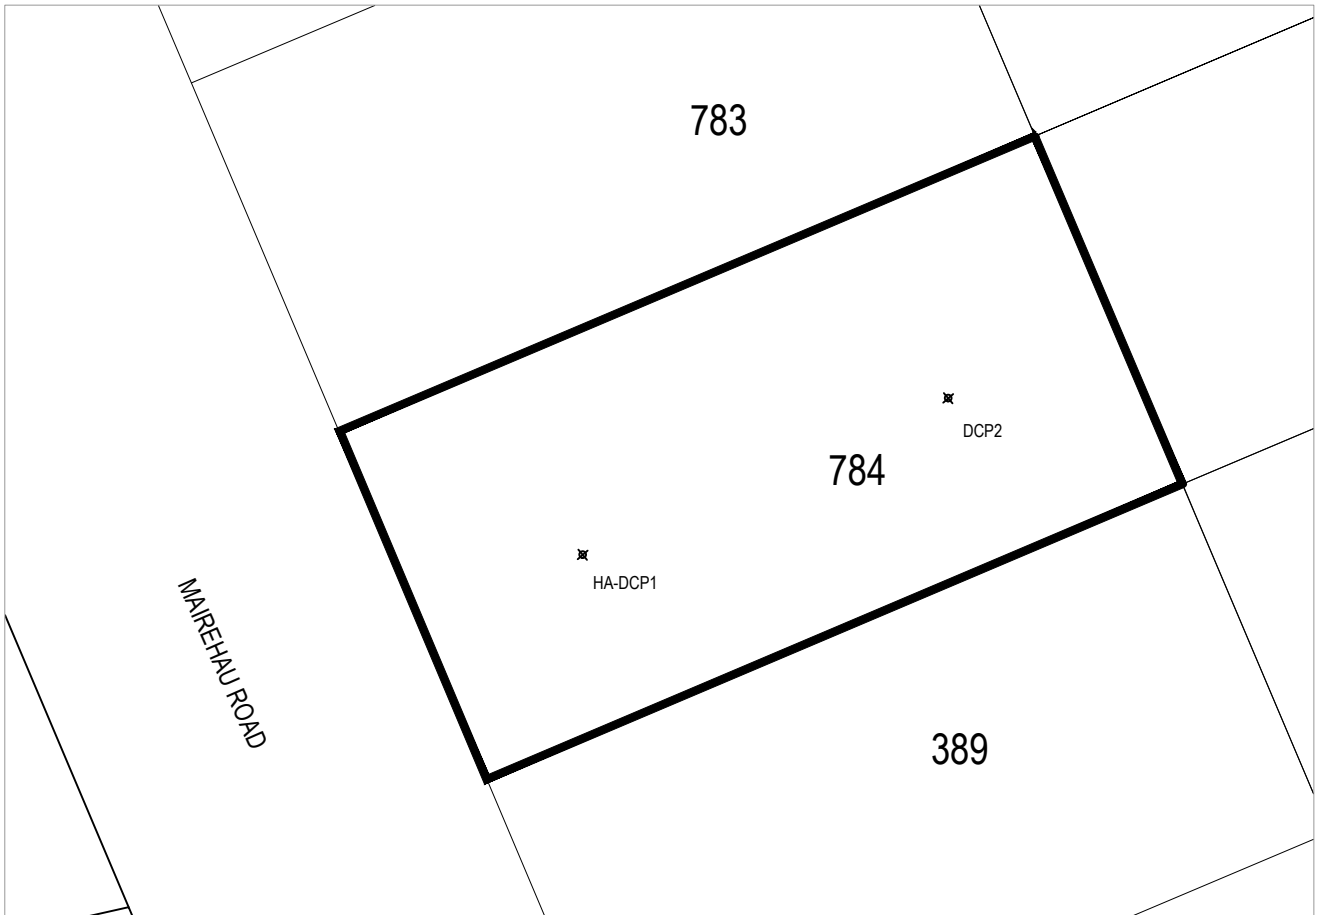
This building consent report is for Lot 784 which is located in Stage 2 of the Prestons Park Subdivision development (refer Figure 1 in Appendix A). The lot is bordered by residential lots to the north, west and east and Mairehau Road to the south.
